Water Year 2017

Oregon Walla Walla Basin Aquifer Recharge Report

FINAL REPORT

February 2018

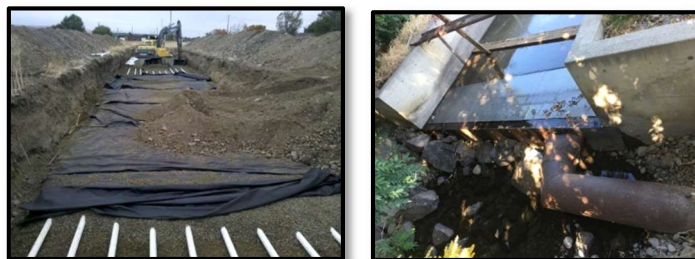
Figure 10 - The Anspach site during construction in 2012 (left) and new intake structure in 2015 (right).

Water for this site is delivered down the HBDIC's White Ditch and diverted into a private pipeline/ditch. The original site was designed to operate at a recharge rate of approximately 1 cfs. In the fall/winter of 2015, the Anspach site was expanded to include a second infiltration gallery and a new turnout and supply pipeline (Figure 11). The second infiltration gallery is similar in design to the original gallery. The expanded site is designed to operate at approximately 1,500 gallons per minute (gpm) which is 5 to 10 times what the site previously operated at. During the WY2017 recharge season, the site operated around 1,300 gpm (~3.0 cfs).

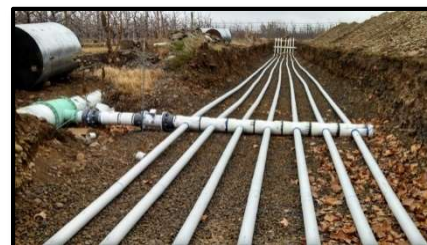
Figure 11 - Barrett site under construction.

The Barrett site was constructed in the winter of 2014 using OWEB funding. The site consists of seven 4-inch diameter perforated drain field pipes buried 4 to 5 feet bgs and extending approximately 600 feet from the source water manifold (Figure 11). The perforated pipes sit on top of approximately 1 to 2 foot of clean gravel and are overlaid with approximately 0.5 to 1 foot of clean gravel (See Appendix C for designs). Water for this site is delivered down the HBDIC's White Ditch and diverted into the Barrett pipeline. The Barrett site's turnout and valve are situated along the pipeline. The site was designed to operate at a recharge rate of approximately 2-3 cfs (approximately 900 to 1300 gpm). During the WY2017 recharge season, the site operated at an average of 1.8 cfs. The site's intake structure is susceptible to clogging, which periodically results in lower intake rates than the designed rates.

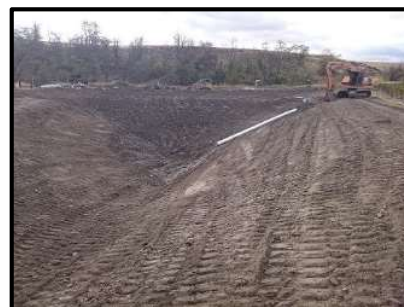
Figure 12 - Chuckhole site under construction.

The Chuckhole site was constructed in the fall of 2015 (Figure 12) but could not begin operating until after LL-1621 was issued on October 18, 2016. The site has an infiltration basin (roughly 0.05 acres in size) and sediment settling pond, located near the end of the Milton pipeline. The site was expected to recharge approximately 300-400 gpm or just under 1 cfs. During WY2017, its first recharge season, the site operated at an average of 0.1 cfs. The low calculated recharge rate may be a result of the flow meter's accuracy at low flow rates and may underestimate actual recharge. The meter's performance will be further evaluated.

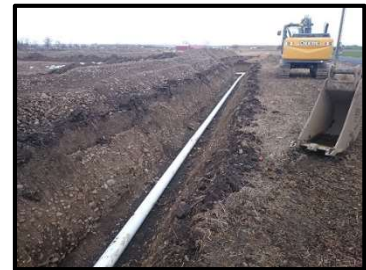
Figure 13 - Fruitvale site under construction.

The Fruitvale site was constructed in the fall of 2015 (Figure 13) but could not begin operating until after LL-1621 was issued on October 18, 2016. The site is an infiltration gallery with 12 x 4" perforated pipes 150' in length. The Fruitvale site is located within the Fruitvale Water Users Association system. The site was expected to recharge approximately 400 gpm or just under 1 cfs. During WY2017, its first recharge season, the site operated at an average of 0.2 cfs. The lower than expected recharge rate may have been a result of the low head (pressure from the gravity-fed system).

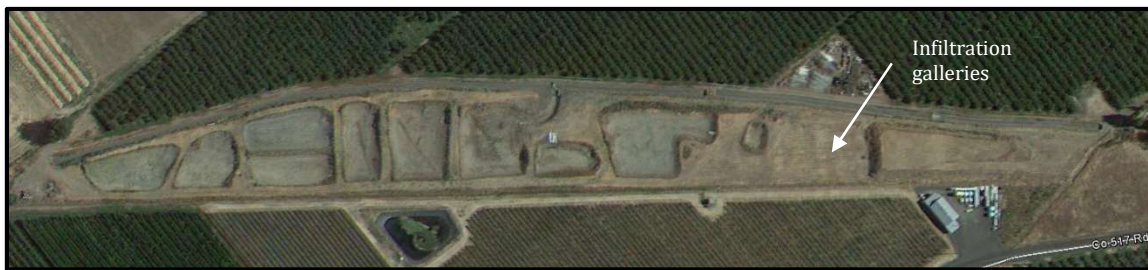
Figure 15 - Aerial photo of the Johnson site in 2013 showing 10 basins and location of infiltration galleries.

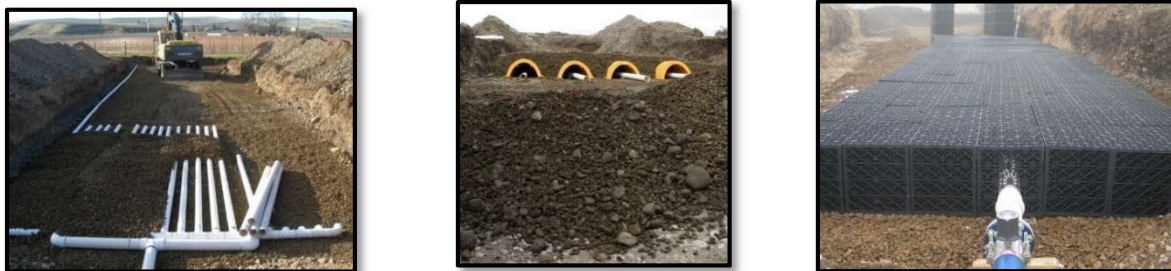
Figure 16 - Photographs of infiltration galleries #2 (left), #3 (center), and #4 (right) being installed at the Johnson site.

During Phase II, four different infiltration gallery (IG) designs were installed at the Johnson site to evaluate each design's performance, longevity, and cost-benefit. IG #1 was constructed of four corrugated 4-inch perforated pipe, IG #2 was constructed of twenty 4-inch drain field pipe, IG #3 was four 4-inch drain field pipe inside Stormtech stormwater chambers, and IG #4 was a single 4-inch drain field pipe inside Atlantis stormwater devices (Figure 16). During the first season of testing IG #1 clogged up and has not been utilized since. IG #2, IG #3 and IG #4 have all continued to function and have been operated during each recharge season.

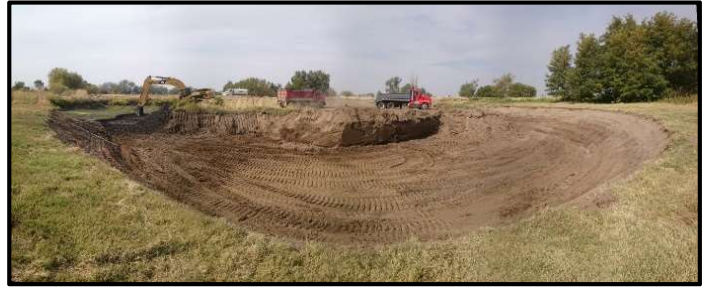
Figure 17 - Photograph of Mud Creek site during construction.

The Mud Creek site was constructed in the fall of 2015 (Figure 17) but could not begin operating until after LL-1621 was issued on October 18, 2016. The site is an infiltration basin approximately 0.6 acres in size within a grass pasture/wildlife area. Water for the project is delivered from the Fruitvale Ditch and then can overflow, if needed, back into the Fruitvale Ditch. The site is upgradient of the Mud Creek headwater springs and is expected to improve instream flows in Mud Creek and recover local groundwater levels. The site was expected to operate around 400-500 gpm or approximately 1 cfs. During WY2017, its first recharge season, the site operated at an estimated average of 0.1 cfs. The low recharge rate may be a function of the limitations of the method used to estimate recharge through the bottom of the basin. The outlet from the basin into the Fruitvale Ditch was reconfigured this year which should help improve estimating recharge rates.

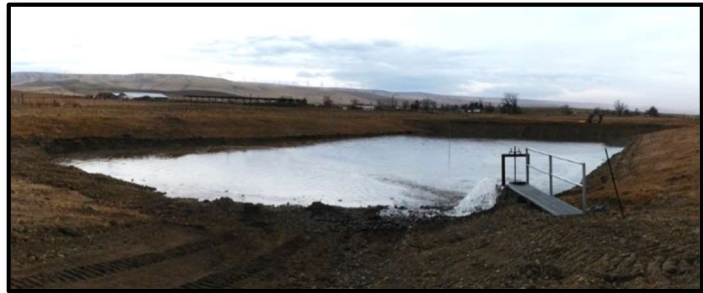
Figure 18 - NW Umapine site during WY2014 recharge season.

The NW Umapine site was constructed in the fall of 2013 (Figure 18). The site consists of a single infiltration basin approximately 0.46 acres in size (Figure 18). The site is supplied by an approximately 1,000-ft long lateral pipeline installed off of HBDIC's Richartz's pipeline. The site was designed to operate at a recharge rate of 2-3 cfs (approximately 900 to 1300 gpm). During the WY2017 recharge season the site averaged 1.6 cfs (718 gpm).

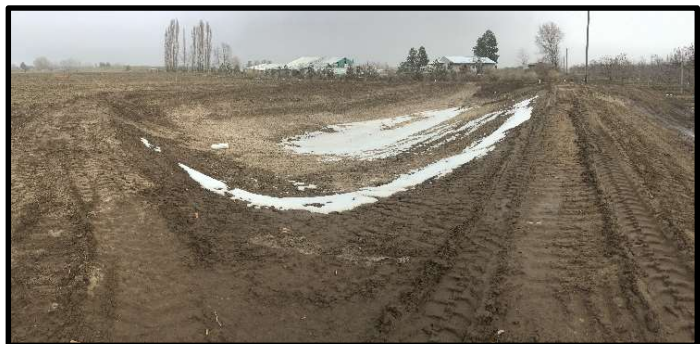
Figure 19 - Triangle Road site under construction in fall 2016.

The Triangle Road site was constructed in the fall of 2016 (Figure 19). The site is an approximately 0.2-acre infiltration basin. Water is delivered from the Fruitvale Ditch and then can overflow, if needed, back into the Fruitvale Ditch. The site is upgradient of the Mud Creek headwater springs and is expected to improve instream flows in Mud Creek and recover local groundwater levels. The site was expected to operate around 400-500 gpm or approximately 1 cfs. In WY 2017, the site operated at an average of 0.4 cfs. The lower than expected recharge rate may have been related to an operational issue.

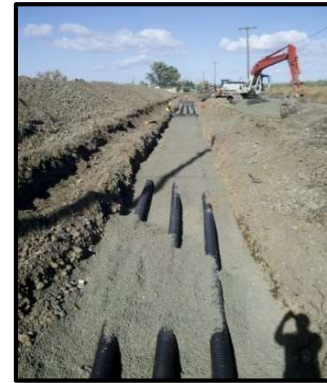
Figure 20 - Trumbull site under construction in October 2012.

The Trumbull site was constructed in October 2012 using a combination of Bonneville Power Administration and OWEB funding. The site consists of three 8-inch perforated pipes buried 6 feet bgs and extending approximately 300 feet in length from the source water discharge and inline flow meter (Figure 20). The perforated pipes sit on top of approximately 1-2 foot of clean gravel and are overlaid with approximately 0.5-1 feet of clean gravel (See Appendix C for designs). The Trumbull site’s water source is at the structure that splits the HBDIC canal into the Hyline pipeline and the Richartz ditch. The site has its own turnout and valve so it can operate independent of the ditch or pipeline. The site was designed to operate at a recharge rate of 2 to 3 cfs (approximately 900 to 1300 gpm). During WY2017, the site operated at an average of 0.8 cfs. As in WY2016, the reduced recharge rate may be due to downgradient control by springs and groundwater mounding as well as limited head pressure in the diversion structure at times during the recharge season.

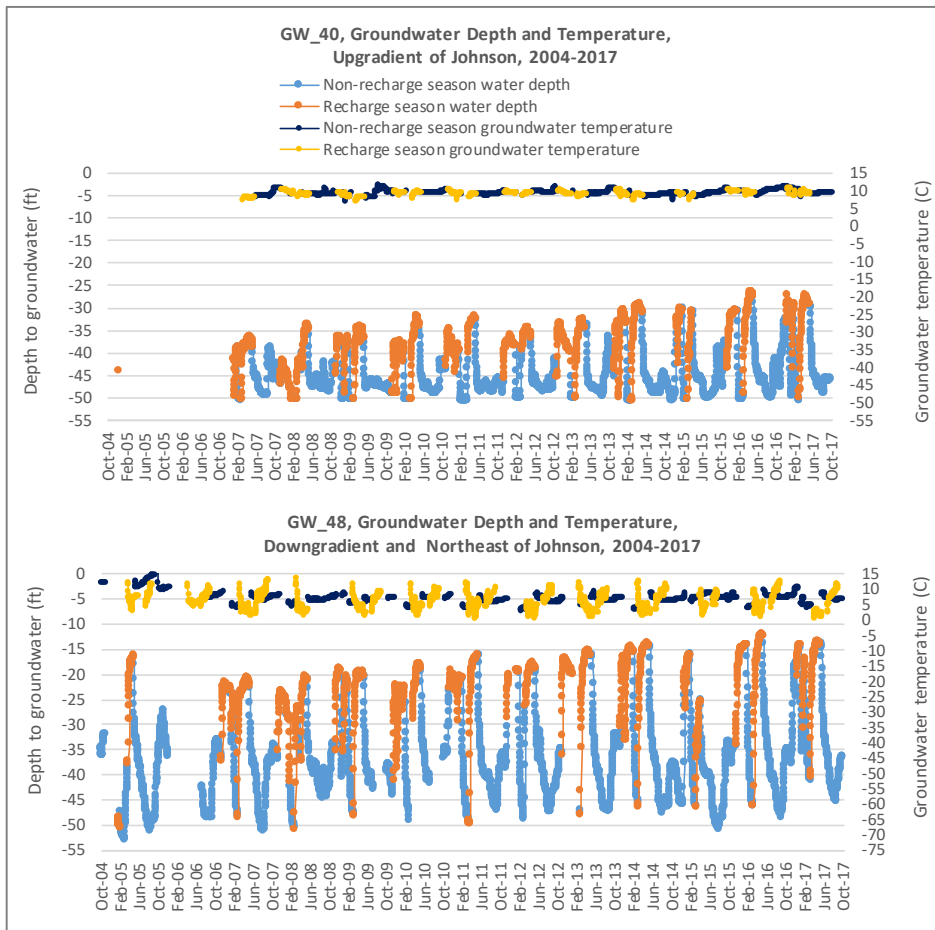
Figure 34 - Hydrographs for GW_40 and GW_48.
