# Water Year 2018

## *Oregon Walla Walla Basin Aquifer Recharge Report*

Water Year 2018  
Oregon Walla Walla Basin Aquifer Recharge Report

Walla Walla Basin Watershed Council  
In Cooperation with Hudson Bay District Improvement Company  
and Fruitvale Water Users Association

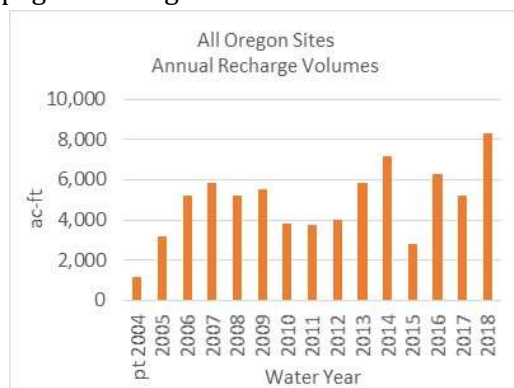
Figure 1. Annual recharge volumes by year.

During WY 2018, active recharge sites were Anspach, Barrett, Chuckhole, East Trolley Lane, Fruitvale, Johnson, LeFore, Locust Road, Mud Creek, NW Umapine, Triangle Road, and Trumbull. These sites were operated under Limited License LL-1621 (Appendix A) issued by the Oregon Water Resources Department (OWRD) on October 18, 2016. Source water for aquifer recharge was diverted from the Walla Walla River near Milton-Freewater between November 23, 2017 and May 15, 2018. During WY2018, the maximum diversion rate needed to deliver the recharge water, taking into account ditch seepage losses, was 31 cubic feet per second (cfs). The sites operated from 40 to 146 days depending on water availability and ditch management. The total amount of water diverted was 8,338 acre-feet (ac-ft)<sup>1</sup>, more volume than any previous year (Figure 1 and Table 1). This increase was primarily due to the increased ditch seepage resulting from more miles of the conveyance network being needed to deliver water to more sites at diverse locations; these seepage losses provided 45% of the water recharged to the aquifer (Figure 2). This achieved one of the design goals of the MAR program -- to place recharge sites near the ends of the conveyance systems to maximize seepage losses and increase the cost-effectiveness of each recharge site due to the added benefit of “passive” recharge from the unlined ditches and canals.

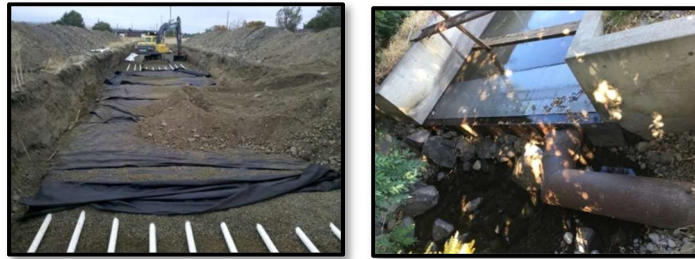
Figure 11. Anspach site under construction in 2012 (left) and new intake structure in 2015 (right).

The Anspach site was constructed in October 2012 then expanded in the fall/winter of 2015. The site consists of a single turnout structure installed in the HBDIC canal that delivers water to a pipeline serving two separate infiltration galleries. Each infiltration gallery is independently controlled via valves and turnout pipes. In each gallery, the pipe manifolds into ten 4-inch diameter perforated drain field pipes buried 6 to 7 feet below ground surface (bgs) and extends approximately 200 feet from the source water manifold (Figure 11). The perforated pipes sit on top of approximately 1 to 2 feet of clean gravel and are overlaid with approximately 0.5 to 1 foot of clean gravel.

Water for this site is delivered down the HBDIC's White Ditch and diverted into a private pipeline/ditch. The original site was designed to operate at a recharge rate of approximately 1 cfs while the maximum design capacity of the expanded site is 3.3 cfs (1,500 gallons per minute [gpm]). During the WY2018 recharge season, the site operated at an average of 628 gpm (1.4 cfs) due to operational issues (discussed in the Monitoring section).

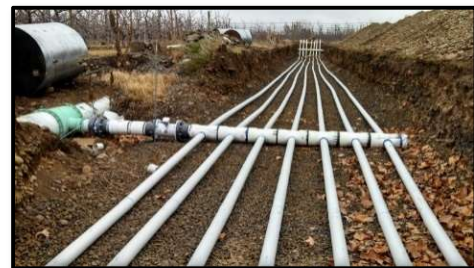
The Barrett site was constructed in the winter of 2014. The site consists of seven 4-inch diameter perforated drain field pipes buried 4 to 5 feet bgs and extending approximately 600 feet from the source water manifold (Figure 12). The perforated pipes sit on top of approximately 1 to 2 foot of clean gravel and are overlaid with approximately 0.5 to 1 foot of clean gravel. Water for this site is delivered down the HBDIC's White Ditch and diverted into the Barrett pipeline. The Barrett site's turnout and valve are situated along the pipeline. The site was designed to operate at a recharge rate of approximately 2-3 cfs (900 to 1300 gpm). During the WY2018 recharge season, based on the totalizer volume divided by the number of days of operation, the average delivery rate to the site was 0.7 cfs but the average of the instantaneous flow rates noted during field visits was 1.4 cfs; the difference was due to two periods when the meter didn't record a flow rate (discussed in the Monitoring section).

Figure 12. Barrett site under construction.

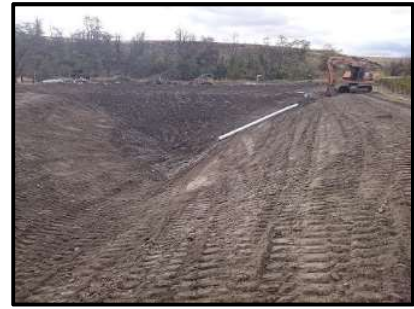
Figure 13. Chuckhole site under construction.

The Chuckhole site was constructed in the fall of 2015 (Figure 13) but could not begin operating until after LL-1621 was issued on October 18, 2016. The site has an infiltration basin (roughly 0.05 acres in size) and sediment settling pond, located near the end of the Milton pipeline. The site was expected to recharge approximately 300-400 gpm or just under 1 cfs. During WY2018, its second recharge season, the site operated at an average of 0.2 cfs. The reason for the low infiltration rate is not known.

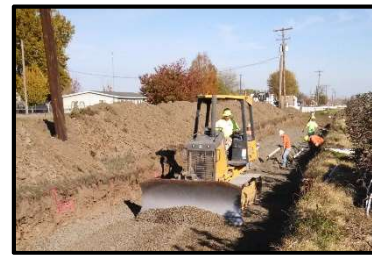
Figure 14. East Trolley Lane site under construction.

The East Trolley Lane Aquifer Recharge site was constructed in October 2013 (Figure 14) but did not begin operations until November 2017 due to the complexities of installing a self-cleaning fish screen. The infiltration gallery has 4 lines of 4" perforated pipes each running approximately 600 feet immediately east of Trolley Lane (see Appendix B for designs), approximately ½ mile south of the Oregon/Washington border. Water is delivered from the Walla Walla River, down the Ford Branch to the West Little Walla Walla River, then into the Trolley Lane pipeline which serves multiple users, with a separate valve specifically for the recharge site. The site was expected to recharge 1-2 cfs. During WY2018, its first year of operations, the average recharge was 215 gpm or 0.5 cfs.

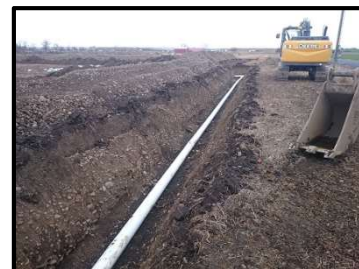
Figure 15. Fruitvale site under construction.

The Fruitvale site was constructed in the fall of 2015 (Figure 15) but could not begin operating until after LL-1621 was issued on October 18, 2016. The site is an infiltration gallery with 12 lines of 4" perforated pipes 150' in length. The Fruitvale site is located within the Fruitvale Water Users Association system. The site was expected to recharge approximately 400 gpm or just under 1 cfs. During WY2018, its second recharge season, the site operated at an average of 0.3 cfs. The lower than expected recharge rate may have been a result of the low head (pressure from the gravity-fed system).

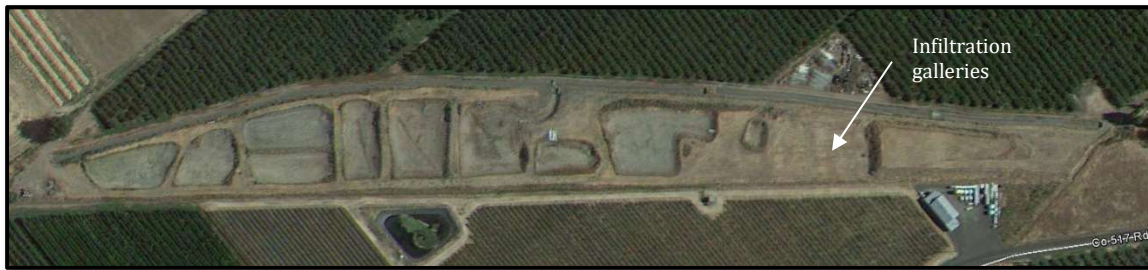
Figure 17. Johnson site in 2013 showing 10 basins and location of infiltration galleries.

The current site designed capacity is approximately 16 to 17 cfs (approximately 7,200 to 7,600 gpm) of infiltration into approximately 3 acres of infiltration basins and three infiltration galleries. During WY2018 the site operated at an average recharge rate of 12.1 cfs.

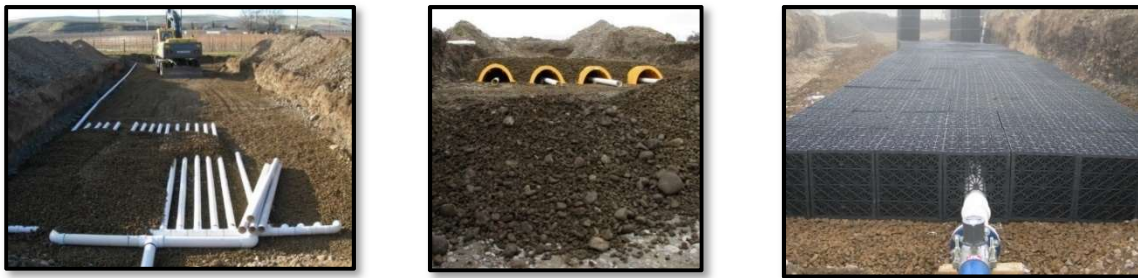
Figure 18. Infiltration galleries #2 (left), #3 (center), and #4 (right) being installed at the Johnson site.

Four different infiltration gallery designs were installed at the site to evaluate each design's performance, longevity, and cost-benefit. Infiltration Gallery #1 was constructed of four corrugated 4-inch perforated pipe, Infiltration Gallery #2 was constructed of twenty 4-inch drain field pipe, Infiltration Gallery #3 was four 4-inch drain field pipe inside Stormtech stormwater chambers, and Infiltration Gallery #4 was a single 4-inch drain field pipe inside Atlantis stormwater devices (Figure 18). During the first season of testing Infiltration Gallery #1 clogged and has not been used since. For additional details on the Johnson site please see WWBWC (2010; 2013; 2014b).

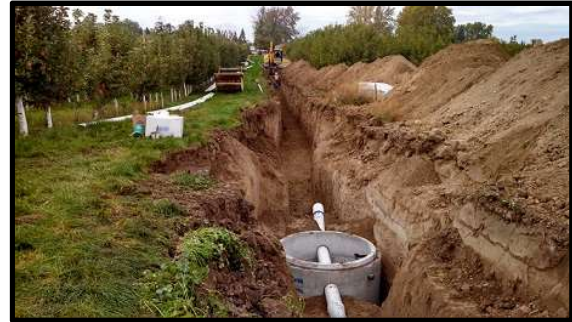
Figure 19. LeFore site under construction.

The LeFore Road site is located just northeast of the city of Milton-Freewater, OR. The site is an infiltration gallery basin design with three 4" perforated pipes 600' in length (see Appendix B for designs). The LeFore Road site is located in an orchard, off a private pressurized irrigation system. It is the only pressurized recharge site in the program. The site was constructed in the fall of 2014 (Figure 19). The site was expected to recharge approximately 300-400 gpm or just under 1 cfs. During WY 2018, its first year of operation, the site typically recharged 317 gpm or 0.7 cfs.

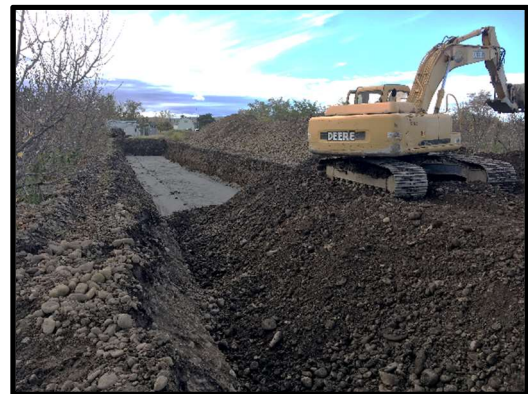
Figure 20. Locust Road site under construction.

The Locust Road site is located just north of the city of Milton-Freewater. It was constructed in the fall of 2016 (Figure 20). The site is an infiltration gallery with eight 4" perforated pipes 260' in length (see Appendix B for designs), located off of the East Branch Crockett ditch within the Walla Walla River Irrigation District. The site was expected to recharge approximately 600-800 gpm or 1-2 cfs. During WY2018, its first year of operation, typical recharge rates were 0.6 cfs or 251 gpm.

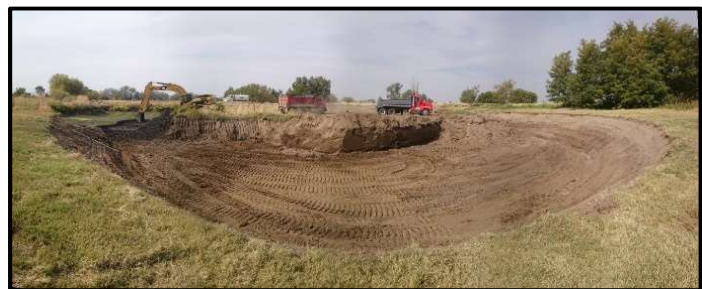
Figure 21. Mud Creek site during construction.

The Mud Creek site was constructed in the fall of 2015 (Figure 21) but could not begin operating until after LL-1621 was issued on October 18, 2016. The site is an infiltration basin approximately 0.6 acres in size within a grass pasture/wildlife area. Water for the project is delivered from the Fruitvale Ditch and then can overflow, if needed, back into the Fruitvale Ditch. The site is upgradient of the Mud Creek headwater springs and is expected to improve instream flows in Mud Creek and recover local groundwater levels. The site was expected to operate around 400-500 gpm or approximately 1 cfs. During WY2018, its second recharge season, the site operated at an estimated average of 0.3 cfs or 117 gpm.

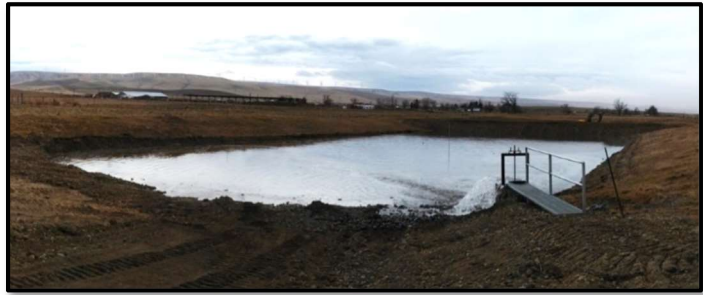
Figure 22. NW Umapine site during WY2014 recharge season.

The NW Umapine site was constructed in the fall of 2013. The site consists of a single infiltration basin approximately 0.46 acres in size (Figure 22). The site is supplied by an approximately 1,000-ft long lateral pipeline off of HBDIC's Richartz's pipeline. The site was designed to operate at a recharge rate of 2-3 cfs (approximately 900 to 1300 gpm). During the WY2018 recharge season the site averaged approximately 1.5 cfs or 664 gpm.

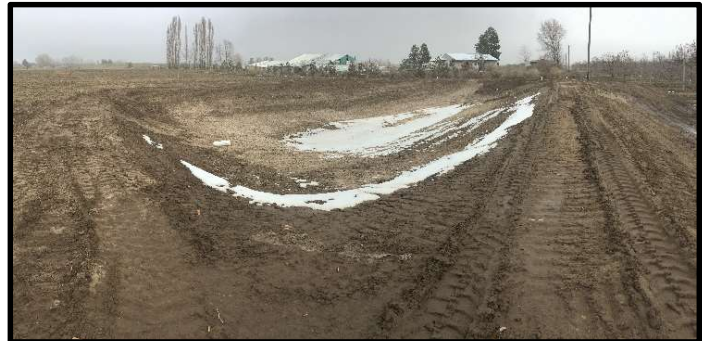
Figure 23. Triangle Road site under construction in fall 2016.

The Triangle Road site was constructed in the fall of 2016 (Figure 23). The site is an approximately 0.2-acre infiltration basin. Water is delivered from the Fruitvale Ditch and then can overflow, if needed, back into the Fruitvale Ditch. The site is upgradient of the Mud Creek headwater springs and is expected to improve instream flows in Mud Creek and recover local groundwater levels. The site was expected to operate around 400-500 gpm or approximately 1 cfs. In WY 2018, the site operated at an average of 0.9 cfs or 400 gpm.

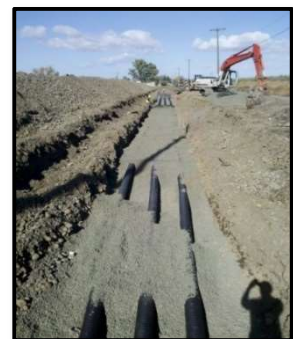
The Trumbull site was constructed in October 2012, consisting of three 8-inch perforated pipes buried 6 feet bgs and extending approximately 300 feet in length (Figure 24). The perforated pipes sit on top of 1-2 feet of clean gravel and are overlaid with 0.5-1 feet of clean gravel. The site's water source is at the structure that splits the HBDIC canal into the Hyline pipeline and the Richartz ditch. The site has its own turnout and valve so it can operate independently of the ditch or pipeline. The site was designed to operate at a recharge rate of 2-3 cfs (898 to 1347 gpm). During WY2018, the site operated at an average of 0.8 cfs or 379 gpm.

Figure 24. Trumbull site under construction in October 2012.

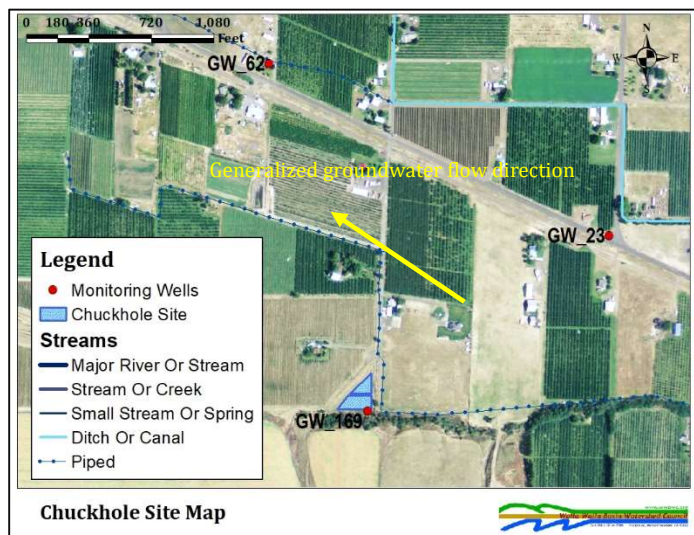
During WY2018, the second recharge season for the Chuckhole site, the site operated for 42 days from April 3 to May 15, 2018, receiving a total of 25 ac-ft of water for an average of 0.6 ac-ft/day or 0.3 cfs. The site has three monitoring wells: GW\_169 upgradient, GW\_62 downgradient, and GW\_23 cross-gradient (Figure 32). As discussed above, GW\_62 is influenced by recharge from the Barrett site. The timing of recharge at the Chuckhole site does not correspond to an increase in groundwater levels at GW\_62 (Figure 33). At GW\_169, approximately 150 feet upgradient of the site, groundwater levels increased and temperature increased slightly during recharge; however, additional years of data are needed to determine if these changes recur in other years. At cross-gradient GW\_23, the quarterly readings do not allow comparison of changes in water levels during the brief recharge season (Figure 34).

Figure 32. Chuckhole monitoring well locations.
