Oregon Walla Walla Basin Aquifer Recharge Report

FINAL REPORT

February 2020

in cooperation with Hudson Bay District Improvement Company
and Fruitvale Water Users Association

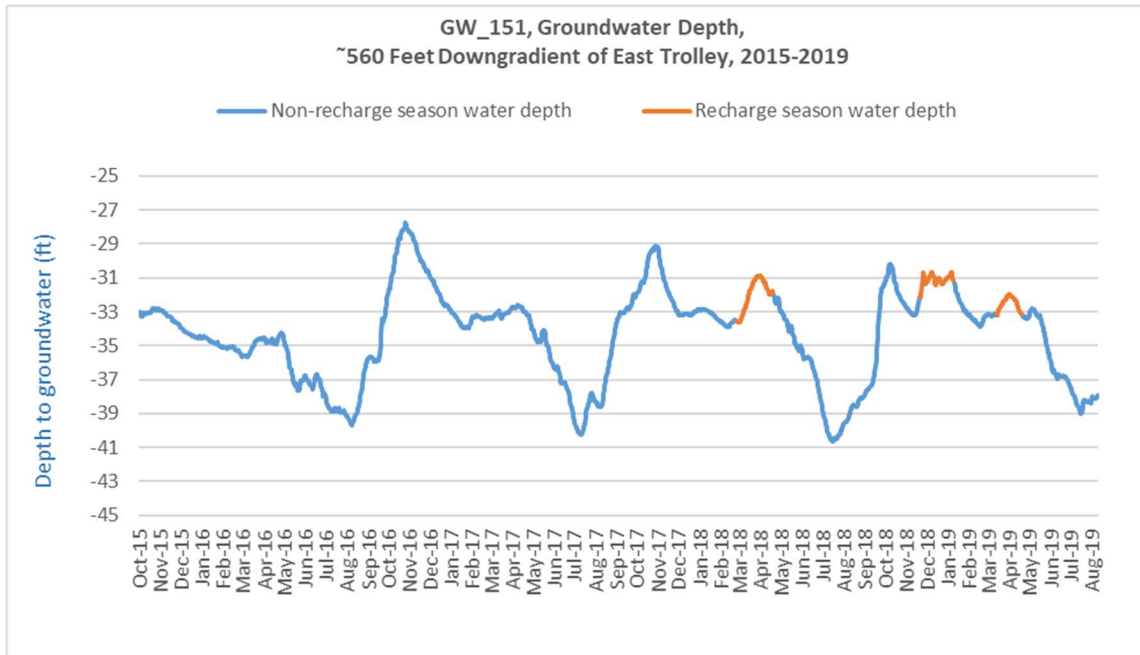
Figure 22. Hydrograph for monitoring well GW_151.

GW_151 is at the distal end of the infiltration gallery (Figure 21). The magnitude and timing of the changes in groundwater levels suggest multiple influences on the seasonal water table (Figure 22).

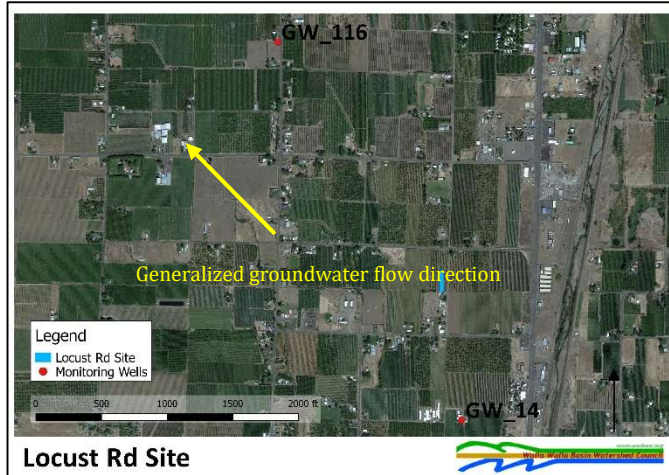
Figure 36. Locust Road monitoring well locations.

GW_14 and GW_116 are approximately 0.4 miles upgradient and 0.8 miles downgradient of the site (Figure 36). The yearly shallowest and deepest values (Figure 37) largely represent conditions before recharge began in the spring of 2018. Changes in groundwater levels solely due to recharge were not apparent in either well (Figure 38). Given the proximity of GW_14 to the river, fluctuations at GW_14 are most likely dominantly influenced by changing flows in the Walla Walla River.

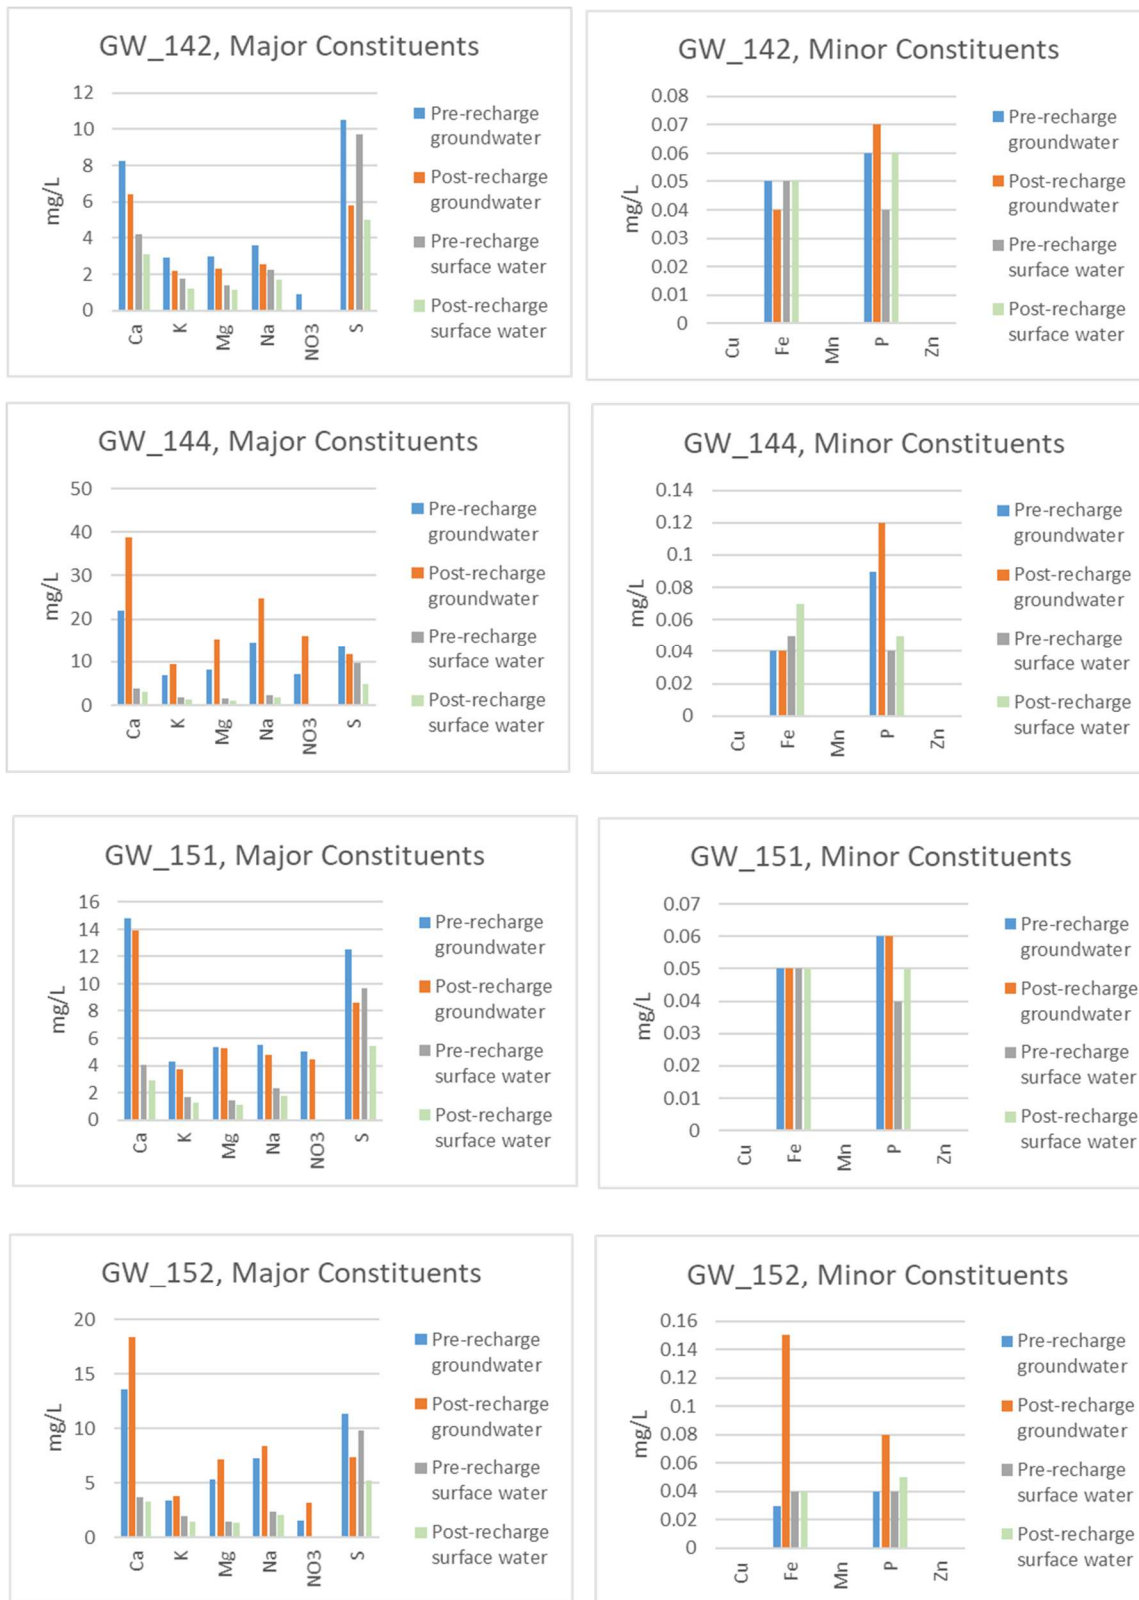
Figure 54. Water quality data, GW_142, GW_144, GW_151, and GW_152.

To evaluate water quality conditions, groundwater concentrations are compared to source water concentrations before and after the recharge season (Figure 53 through Figure 55 and Table 7 through Table 9). Table 10 lists the source water sites relevant for each groundwater sampling site.

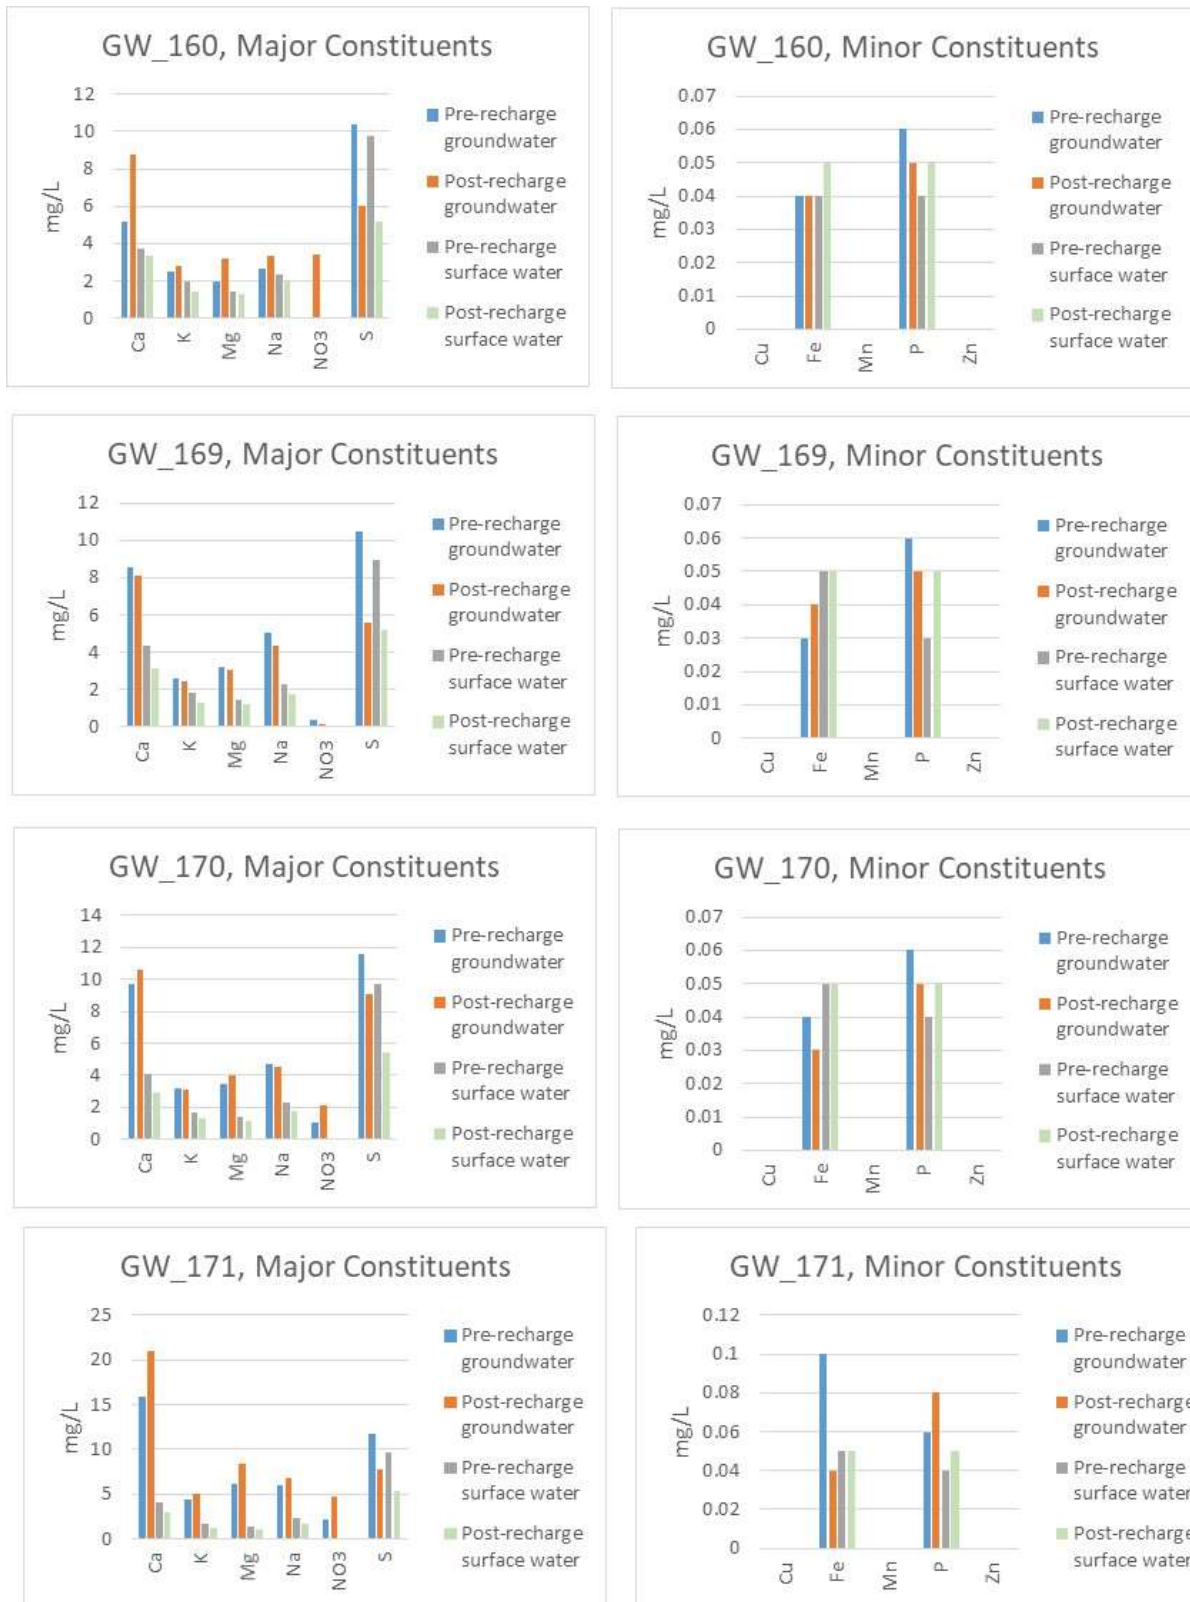
Figure 55. Water quality data, GW_160, GW_169, GW_170, and GW_171.
