Oregon Walla Walla Basin Aquifer Recharge Report

FINAL REPORT

February 2021

Walla Walla Basin Watershed Council

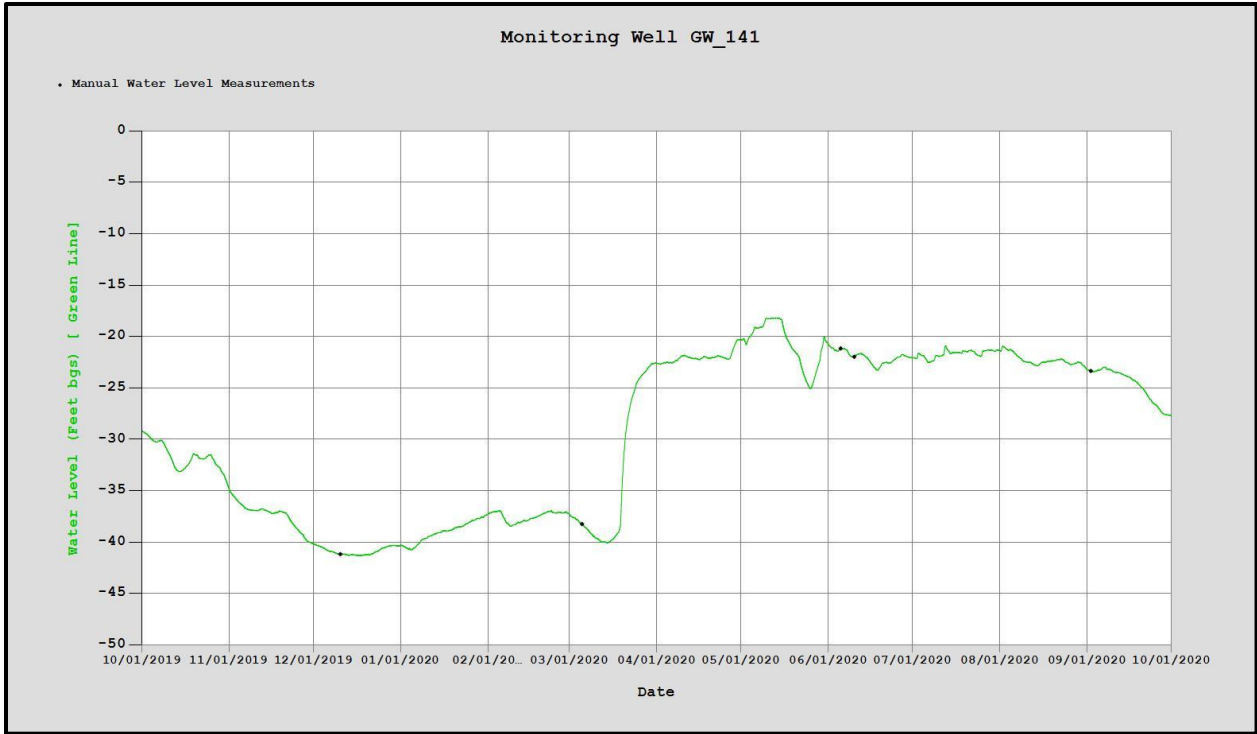
Figure 14. Hydrograph for monitoring well GW_141.

The site has two upgradient wells, GW_135 and GW_141, and one cross-gradient well, GW_23 (Figure 11). The shallowest groundwater elevations at GW_141 rose by more than 10 feet during the early years of managed recharge and have remained elevated despite decreased recharge volumes at this site in the last three years (Figure 12). While GW_135 and GW_141 are upgradient of the recharge site, the timing of the seasonal patterns (Figure 13 and 14) suggests both wells are influenced by managed recharge operations, perhaps as a result of groundwater mounding under the Anspach site. At cross-gradient GW_23, quarterly readings preclude observing changes between each month; between years, groundwater levels may be stabilizing after declines in the three previous decades (Figure 15).

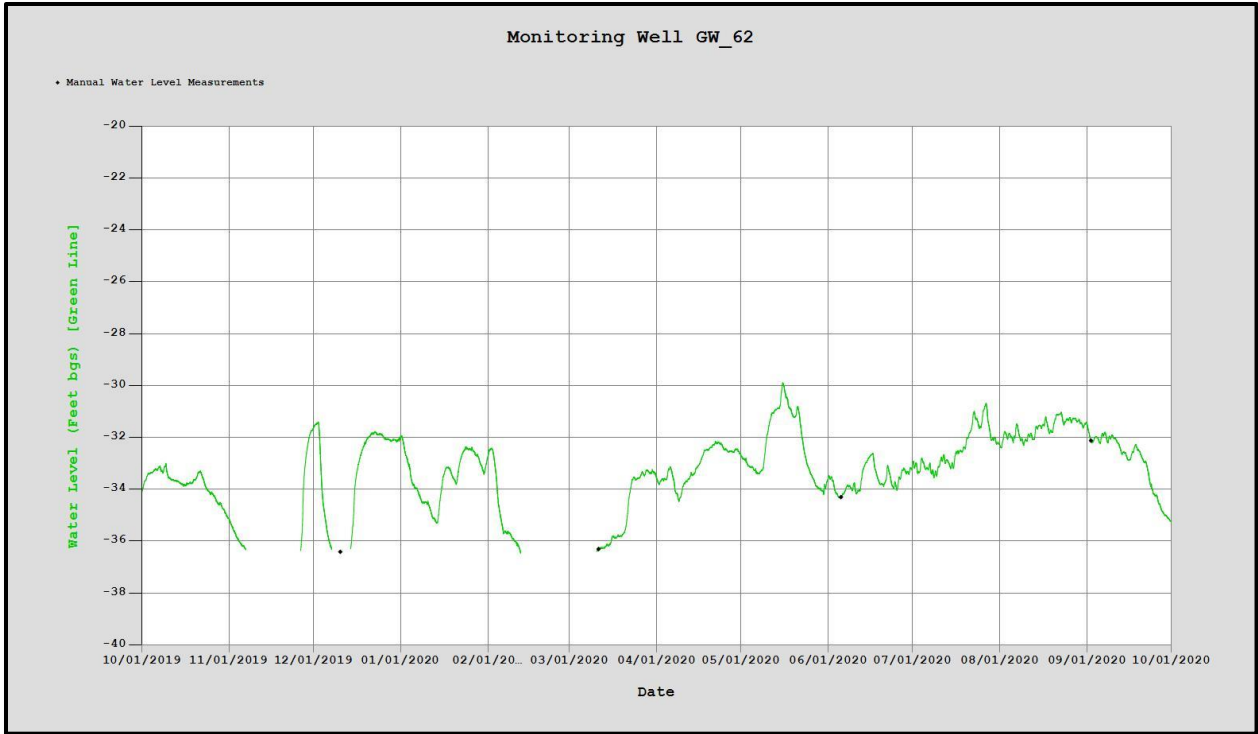
Figure 17. WY 2020 hydrograph for monitoring well GW_62

GW_62 is upgradient and GW_150 is approximately 0.3 miles downgradient of the site (Figure 16). Response to recharge operations at the Barrett site were observed at the up-gradient groundwater monitoring well, GW_62, and includes influences from the Chuckhole recharge site (see below). Groundwater levels in the monitoring well increased to peak levels during recharge operations and decreased when recharge operations stopped (Figure 17). The 2005-2016 hydrograph for GW_62 is included for longer term groundwater levels at the Barrett site, which began operation in WY 2016 (Figure 18). At downgradient GW_150, a sustained peak during recharge season is apparent, but the timing of peaks and troughs likely also reflects the influence of flows in the nearby White Ditch on groundwater levels (Figure 19).

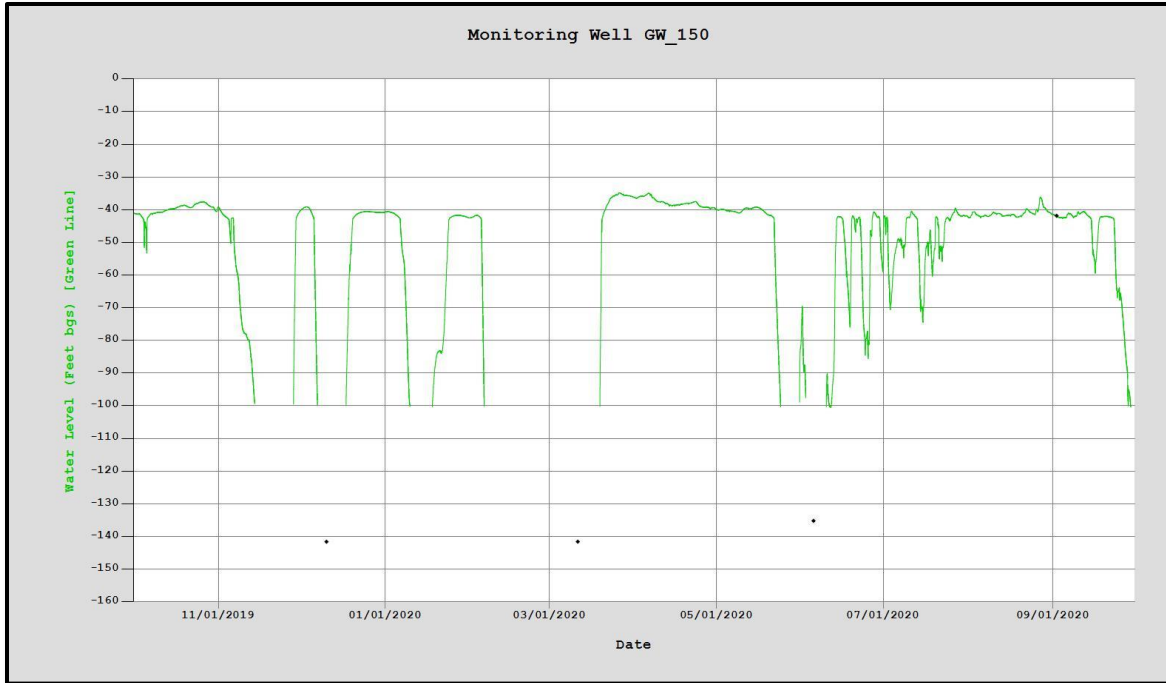
Figure 19. WY 2020 hydrograph for GW_150.

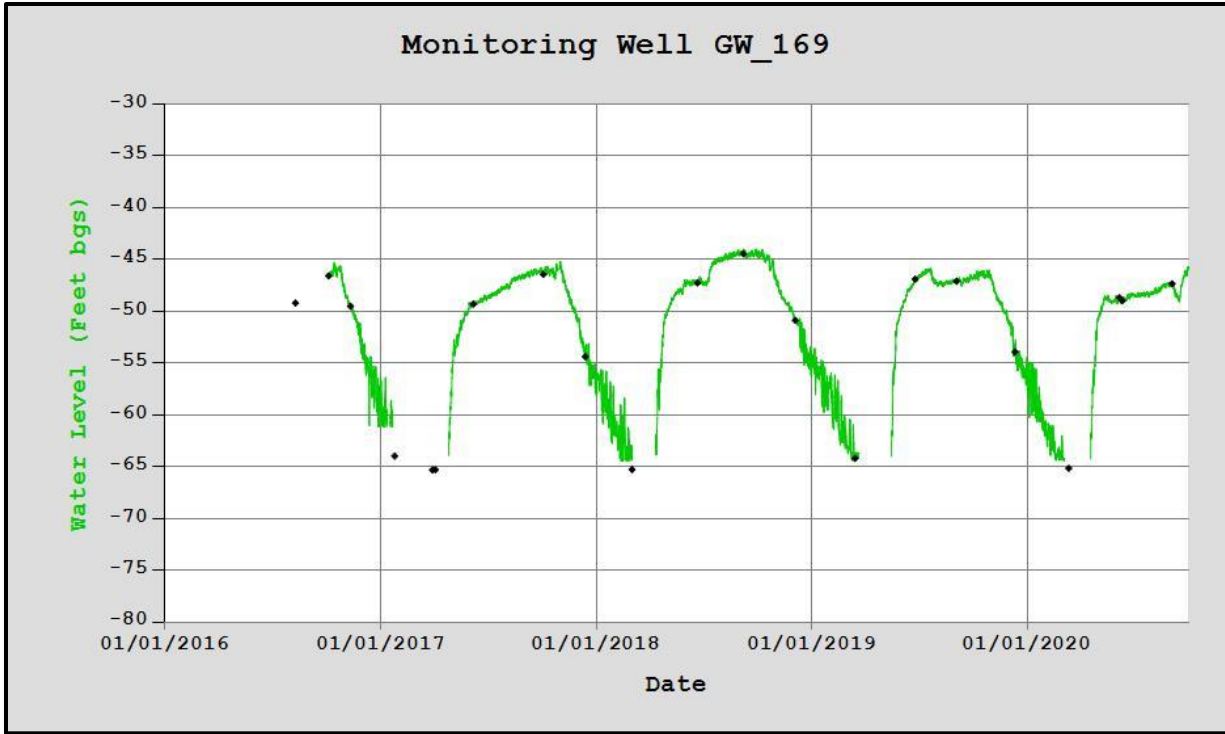
Figure 21. Groundwater levels in monitoring well GW_169 from WY2017-2020. Springtime data gaps represent times when the water level drops below the elevation of the sensor.

Three monitoring wells are in the vicinity of the site: GW_169 upgradient, GW_62 downgradient, and GW_23 cross-gradient (Figure 20). As discussed above, GW_62 water levels show the influence of the Barrett recharge site and the influence of the Chuckhole site. GW_62 groundwater levels increase in in March with the start of recharge at the Barrett site and further increase in April, coinciding with the start of recharge at the Chuckhole site. Groundwater level decrease in mid-May when recharge operations at both sites are terminated for the year. At GW_169 groundwater levels have increased during recharge season since the site began operating in 2016 (Figure 21). Each spring, the water level drops below the elevation of the sensor, producing the gaps seen on the hydrograph. At cross-gradient GW_23, the quarterly readings during WY 2020 did not occur within the brief 6-week recharge season (Figure 22).

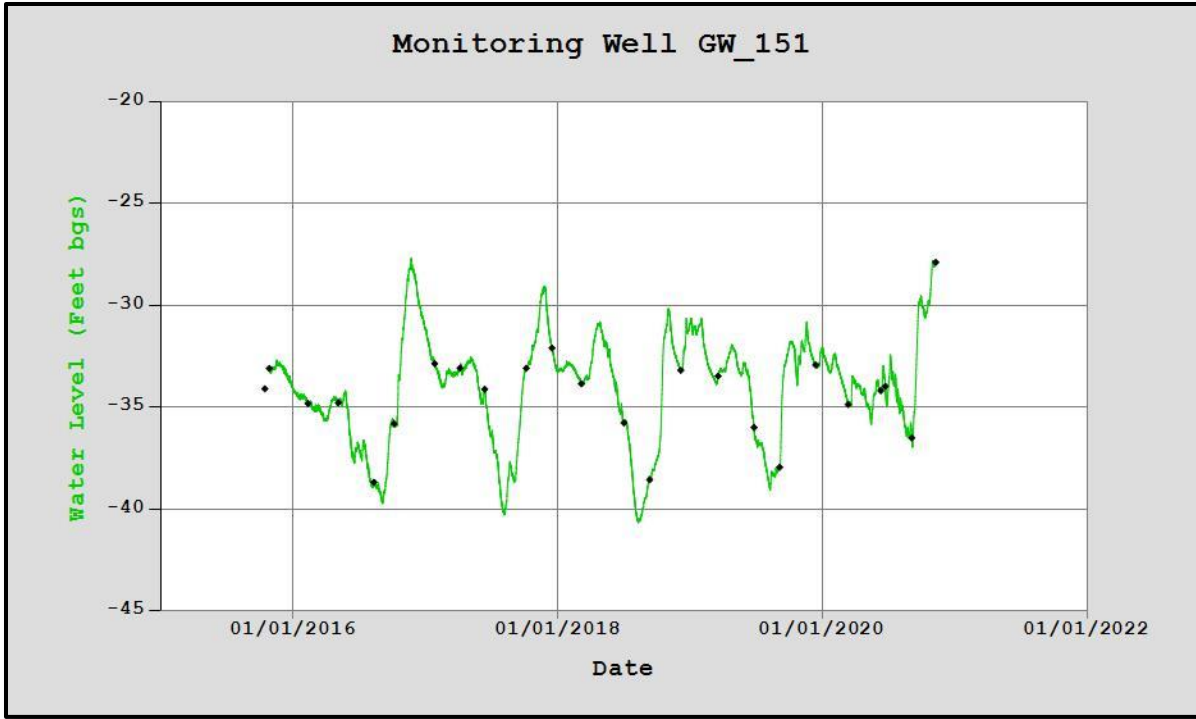
Figure 25. GW_151 hydrograph from WY2016-2020.

GW_151 is at the distal end of the infiltration gallery (Figure 23). The magnitude and timing of the changes in groundwater levels suggest multiple influences on the seasonal water table (Figures 24-25).

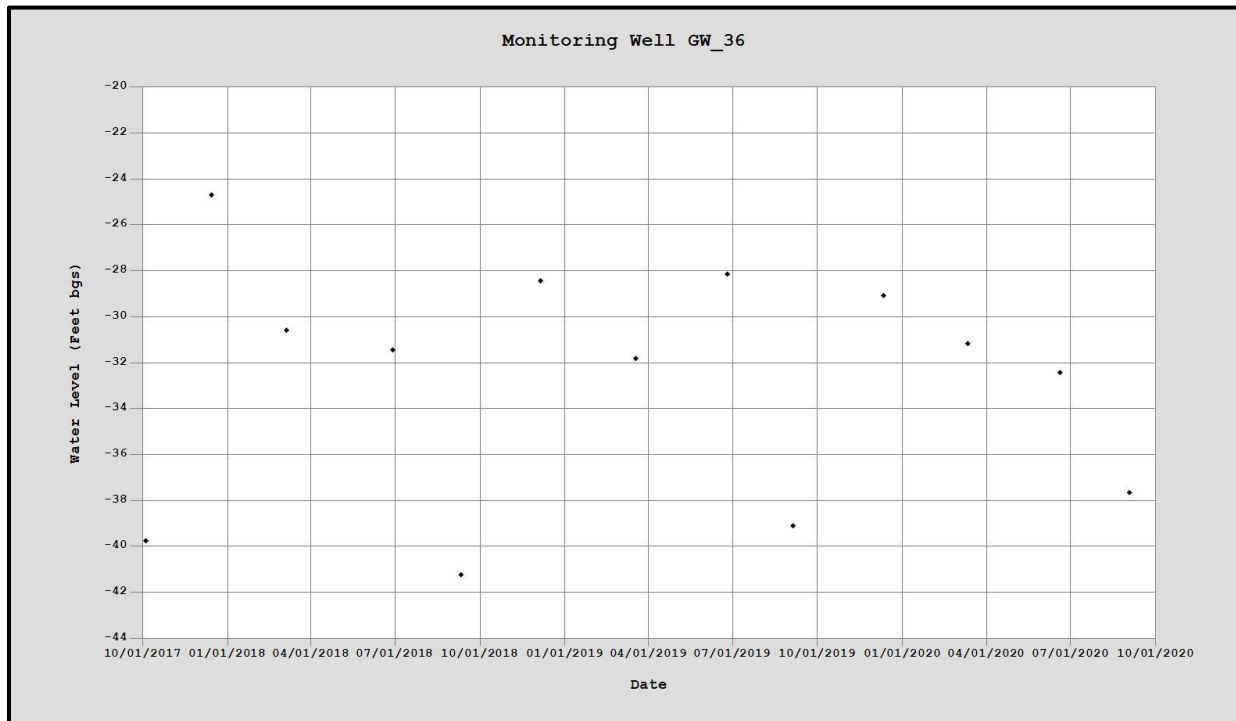
Figure 30. GW_36 hydrograph from WY2018-2020.

GW_36 is upgradient of the site (Figure 29). None of the quarterly measurements occurred during the 20 days the Gallagher site operated. The September static measurements, however, have risen for two consecutive years since the Gallagher site began operating in WY2019, suggesting a possible link between recharge operations and increasing groundwater levels (Figure 30). Data from future years will help to evaluate the trend more fully.

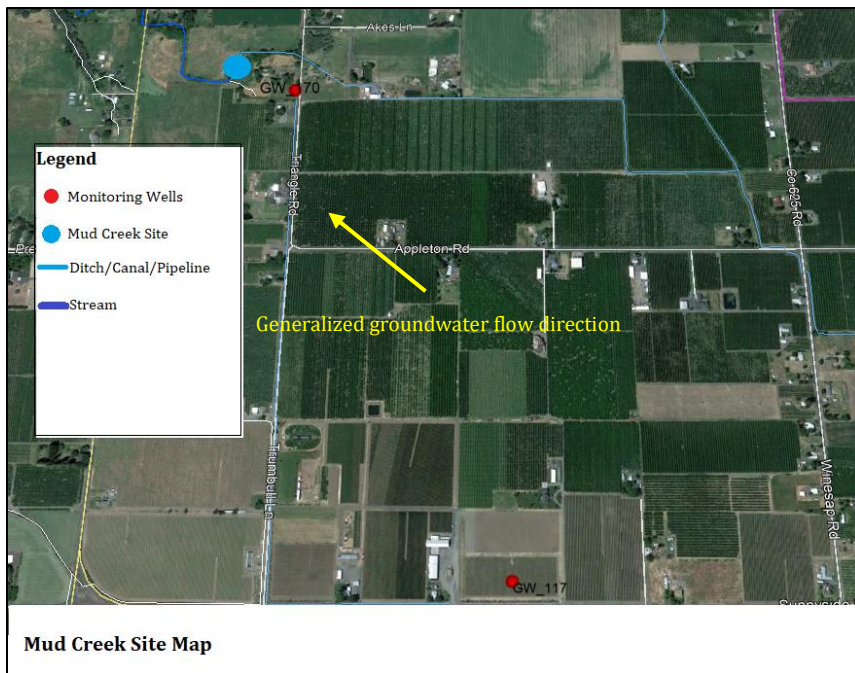
Figure 45. Mud Creek monitoring well locations.

Monitoring wells GW_170 and GW_117 are upgradient wells located approximately 0.1 and 0.9 miles from the site, respectively (Figure 45). The roughly 40-foot difference in groundwater levels between the two wells illustrate the highly variable conditions in the alluvial aquifer (Figures 46-47). At nearby GW_170, groundwater levels increased during the recharge season, particularly from March-May. However, that springtime elevation increase was present prior to Mud Creek recharge operations in WY2017, suggesting groundwater levels are responding to other factors as well (Figure 48). The 2009-2020 dataset from GW_117 also shows multiple influences (Figure 49).

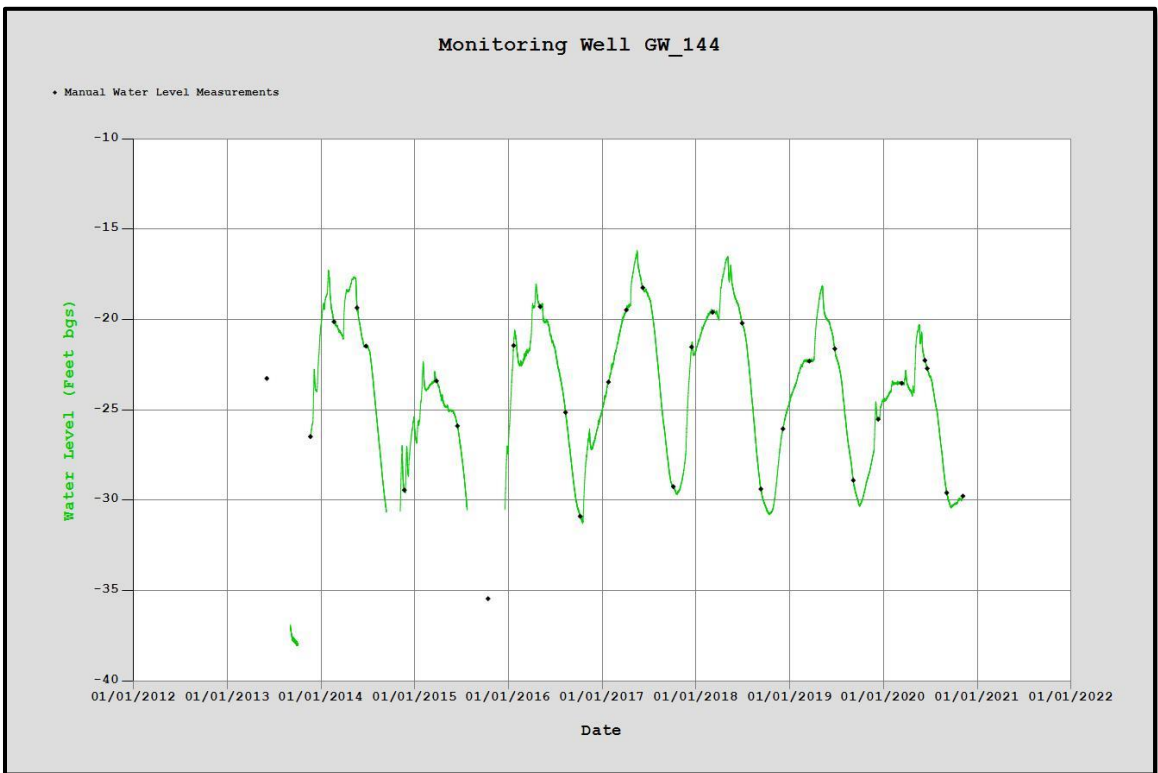
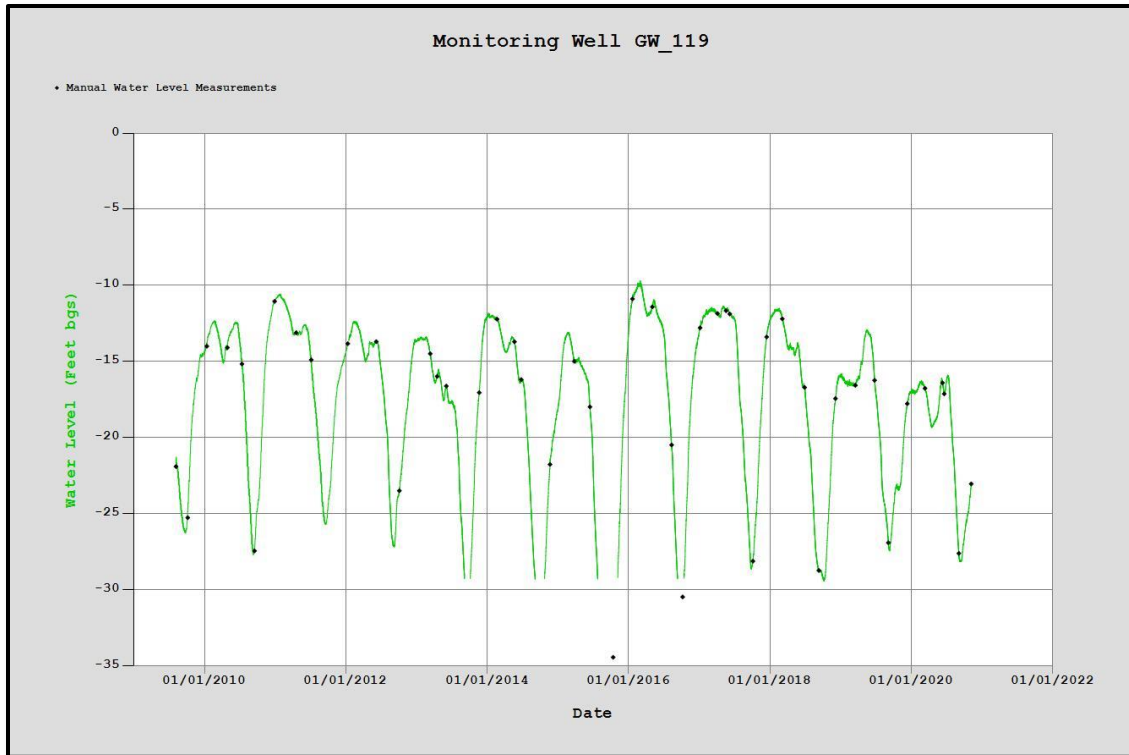
Figure 51. Hydrograph for monitoring well GW_34 during WY 2020.

Figure 52. GW_144 water level during the 2020 water year.

Figure 53. Hydrograph for monitoring well GW_34 from 2006-2020.

Figure 54. Water levels in GW_144 from 2013-2020.

Figure 55. Groundwater levels in GW_119 from 2009-2020.

Five monitoring wells are in the area of the site (Figure 50). GW_66 is discussed under the Ringer Road site and GW_036 is reported under the Gallagher site because they are closer to those sites. The influence of recharge operations on water levels in GW_34 and GW_144 during the 2020 water year is not apparent (Figures 51-52). Looking at the longer-term datasets, the yearly minimum and maximum groundwater levels at GW_34, GW_144, and GW_119 appear relatively stable and, in the case of GW_144, annual lows show a possible upward trend (Figures 53-54). Groundwater levels at upgradient GW_119 appear similar in the years before and after NW Umapine recharge began in WY2014 (Figure 55).

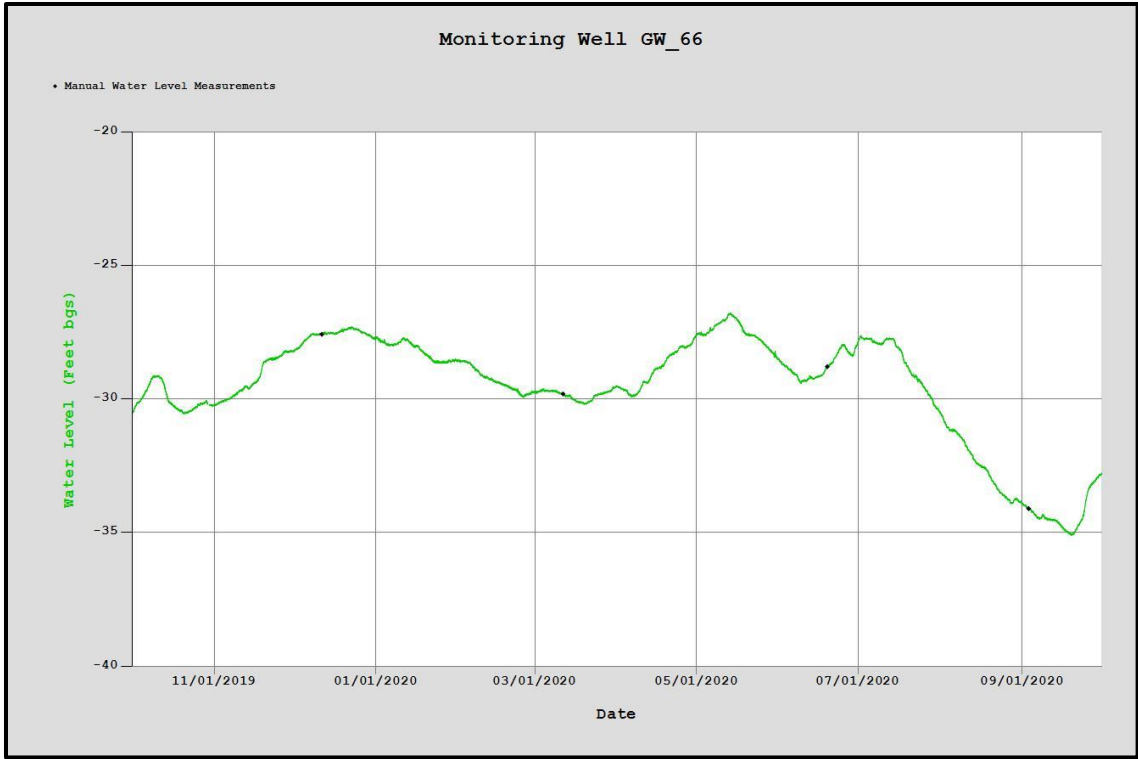
Figure 57. Water levels in GW_66 during the 2020 water year.

GW_66 is cross-gradient of the site (Figure 56). Additional years of data are needed to assess the influence of this site, if any, on the cross-gradient well, although the annual lows were higher the last two years, potentially suggesting increased groundwater storage due to recharge operations, which began in WY 2019 (Figures 57-58).

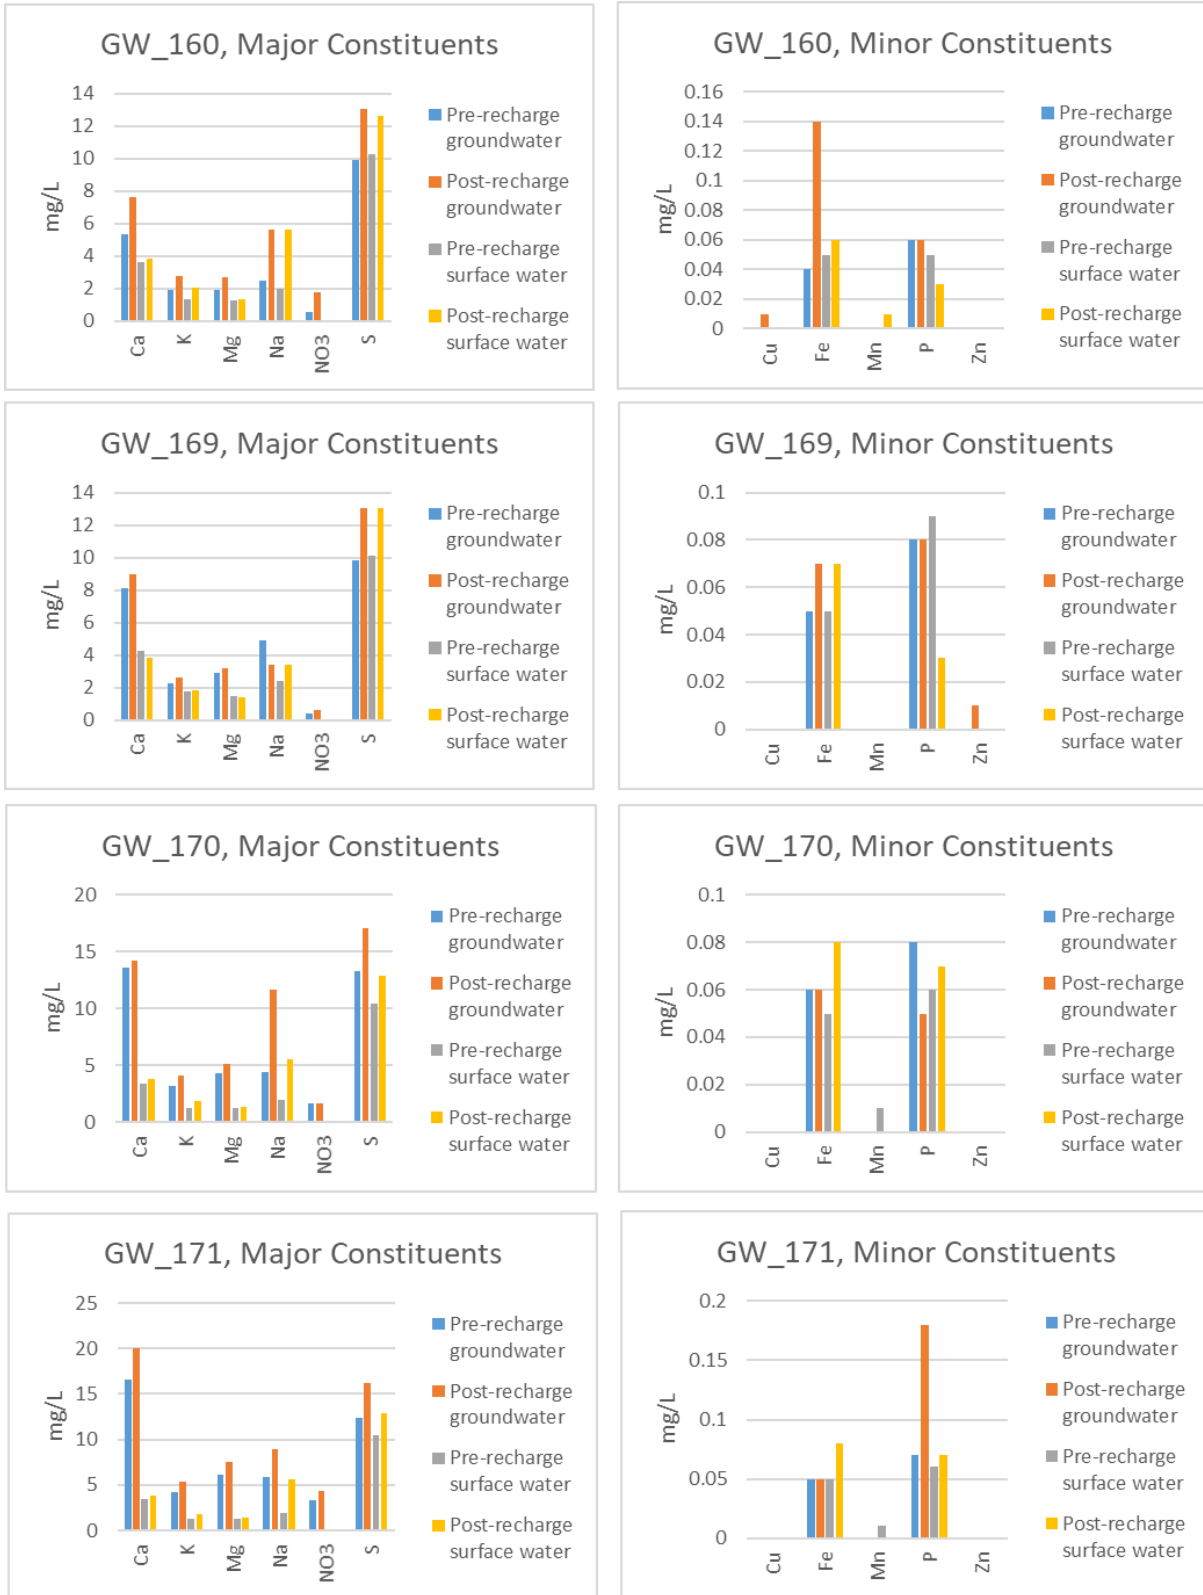
Figure 70. Water quality data, GW_160, GW_169, GW_170, and GW_171. Relevant source water locations are identified in Table 6.

Using the Unibest method, zinc was detected only in the post-recharge sample at GW_169 (0.01 mg/L, Table 9). Using method EPA 200.8 with a detection limit of 0.001 mg/L, zinc was found in the source water at WQ_1 (0.0037mg/L) and WQ_4 (0.00219 mg/L). Downgradient groundwater zinc concentrations increased from ND (not detected) pre-recharge to 0.00302 mg/L post-recharge at GW_169 and from ND pre-recharge to 0.00187 mg/L post recharge in GW_170 (Tables 10-11).
