Water Year 2021

Oregon Walla Walla Basin Aquifer Recharge Report

February 2022

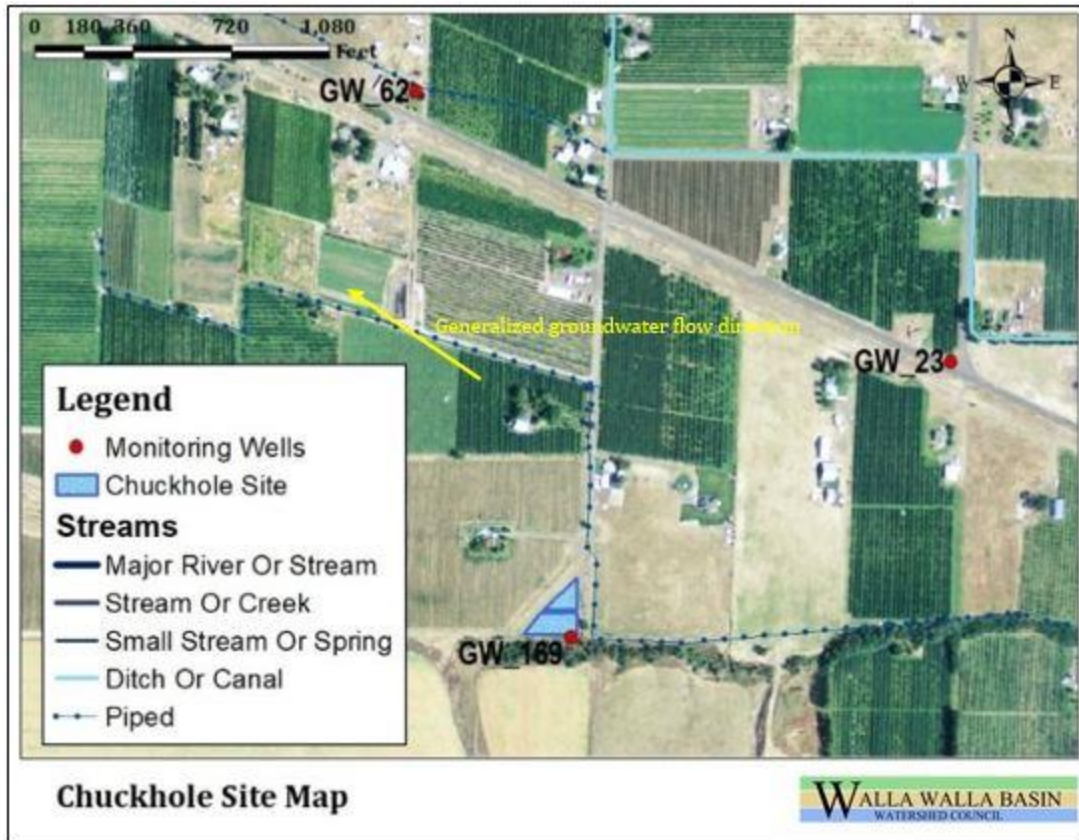
Figure 20. Chuckhole monitoring well locations.

Three monitoring wells are in the vicinity of the site: GW_169 up-gradient, GW_62 down-gradient, and GW_23 cross-gradient (Figure 20). As discussed above, GW_62 water levels show the influence of the Barrett recharge site and the influence of the Chuckhole site. GW_62 groundwater levels increase in November with the start of recharge at the Barrett site and further increase in March/April, coinciding with the start of recharge at the Chuckhole site. Groundwater level decrease in mid-May when recharge operations at both sites are concluded for the year. At GW_169 groundwater levels have increased during recharge season since the site began operating in 2016 (Figure 21). Each spring, the water level drops below the elevation of the sensor, producing the gaps seen on the hydrograph. At cross-gradient GW_23, the quarterly readings during WY 2021 did not occur within the brief 6-week recharge season (Figure 22).

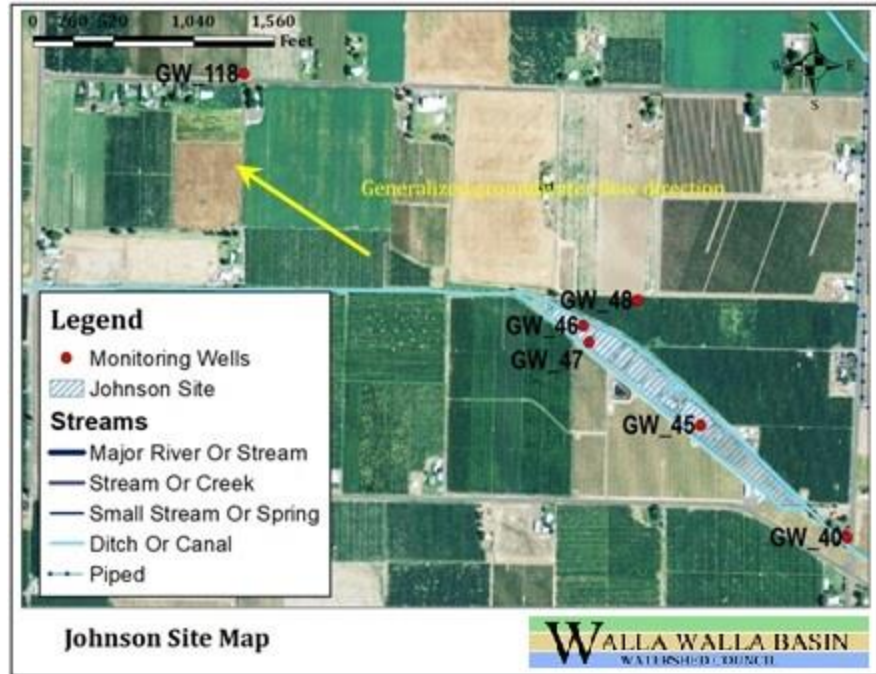
Figure 31. Johnson monitoring well locations.

During recharge season, groundwater levels under the Johnson site (GW_45, GW_46, and GW_47) are roughly 15-20 ft closer to the ground surface than at the up-gradient well (GW_40). The shallowest groundwater levels in down-gradient GW_118 are similar to levels under the Johnson site during the recharge season.

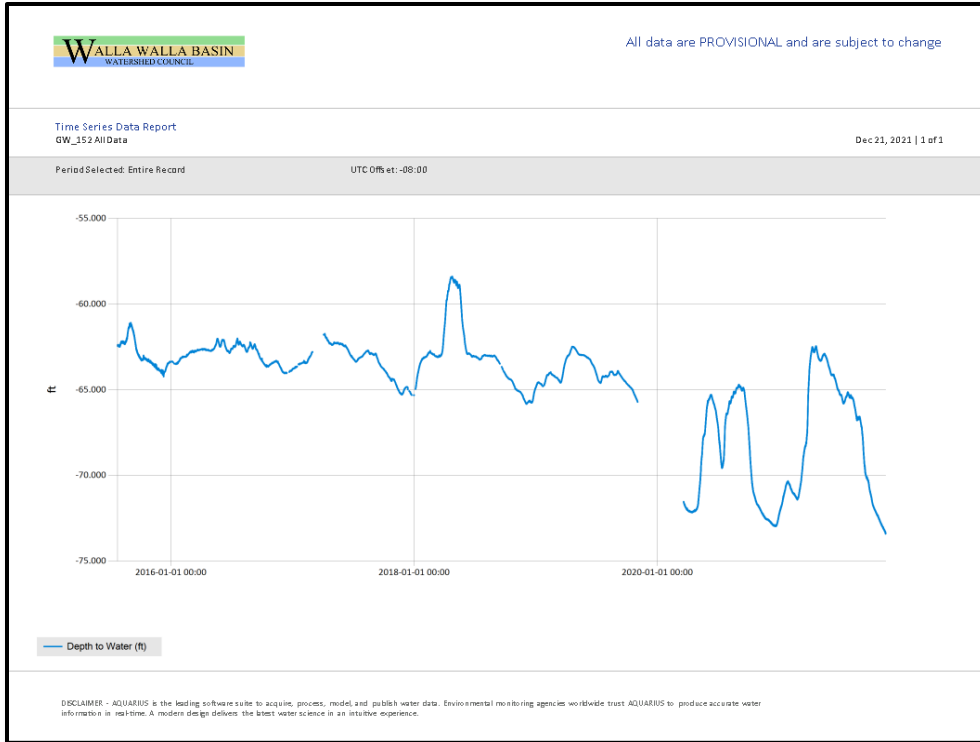
Figure 40. GW_152 hydrograph from WY 2015-2021. The notable increase during the spring of 2018 aligns with recharge operations at the LeFore site.

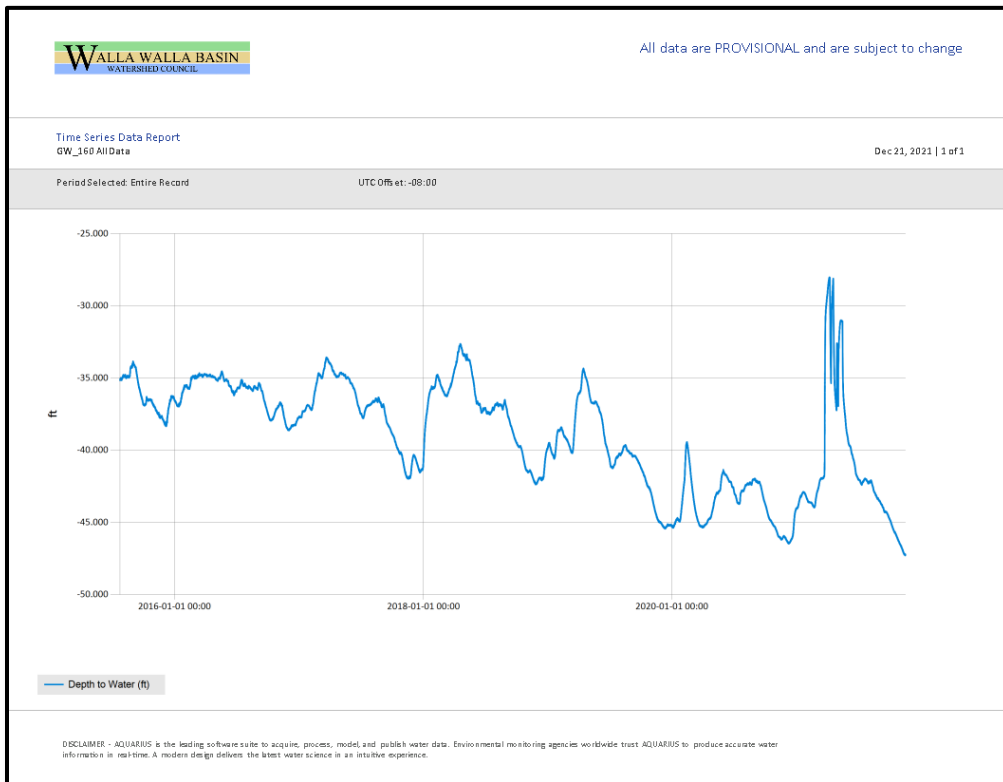
Figure 41. GW_160 hydrograph from WY 2015-2021. The 2021 peak reflects Miller Road recharge operations.

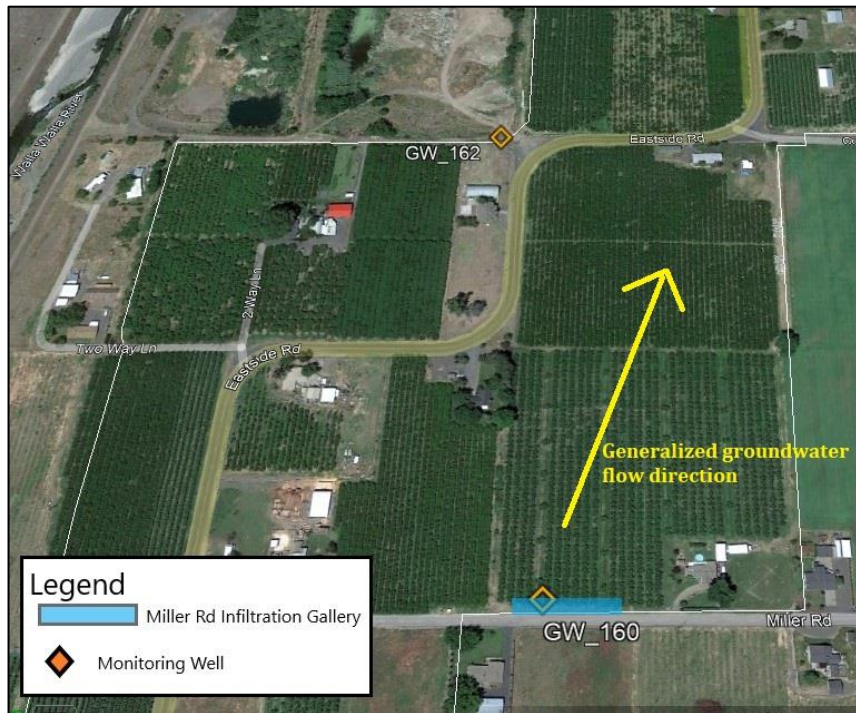
Figure 45. Miller Road monitoring well location

GW_160 is located at the site of the infiltration galleries, while GW_162 is 0.2 miles away (Figure 45). WY 2021 is the first season of operation at this site. The hydrographs from GW_160 and GW_162 show a significant influence from the recharged water (Figures 46-47). Annual low groundwater elevations, however, continue to drop at an alarming rate. While the site was running, water emerged on the ground surface three separate times due presumably to ground saturation. In each case, the site was shut off temporarily to allow for water dispersal before turning back on. The Eastside Pipeline is pressurized, allowing for a high rate of water inflow. We learned this season that the intake valve should be partially closed in order to keep the water inflow rate within the design specifications for the site.

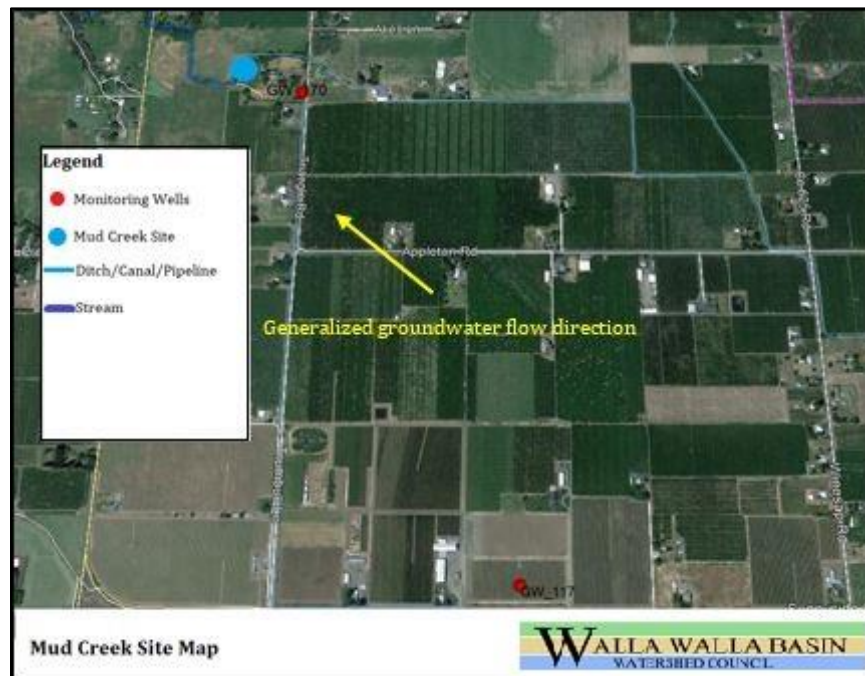
Figure 48. Mud Creek monitoring well locations.

Monitoring wells GW_170 and GW_117 are located up-gradient approximately 0.1 and 0.9 miles from the site, respectively (Figure 48). The roughly 40-foot difference in groundwater levels between the two wells illustrate the highly variable conditions in the alluvial aquifer (Figures 49-50). At nearby GW_170, groundwater levels increased during the recharge season, particularly from March-May. However, the springtime elevation increase was present prior to when Mud Creek recharge operations began in WY 2017, suggesting groundwater levels are responding to other factors as well, possibly recharge at the down-gradient recharge sites (Figure 51).

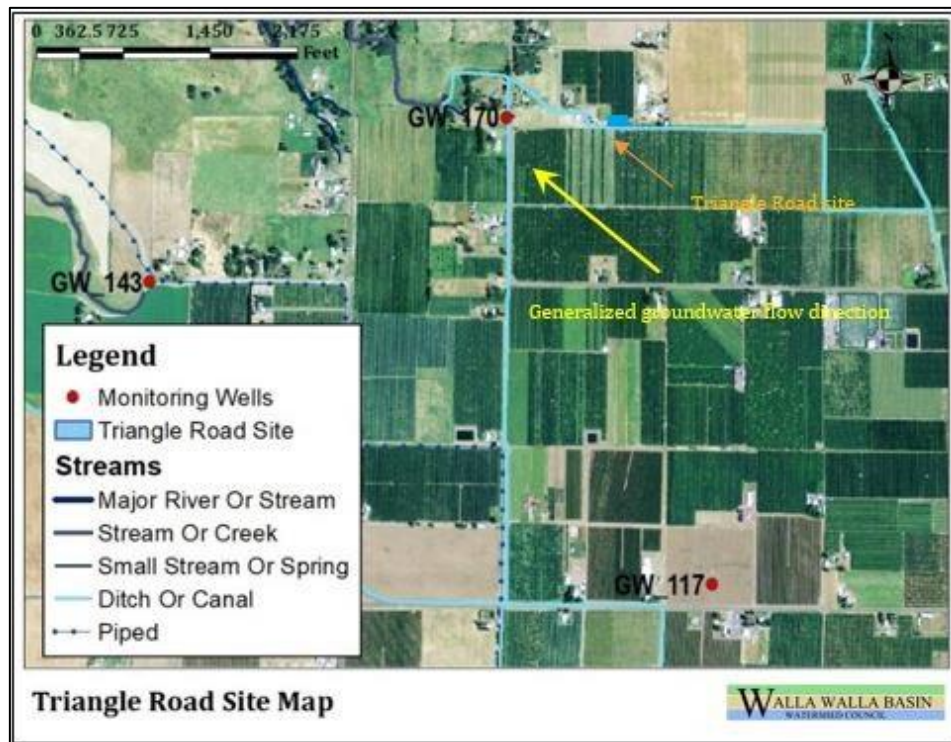
Figure 65. Triangle Road monitoring well locations (GW_171 not shown).

³ GW_171, one of the four monitoring wells associated with the Triangle Road site, is not shown in Figure 65 because it is 1.6 miles northwest of the site; the location of GW_171 can be seen in Figure 26.

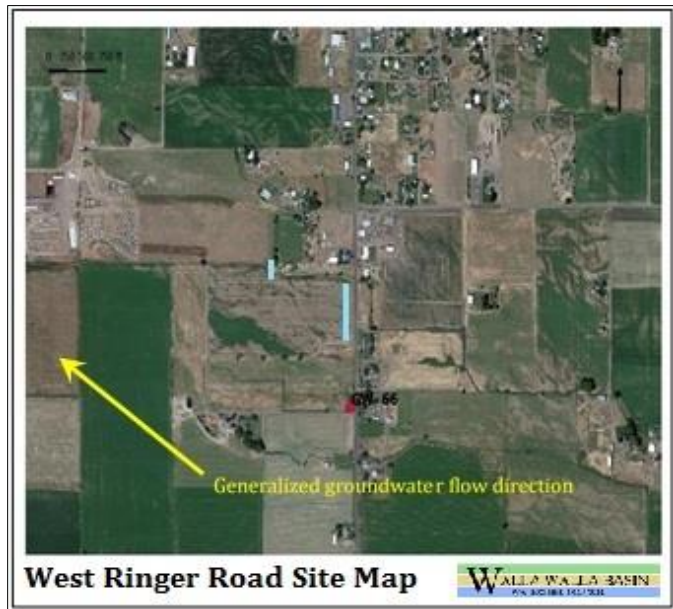
Figure 73. Ringer Road monitoring well location

GW_66 is up-gradient of the site (Figure 73). The WY 2021 elevation increases and decreases correlate with recharge operations. Additional years of data are needed to assess the influence of the Ringer Road site relative to other down-gradient recharge operations. However, annual groundwater elevation lows were higher during the first two years after Ringer operations began in WY 2019, potentially suggesting increased groundwater storage (Figures 74-75). The low in 2021 was lower but, as it was observed in other wells across the valley, that response could have been strongly influenced by an exceptionally hot summer and increased demand for groundwater use.
