WALLA WALLA BASIN WATERSHED COUNCIL

Water Year 2022

Oregon Walla Walla Basin Aquifer Recharge Report

February 2023

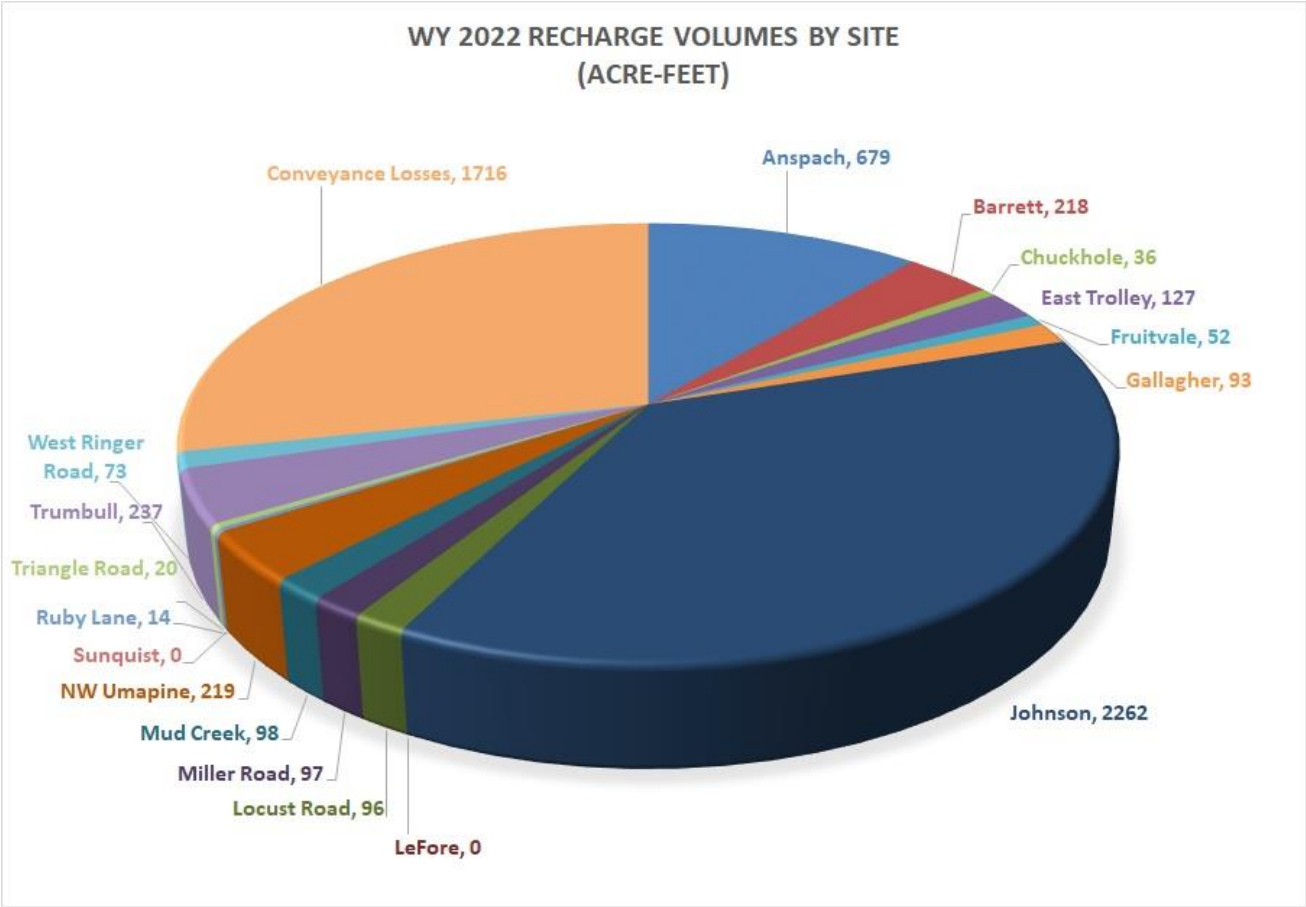
Figure 2. Recharge volumes by site during WY 2022.

During WY 2022, active recharge sites were Anspach, Barrett, Chuckhole, East Trolley Lane, Fruitvale, Gallagher, Johnson, Locust Road, Miller Road, Mud Creek, NW Umapine, Ringer Road, Ruby Lane, Triangle Road, and Trumbull. Figure 2 shows WY 2022 recharge volumes by site, including estimated conveyance losses (i.e. canal seepage) that become groundwater recharge. The Lefore and Sunquist recharge sites didn’t operate because site management and operational procedures were not yet fully developed.

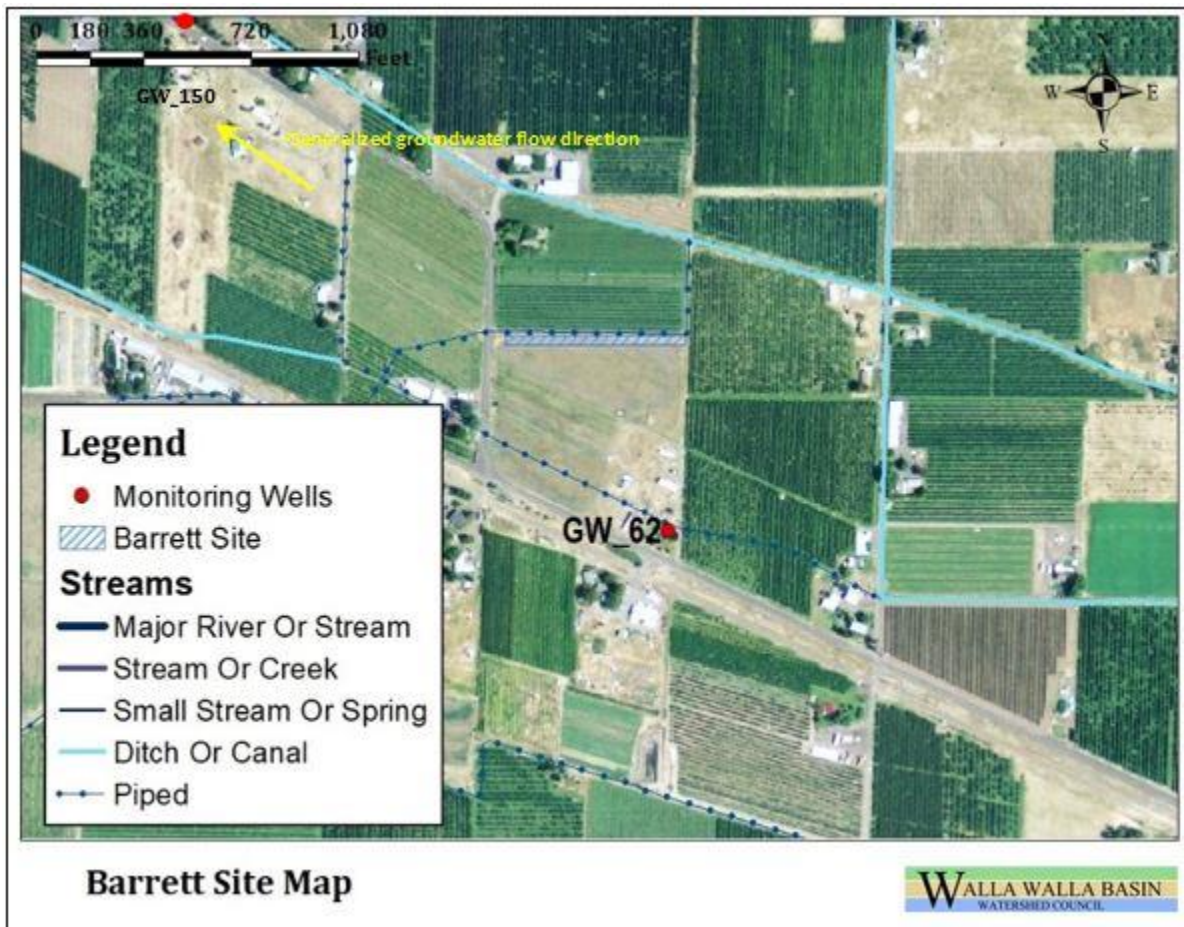
Figure 16. Barrett monitoring well locations.

GW_62 is up-gradient of the site (Figure 16). Response to recharge operations at the Barrett site were observed at the up-gradient groundwater monitoring well, GW_62, and includes influences from the Chuckhole recharge site (see below). Groundwater levels in the monitoring well increased to peak levels during recharge operations and decreased when recharge operations stopped (Figure 17). The 2006-2022 hydrograph for GW_62 is included for longer term groundwater levels at the Barrett site, which began operation in WY 2014 (Figure 18).

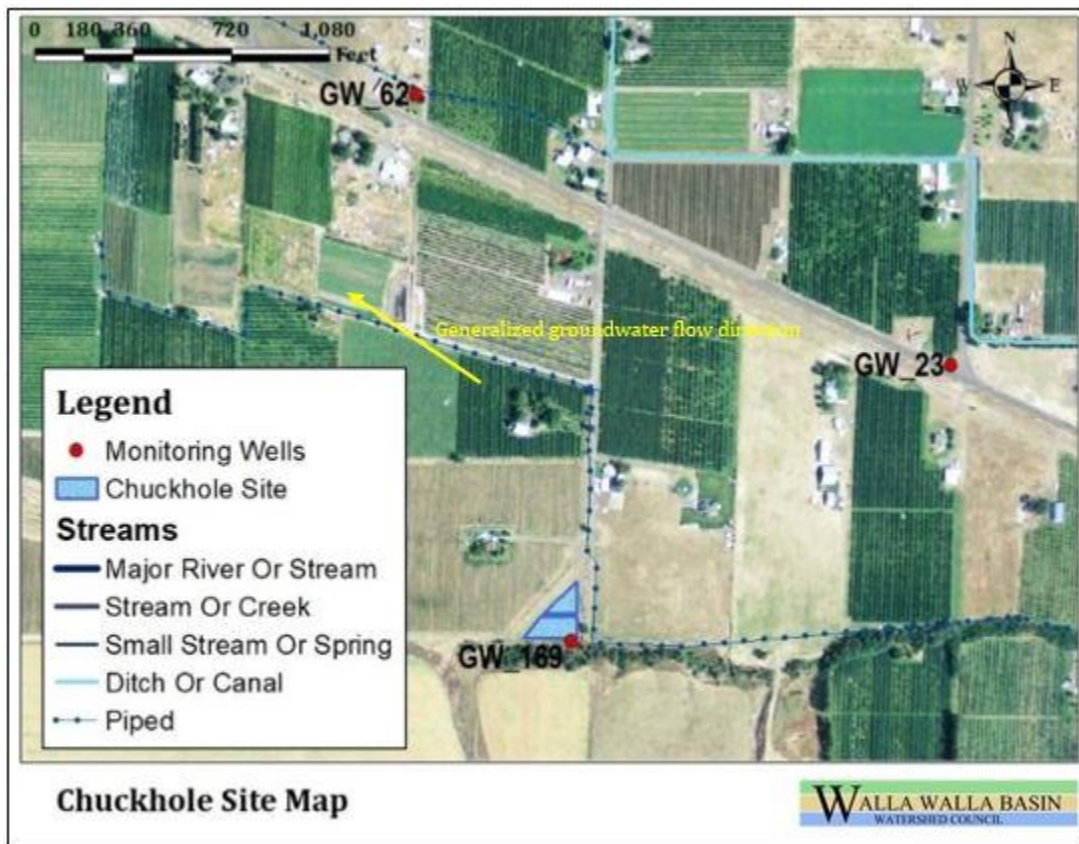
Figure 19. Chuckhole monitoring well locations.

Three monitoring wells are in the vicinity of the site: GW_169 up-gradient, GW_62 down-gradient, and GW_23 cross-gradient (Figure 19). As discussed above, GW_62 water levels show the influence of the Barrett recharge site and the influence of the Chuckhole site. GW_62 groundwater levels increase in November with the start of recharge at the Barrett site and peak in March/April, coinciding with the start of recharge at the Chuckhole site. Groundwater level decrease in mid-May when recharge operations at both sites are concluded for the year. At GW_169 groundwater levels have increased during recharge season since the site began operating in 2016 (Figure 20). Each spring, the water level drops below the elevation of the sensor, producing the gaps seen on the hydrograph. At cross-gradient GW_23, the static water level measurement collected during the brief 6-week recharge season was 20 feet above the lowest elevation measured for the year, taken in February (Figure 21).

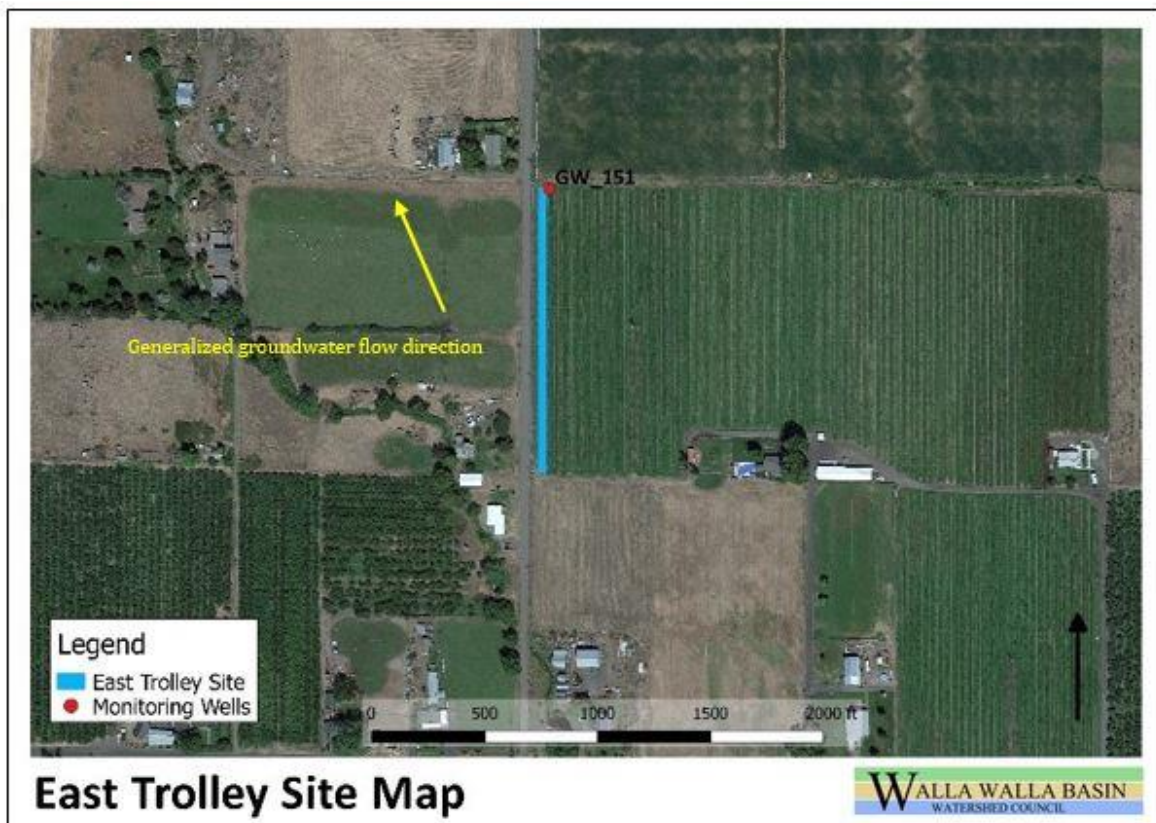
Figure 22. East Trolley monitoring well location.

GW_151 is at the distal end of the infiltration gallery (Figure 22). The magnitude and timing of the changes in groundwater levels suggest multiple influences on the seasonal water table (Figures 23-24). The springtime peak does appear to reflect the slightly lower volume recharged this year compared to the 2020-21 season, but the longer term trend since the site became active in 2017-2018 recharge season remains inconclusive.

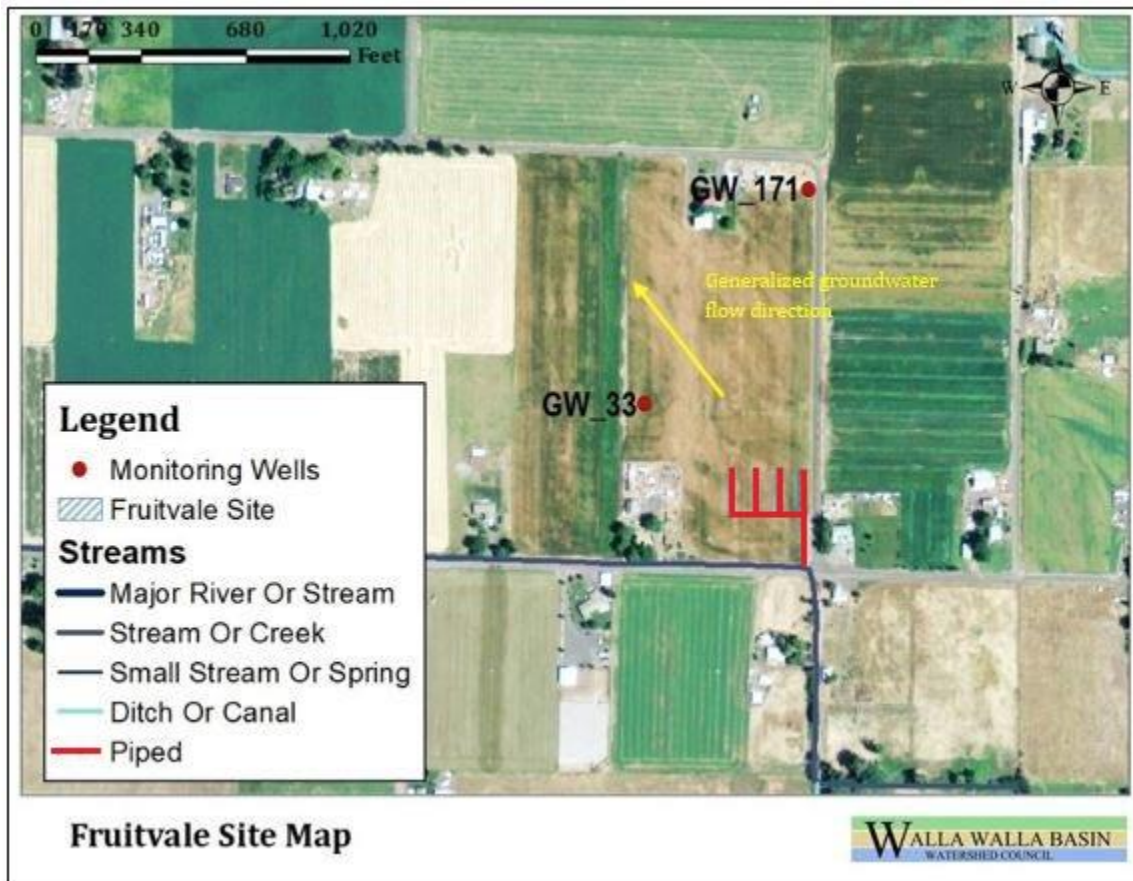
Figure 25. Fruitvale monitoring well locations.

This site is located between the inner and middle zone of springs described by Newcomb (1965). The landowner has described that springs used to surface near this site. Groundwater monitoring wells GW_33 and GW_171 are down-gradient of the site (Figure 25). At both locations, peaks and troughs correlate with recharge season (Figures 26-27). At GW_33, the seasonal high and low values since the site became active in the 2016-2017 recharge season are generally shallower than those documented prior to the site becoming active. Increased spring yield at nearby monitoring sites has been observed by WWBWC (see WWBWC, 2019) and suggests increased groundwater storage in the vicinity.

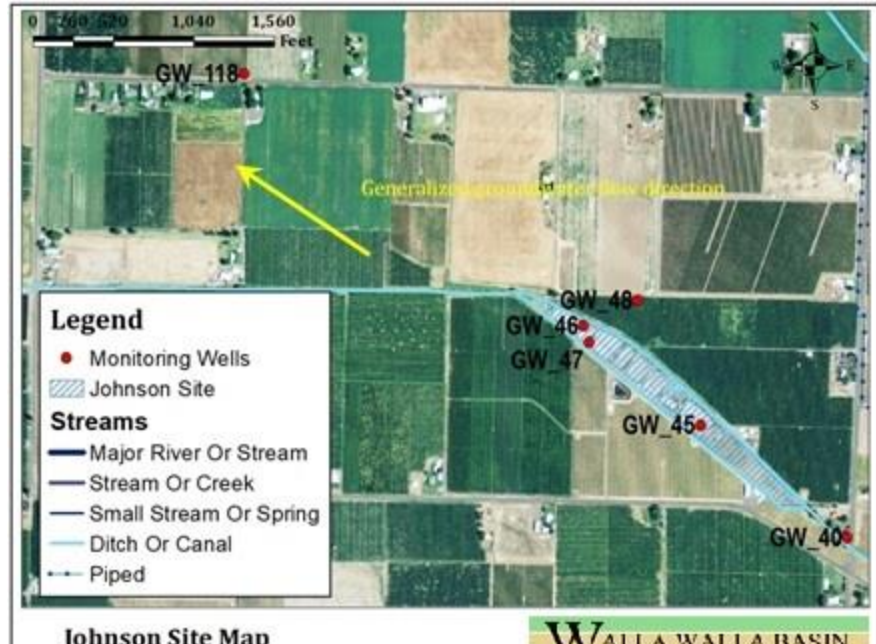
Figure 30. Johnson monitoring well locations.

Six monitoring wells are on or near the site (Figure 30). During recharge season, groundwater levels under the Johnson site (GW_45, GW_46, and GW_47) are roughly 15-20 ft. closer to the ground surface than at the up-gradient well (GW_40). The shallowest groundwater levels in down-gradient GW_118 are similar to levels under the Johnson site during the recharge season.

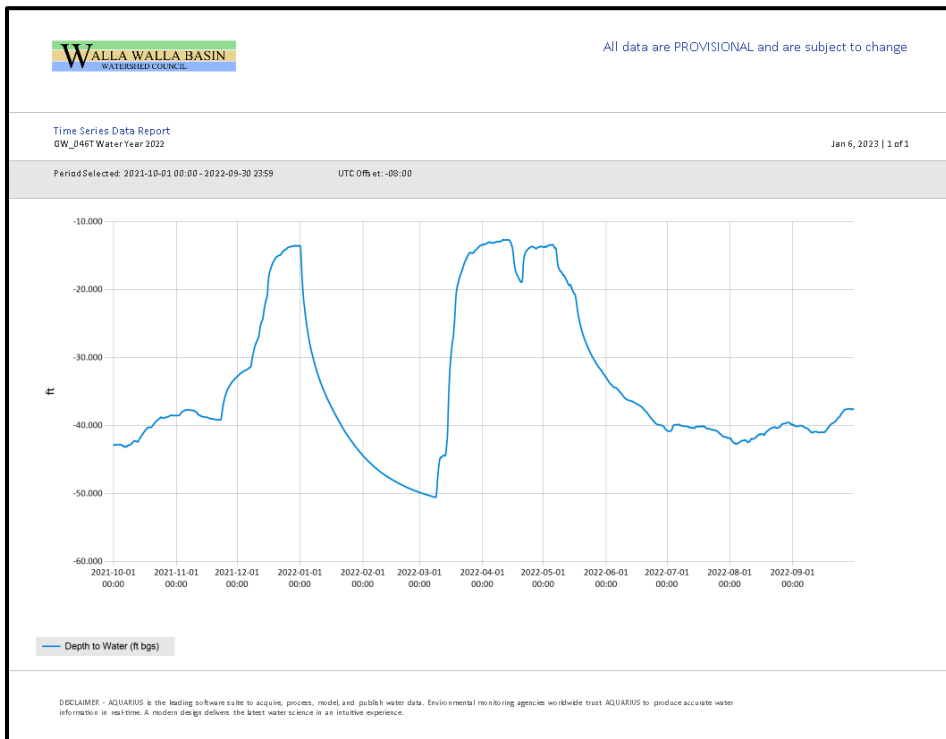
Groundwater monitoring wells (Figures 31-37) near the Johnson site were all observed to have a distinct increase in water levels in November shortly after operations began at the site. Up-gradient monitoring well GW_40 also showed a strong response to recharge operations with water levels increasing rapidly during recharge operations and decreasing after recharge operations were suspended. GW_40 water levels also show a response to nearby White Ditch flows during the fall.

Water levels in GW_45, GW_46 and GW_47 were observed to decrease approximately 30-40 feet between approximately December 31st and March 8th, 2022, when recharge operations were interrupted, and again at the end of recharge season. However, water levels after the end of recharge season decreased slower than the rate of water level increase at the beginning of recharge operations, suggesting that groundwater storage was occurring beneath the site.

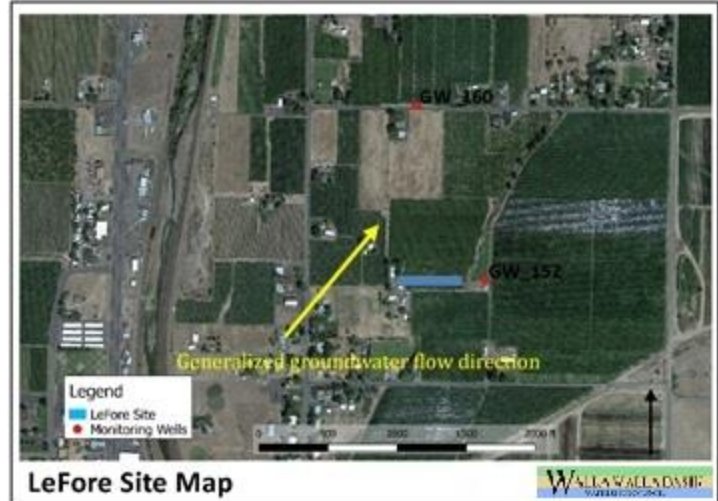
Figure 38. LeFore monitoring well locations.

GW_152 is down-gradient and GW_160 is cross-gradient of the site (Figure 38). During WY 2020, one day of operations was not adequate to affect groundwater levels. However, the response to operations in WY 2018, when 78 ac-ft. was recharged, is in sharp contrast to the years during which recharge did not occur (Figure 39). The dramatic decline in groundwater elevations measured during the 2020-2022 water years compared to previous years is concerning, and the cause is unknown (Figure 40). The springtime peaks in 2021 and 2022 at GW_160 and, to a lesser extent at GW_152, reflect the first two years of recharge operations at the Miller Road recharge site.

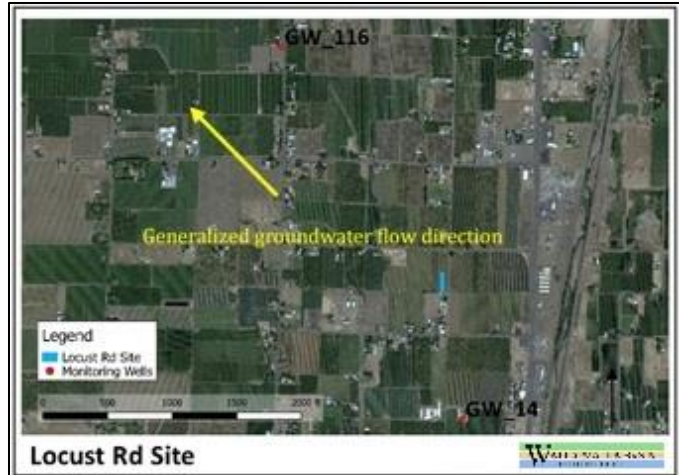
Figure 41. Locust Road monitoring well locations.

GW_14 and GW_116 are approximately 0.4 miles up-gradient and 0.8 miles down-gradient of the site, respectively (Figure 41). Since recharge began in the spring of 2018, changes in groundwater levels solely due to recharge are not apparent in either well (Figures 42 and 43). Given the proximity of both GW_14 and GW_116 to the Little Walla Walla River irrigation canal, groundwater fluctuations at those sites appears to be more strongly influenced by seepage losses from the canal than by water recharged at the Locust Road Site. Annual lows at GW_116 appear to be declining since 2015 (Figure 43).

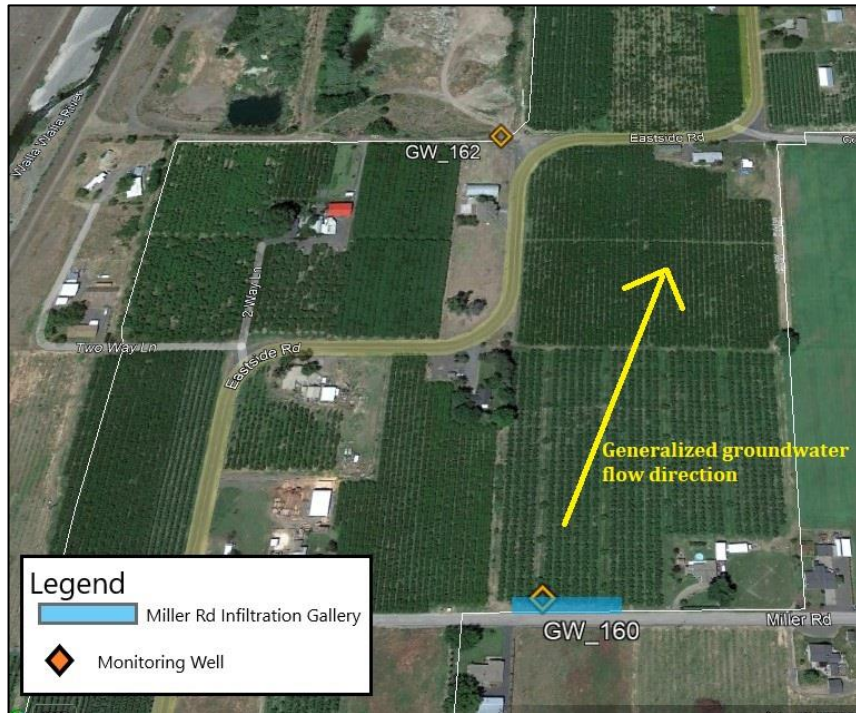
Figure 44. Miller Road monitoring well location

GW_160 is located at the site of the infiltration galleries, while GW_162 is 0.2 miles and down gradient from the site (Figure 44). WY 2021 was the first season of operation at this site. The hydrographs from GW_160 and GW_162 show a significant influence from the recharged water (Figures 45-46). Annual low groundwater elevations, however, continue to drop at an alarming rate. The Eastside Pipeline is pressurized, allowing for a high rate of water inflow.

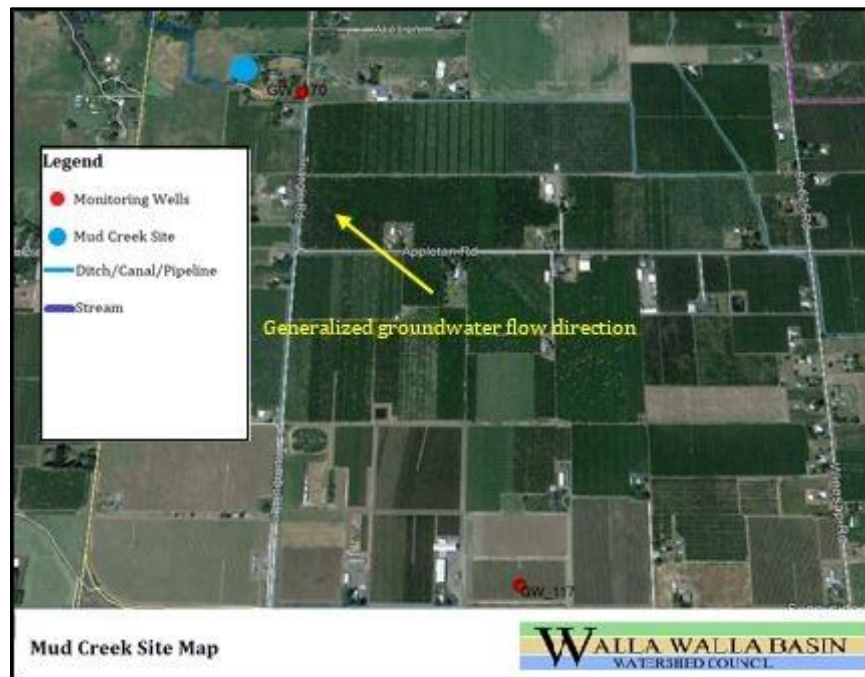
Figure 47. Mud Creek monitoring well locations.

Monitoring wells GW_170 and GW_117 are located up-gradient approximately 0.1 and 0.9 miles from the site, respectively (Figure 47). The roughly 40-foot difference in groundwater levels between the two wells illustrate the highly variable conditions in the alluvial aquifer (Figures 48-49). At nearby GW_170, groundwater levels increased during the recharge season, particularly from March-May. However, the springtime elevation increase was present prior to when Mud Creek recharge operations began in WY 2017, suggesting groundwater levels are responding to other factors as well, possibly recharge at the down-gradient recharge sites (Figure 50).

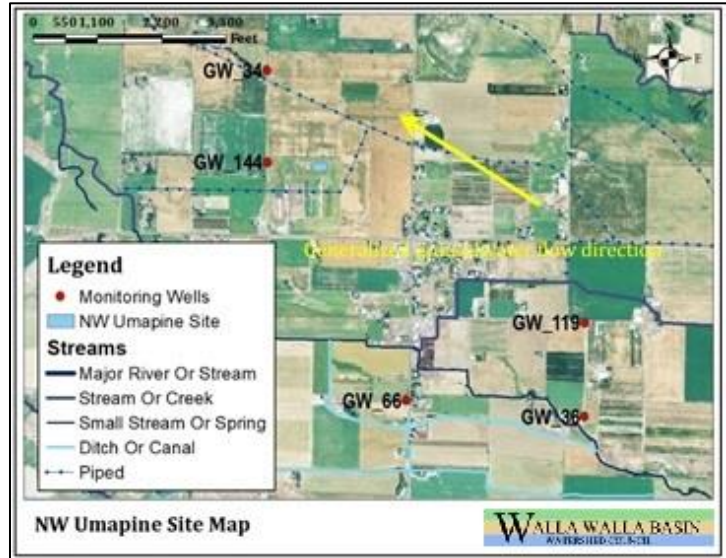
Figure 55. NW Umapine monitoring well locations.

Five monitoring wells are in the area of the site (Figure 55). GW_66 is discussed under the West Ringer Road site and GW_036 is reported under the Gallagher site. The annual groundwater cycle in the down-gradient wells GW_34 and GW_144 correlates with the recharge season (Figures 56-57), but that cycle was present prior to WY 2014, when the NW Umapine site began operation (Figure 58). The long-term datasets also show the yearly minimum and maximum groundwater levels at GW_34, GW_144, and GW_119 appearing to be relatively stable, with this year's annual lows at GW_144 and GW_119 being the shallowest on record (Figures 58-60). Groundwater levels at up-gradient GW_119 appear similar in the years before and after NW Umapine recharge began in WY 2014.

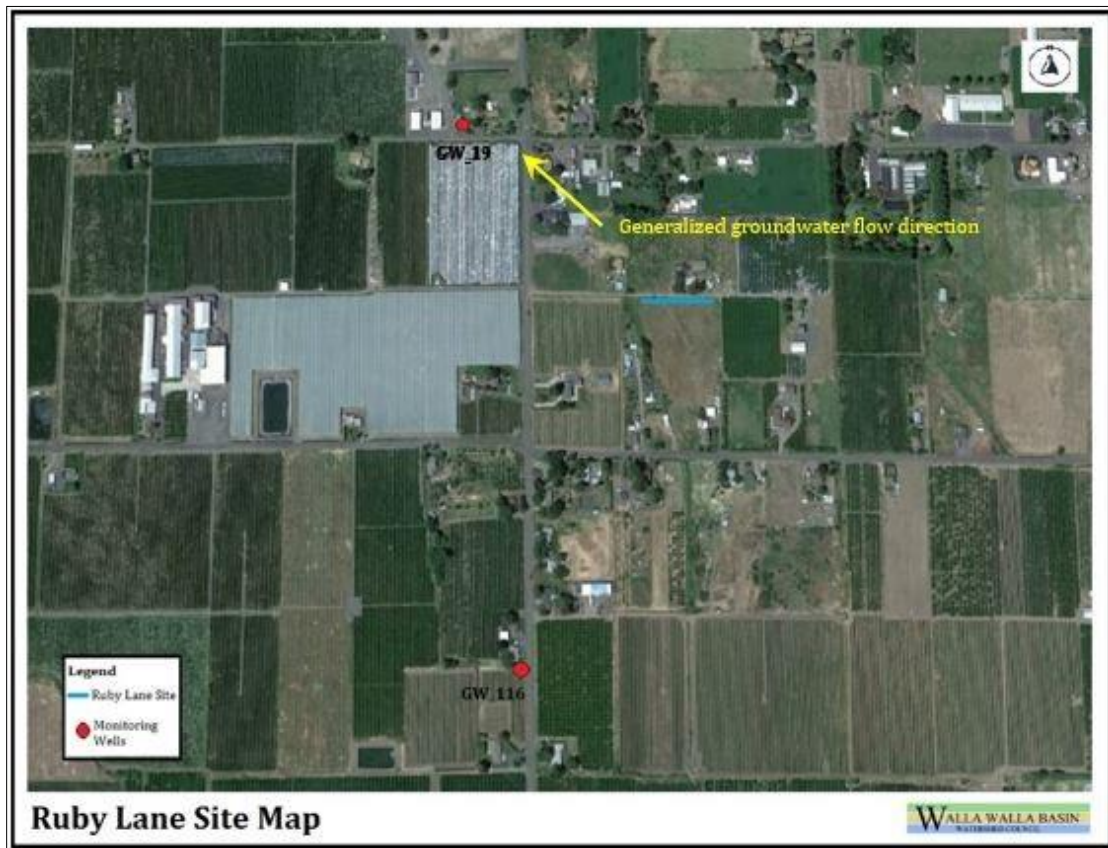
Figure 61. Ruby Lane monitoring well locations.

GW_116 is 0.3 miles up-gradient of the site and GW_19 is 0.2 miles down-gradient of the site (Figure 61). WY 2021 was the first year of Ruby Lane recharge operation, and we encountered difficulty getting enough water into the recharge site intake pipeline. There was inadequate water available in the irrigation ditch to back up and enter the infiltration gallery intake. In WY 2022, we experienced issues with keeping the screen to the intake clean, limiting the amount of recharge. Based on the timing of annual peaks and troughs, groundwater levels in both the up and down-gradient wells appear to be more influenced by high summertime flow rates and conveyance losses in the Little Walla Walla River than by the limited recharge operations at Ruby Lane (Figures 62-63).

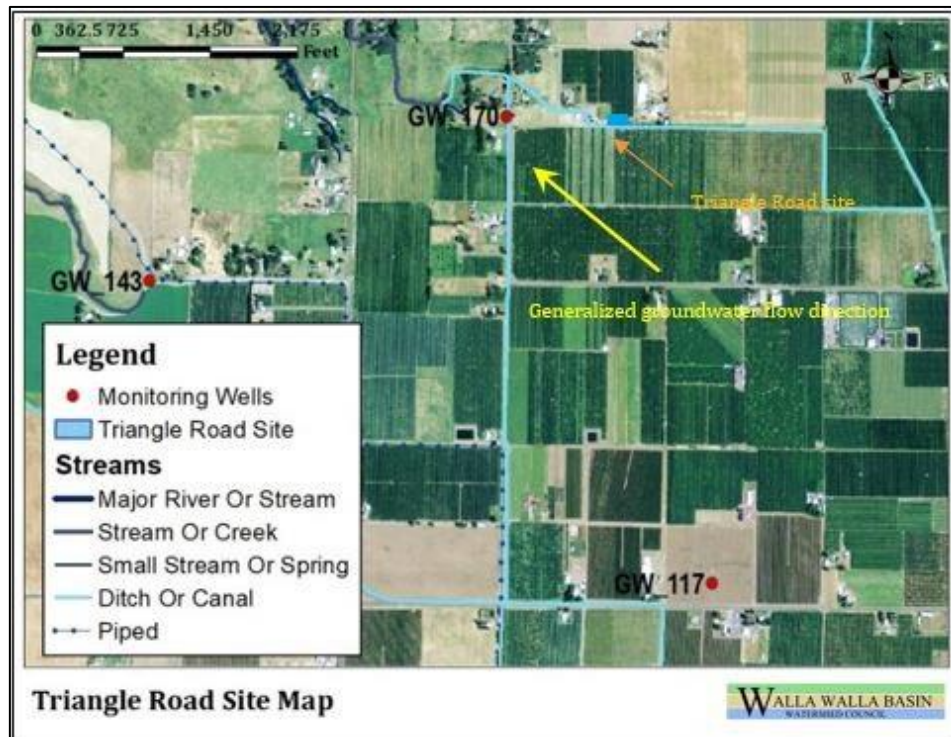
Figure 64. Triangle Road monitoring well locations (GW_171 not shown).

Four monitoring wells are in the vicinity of the site: up-gradient GW_117, cross-gradient GW_143, and down-gradient wells GW_170 and GW_171 (Figure 64, GW_171 not shown). As shown in Figures 49 and 51, GW_117 elevations correlate with recharge season but are likely influenced by other factors as well. Figure 65 shows elevations in GW_143 that correlate with recharge season during the 2022 water year. Annual patterns of groundwater elevations in GW_143, however, are similar to the years before Triangle Road recharge operations began in 2017 (Figure 66). It's likely that GW_143 water levels are influenced more by Johnson and maybe Trumbull Rd operations than by Triangle Road recharge.

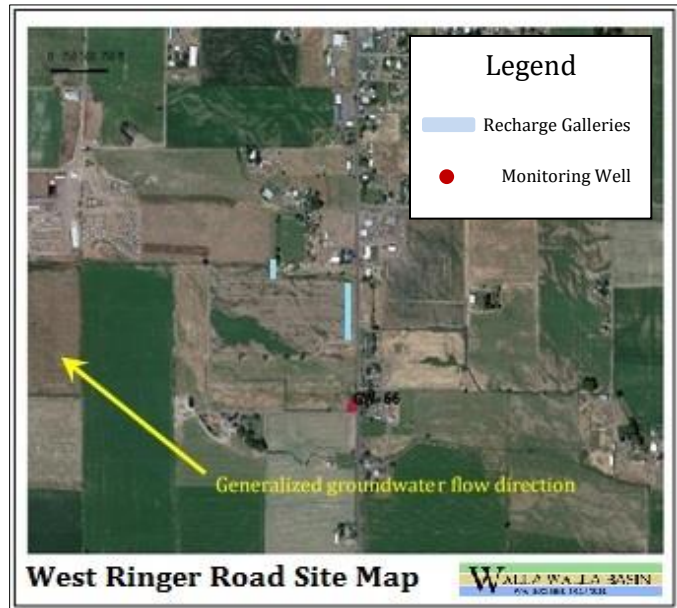
Figure 72. Ringer Road monitoring well location.

GW_66 is up-gradient of the site and likely influenced both by Ringer Road operations as well as upgradient recharge operations at other sites (Figure 72). There's a data gap in the hydrograph for the WY 2022 at the time when upgradient recharge sites turned on, making it difficult to detect patterns (Figure 73). Additional years of data and site operation are needed to assess the influence of the Ringer Road site relative to other up-gradient recharge operations (Figure 74).

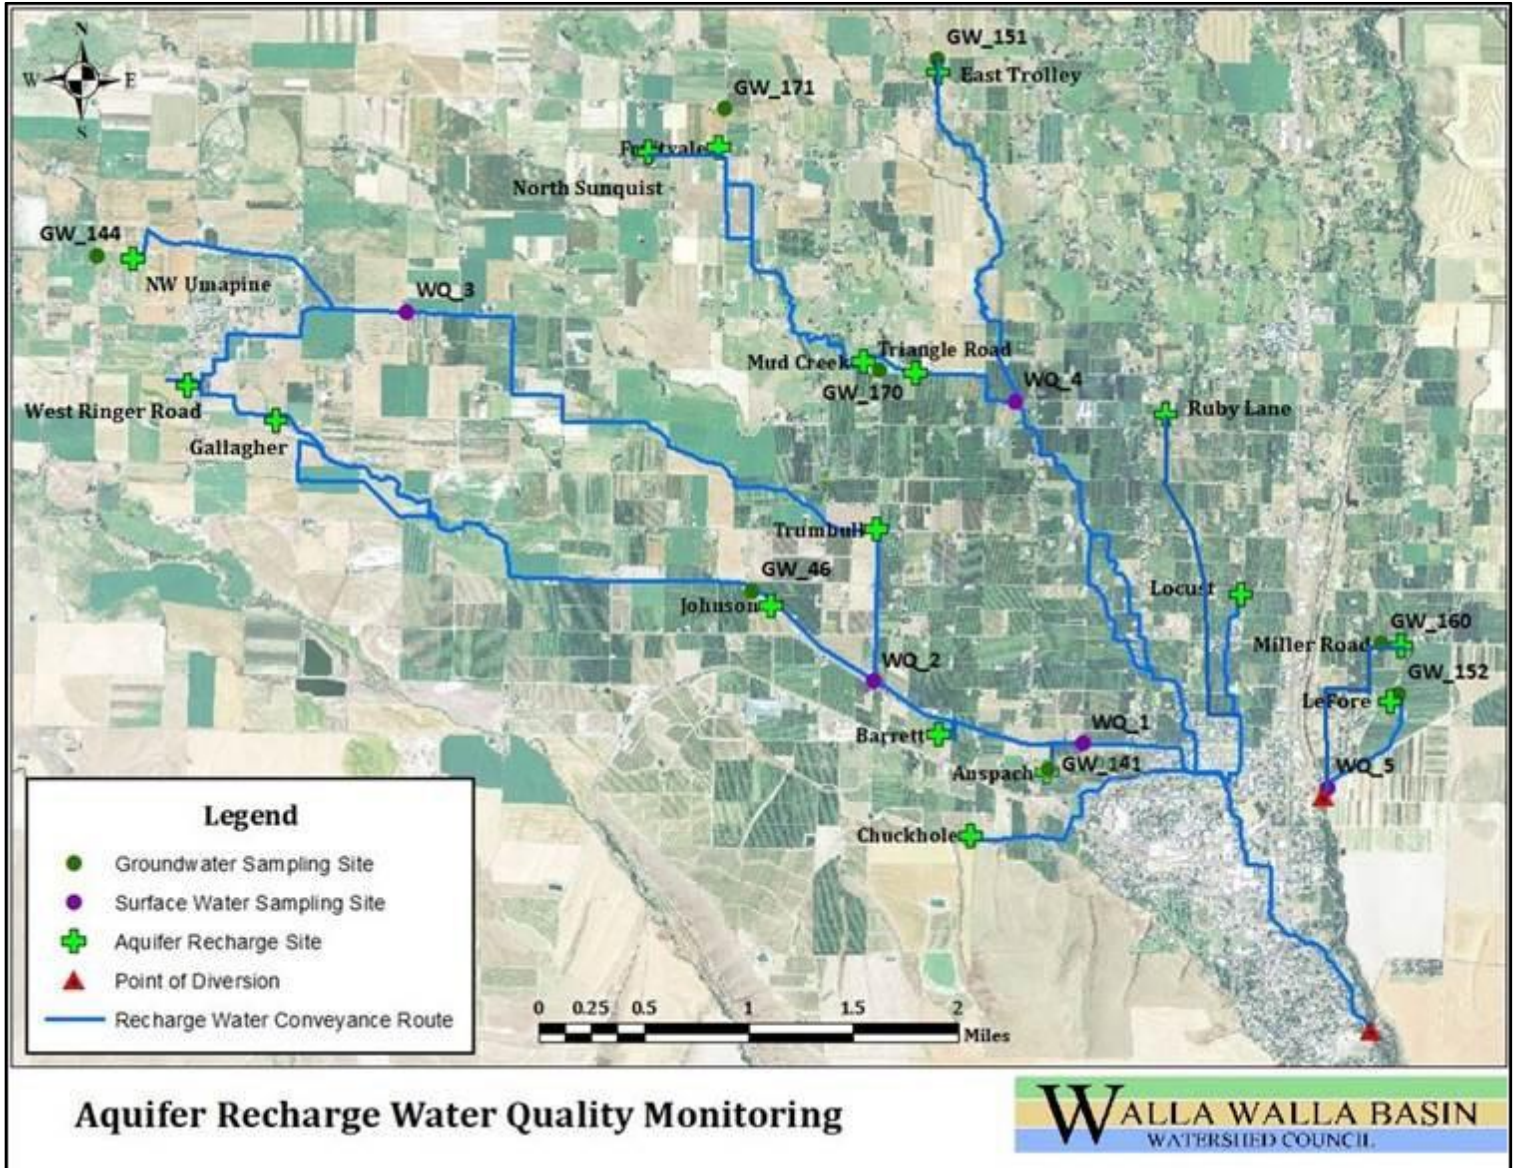
Figure 81. Water quality sampling locations for the managed aquifer recharge program in WY 2022.

To evaluate the impacts to groundwater quality from managed aquifer recharge, analyte concentrations in groundwater were compared to source water concentrations before and after the recharge season. Table 6 lists the source water sites relevant for each groundwater sampling site.
