Oregon Walla Walla Basin Aquifer Recharge Report

2024 Water Year

Walla Walla Basin Watershed Council

In Cooperation with Hudson Bay District Improvement Company
and Fruitvale Water Users Association

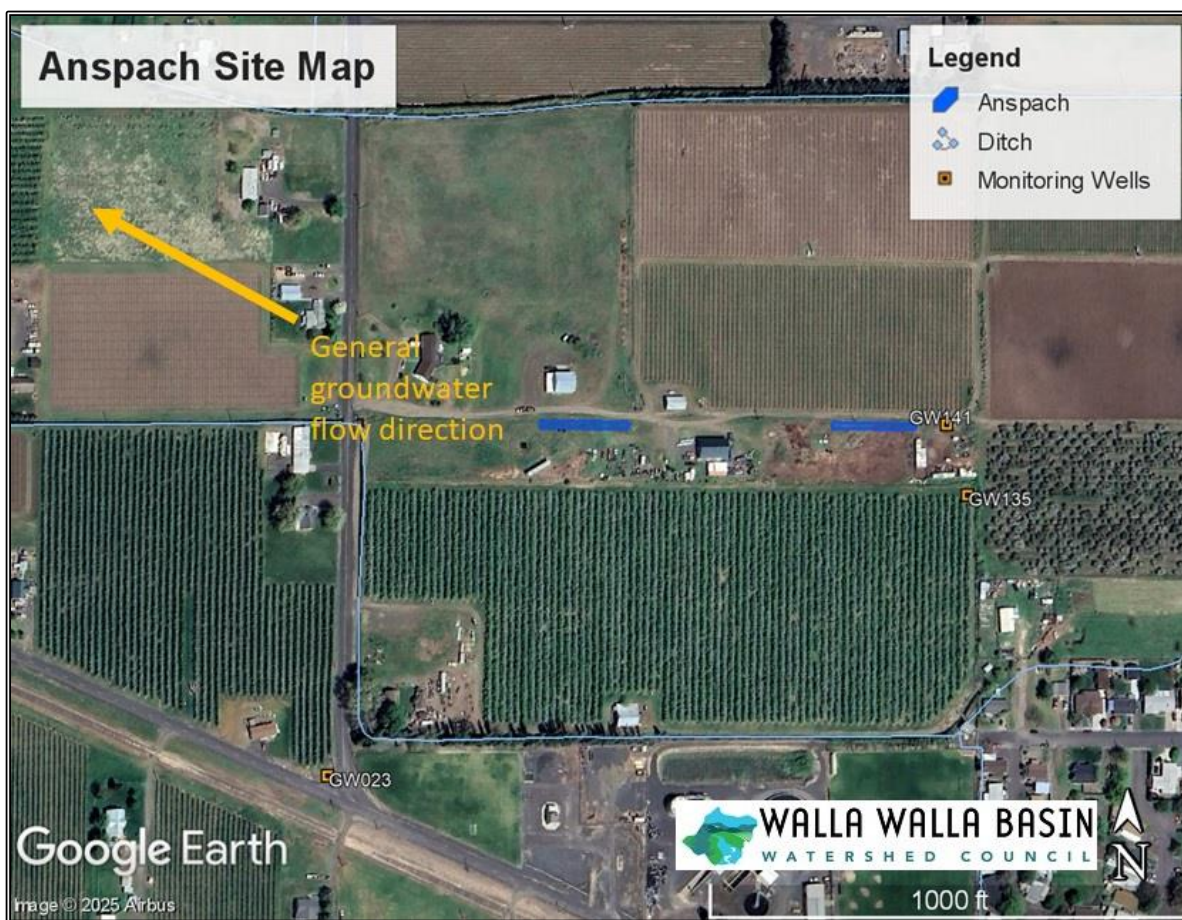
Figure 11. Anspach site and monitoring wells locations.

The site has two up-gradient wells, GW_135 and GW_141, and one cross-gradient well, GW_23 (Figure 11). The shallowest groundwater elevations at GW_141 rose by more than 10 feet during the early years of managed recharge (Figure 12). This year's groundwater trends look similar to the 2022 and 2023 seasons, both of which were high-volume recharge years at Anspach. GW_141 is up-gradient of the recharge site, the timing of the seasonal patterns (Figure 13) suggests the well is influenced by managed recharge operations, perhaps as a result of groundwater mounding under the Anspach site. Quarterly measurements at GW_135 show that the annual low elevation, typically in January/February, has steadily increased since 2018 (Figure 14). At cross-gradient GW_23, quarterly readings preclude observing changes between each month; between years, groundwater levels may be stabilizing after declines in the three previous decades (Figure 15).

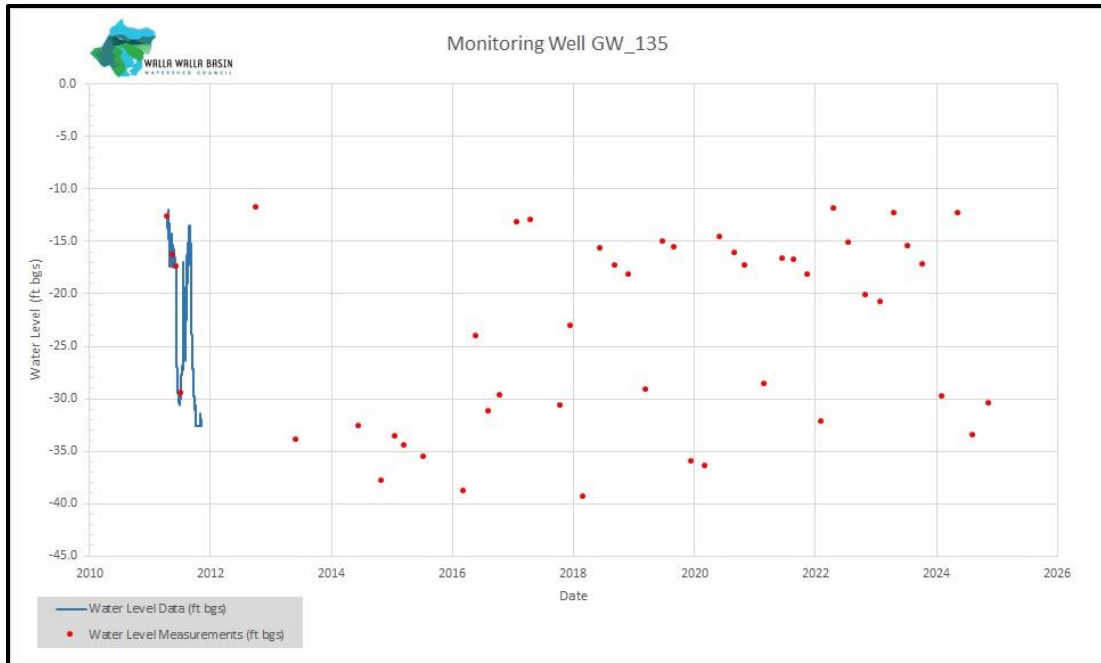
Figure 14. GW_135 hydrograph from 2014-2024.

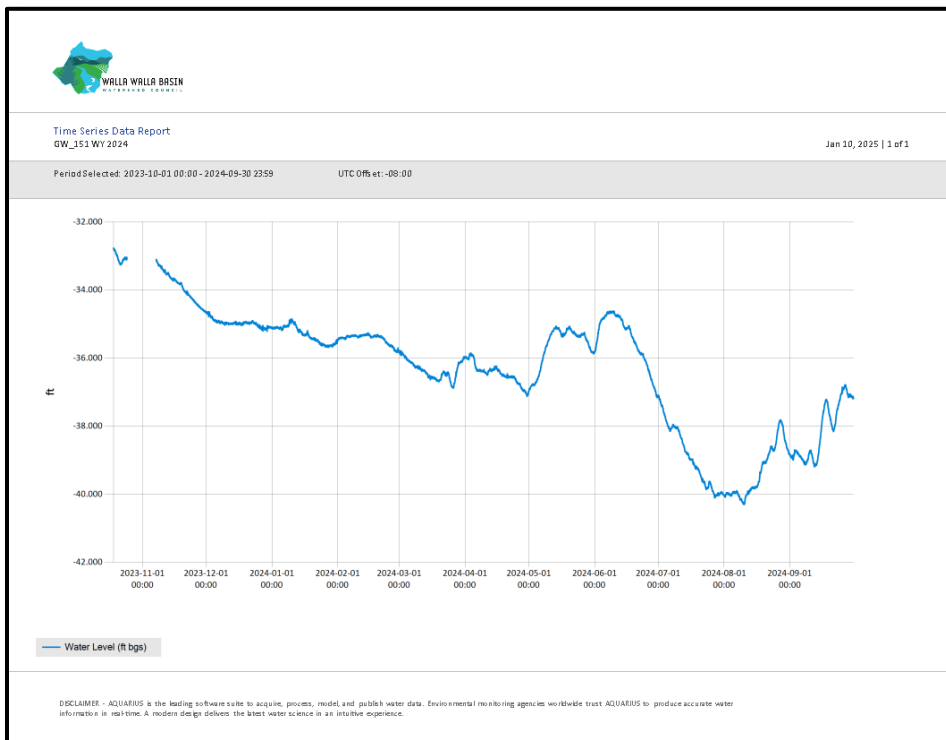
Figure 23. GW_151 hydrograph from WY 2024.

GW_151 is at the distal end of the infiltration gallery (Figure 22). The magnitude and timing of the changes in groundwater levels suggest multiple influences on the seasonal water table (Figures 23-24). The springtime peak may be due to recharge operations but the longer term trend since the site became active in 2017-2018 recharge season remains inconclusive.

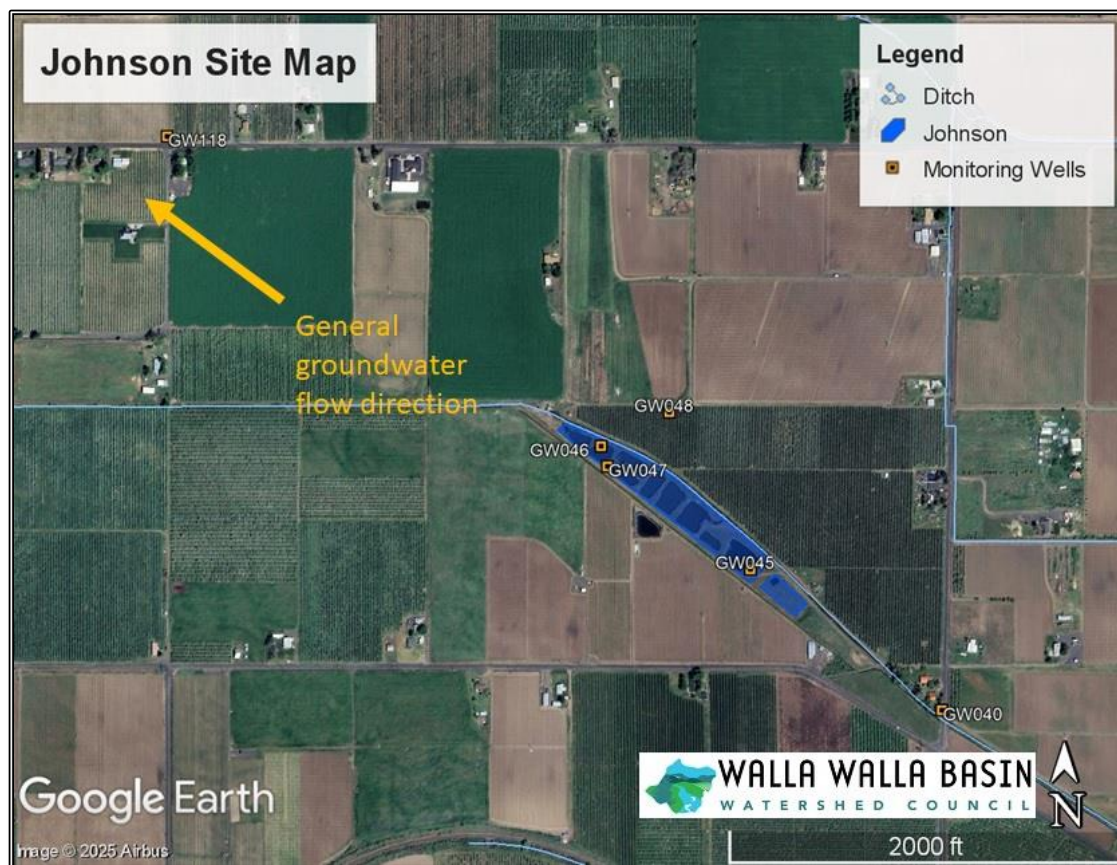
Figure 30. Johnson site and monitoring wells locations.

Six monitoring wells are on or near the site (Figure 30). During recharge season, groundwater levels under the Johnson site (GW_45, GW_46, and GW_47) are roughly 15-20 ft. closer to the ground surface than at the up-gradient well (GW_40). The shallowest groundwater levels in down-gradient GW_118 are similar to levels under the Johnson site during the recharge season.

Groundwater monitoring wells (Figures 31-37) near the Johnson site were all observed to have a distinct increase in water levels in November shortly after operations began at the site. Up-gradient monitoring well GW_40 also showed a strong response to recharge operations with water levels increasing rapidly during recharge operations and decreasing after recharge operations were suspended. GW_40 water levels also show a response to nearby White Ditch flows during the fall.

Water levels in GW_45, GW_46 and GW_47 were observed to decrease approximately 40-50 feet between approximately January 10th and March 16th, 2024, when recharge operations were interrupted. However, water levels after the end of recharge season decreased slower than the rate of water level increase at the beginning of recharge operations, suggesting that groundwater storage was occurring beneath the site.

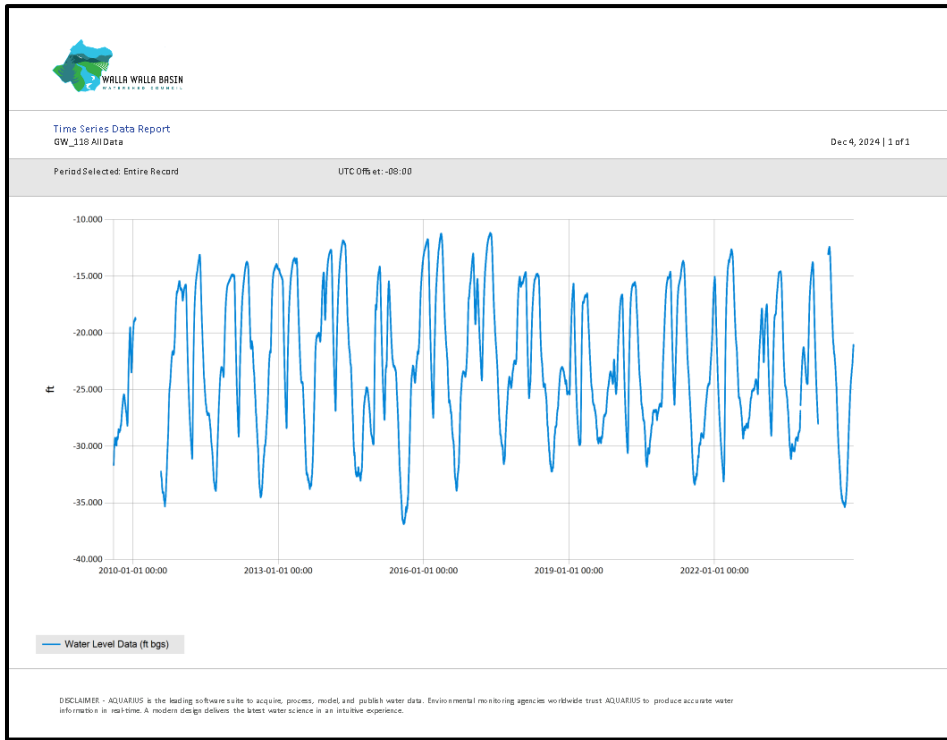
Figure 37. GW_118 hydrograph from WY 2010-2024.

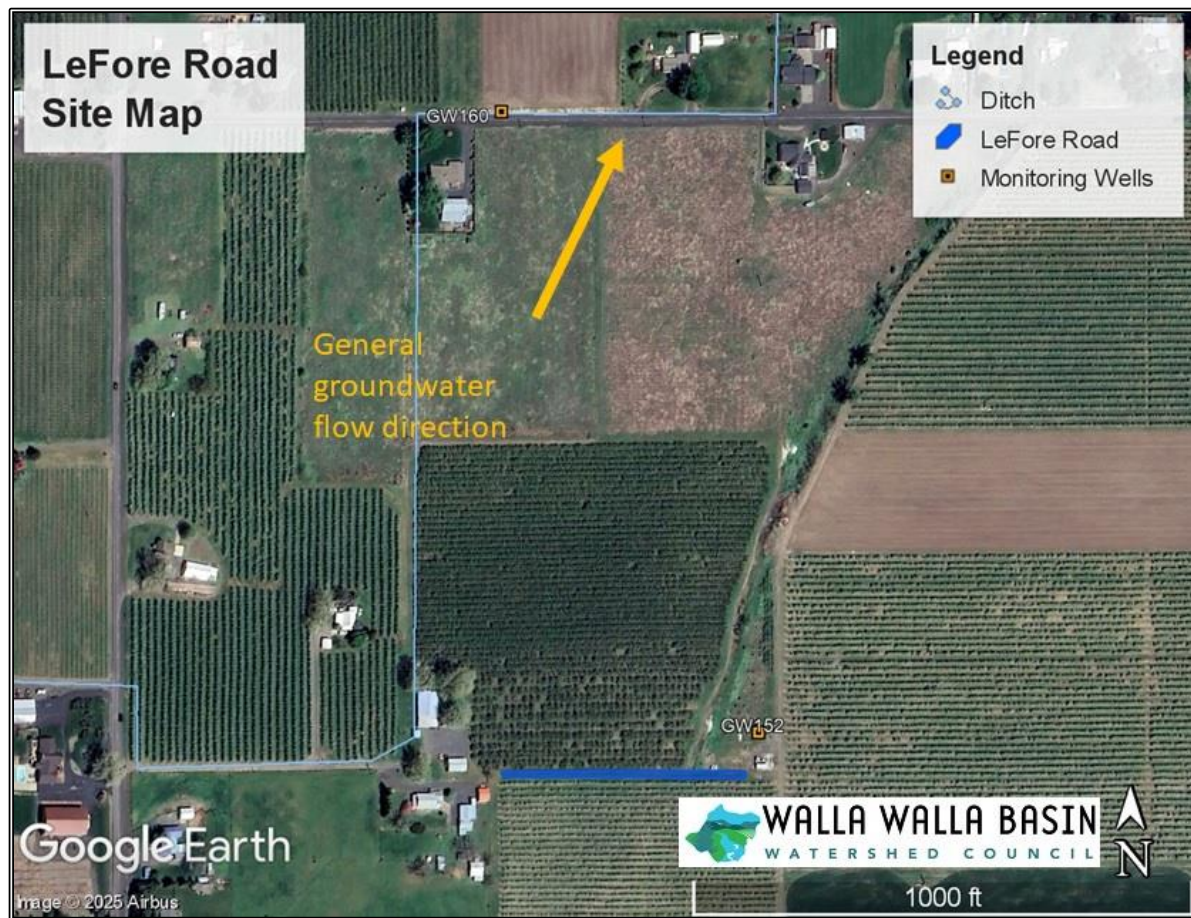
Figure 38. LeFore Road site and monitoring wells locations.

GW_152 is down-gradient and GW_160 is cross-gradient of the site (Figure 38). The response to operations in WY 2018, when 78 ac-ft. was recharged, is in sharp contrast to the years during which recharge did not occur (Figure 39). The dramatic decline in groundwater elevations measured during the 2020-2024 water years compared to previous years is concerning, and the cause is unknown (Figure 40). The springtime peaks from 2021 to 2024 at GW_160 and, to a lesser extent at GW_152, reflect the first four years of recharge operations at the Miller Road recharge site.

The LeFore Site did not operate during the 2024 water year because funding was not available to pay the landowner for pumping costs associated with water delivery to the site.

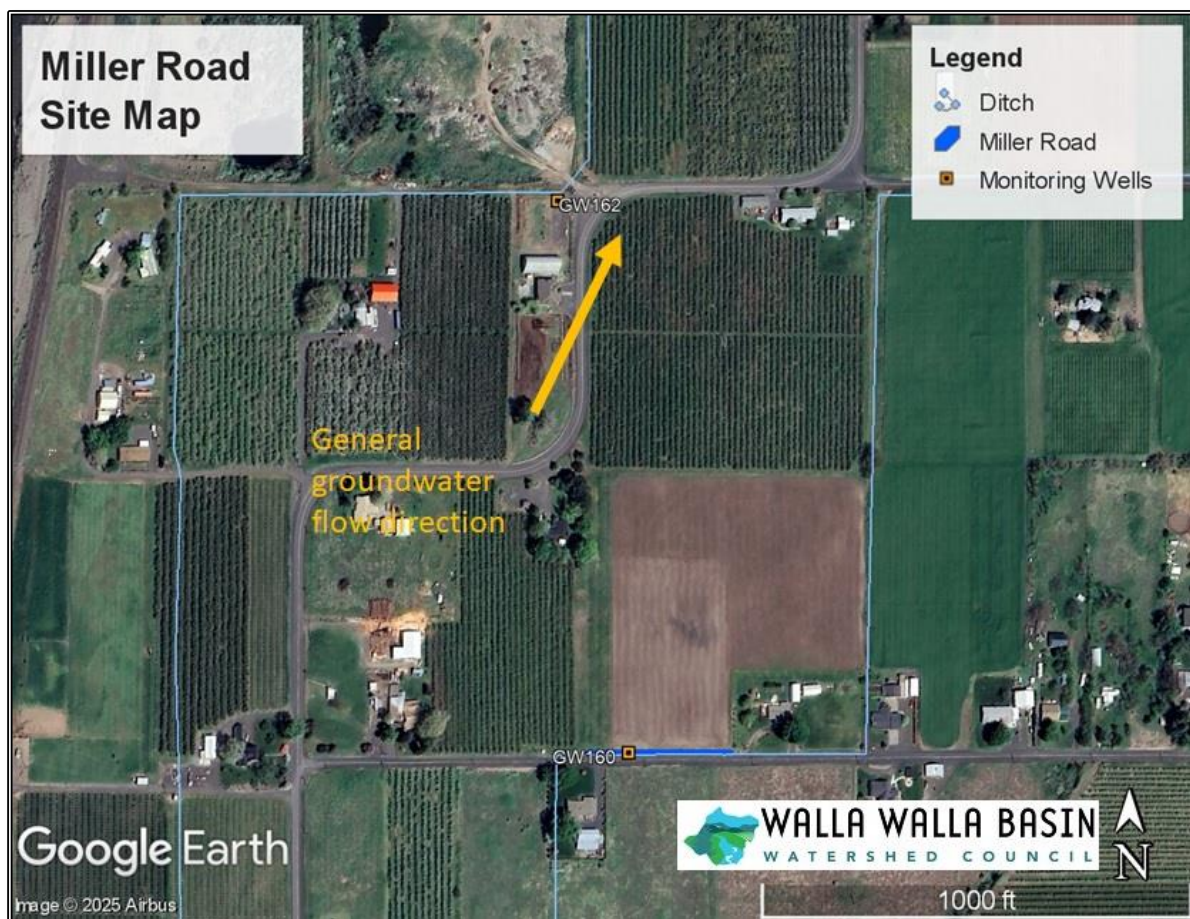
Figure 44. Miller Road site and monitoring wells locations.

GW_160 is located at the site of the infiltration gallery, while GW_162 is 0.2 miles down gradient from the site (Figure 44). WY 2021 was the first season of operation at this site. The hydrographs from GW_160 and GW_162 show a significant influence from the recharged water (Figures 45-46). The trending increased depth to GW prior to this site becoming active in WY 2021 has stabilized, potentially indicating the site has stabilized groundwater conditions.

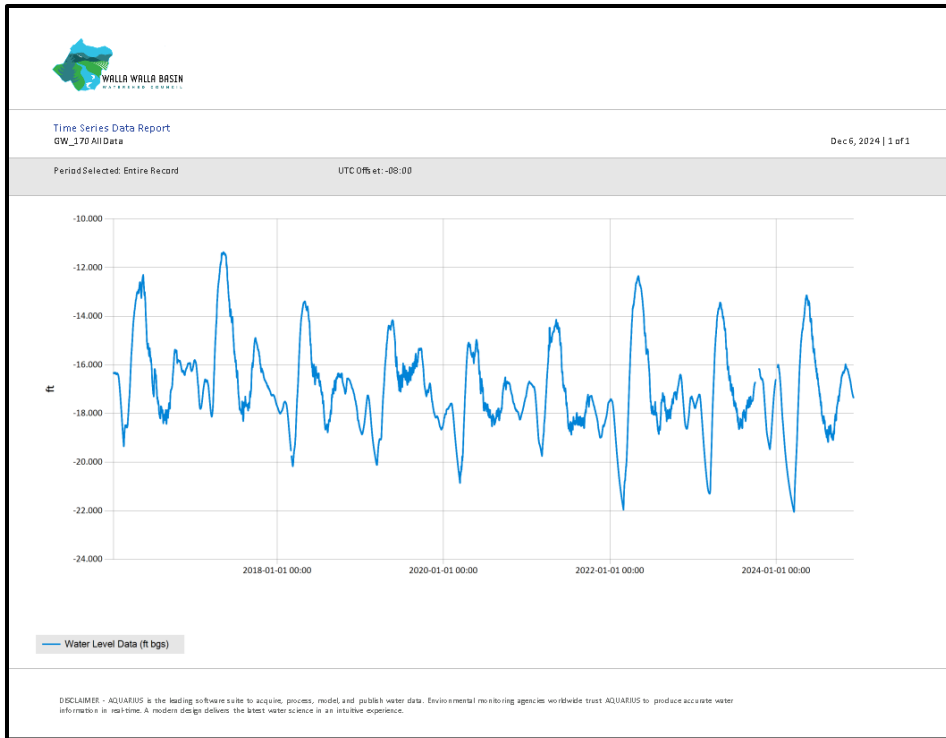
Figure 48. GW_170 hydrograph from WY 2024.

Figure 49. GW_117 hydrograph from WY 2024.

Figure 50. GW_170 hydrograph from WY 2016-2024.

Figure 51. GW_117 hydrograph from WY 2009-2024.

Monitoring wells GW_170 and GW_117 are located up-gradient approximately 0.1 and 0.9 miles from the site, respectively (Figure 47). The roughly 40-foot difference in groundwater levels between the two wells illustrates the highly variable conditions in the alluvial aquifer (Figures 48-49). At nearby GW_170, groundwater levels increased during the recharge season, particularly from March-May. However, the springtime elevation increase was present prior to when Mud Creek recharge operations began in WY 2017, suggesting groundwater levels are responding to other factors as well, possibly recharge at the down-gradient recharge sites (Figure 50).

GW_117 water levels rose during recharge season, peaked in May and leveled off at a higher summertime elevation compared to the fall (Figure 49). The 2009-2024 dataset from GW_117 suggests multiple influences (Figure 51).

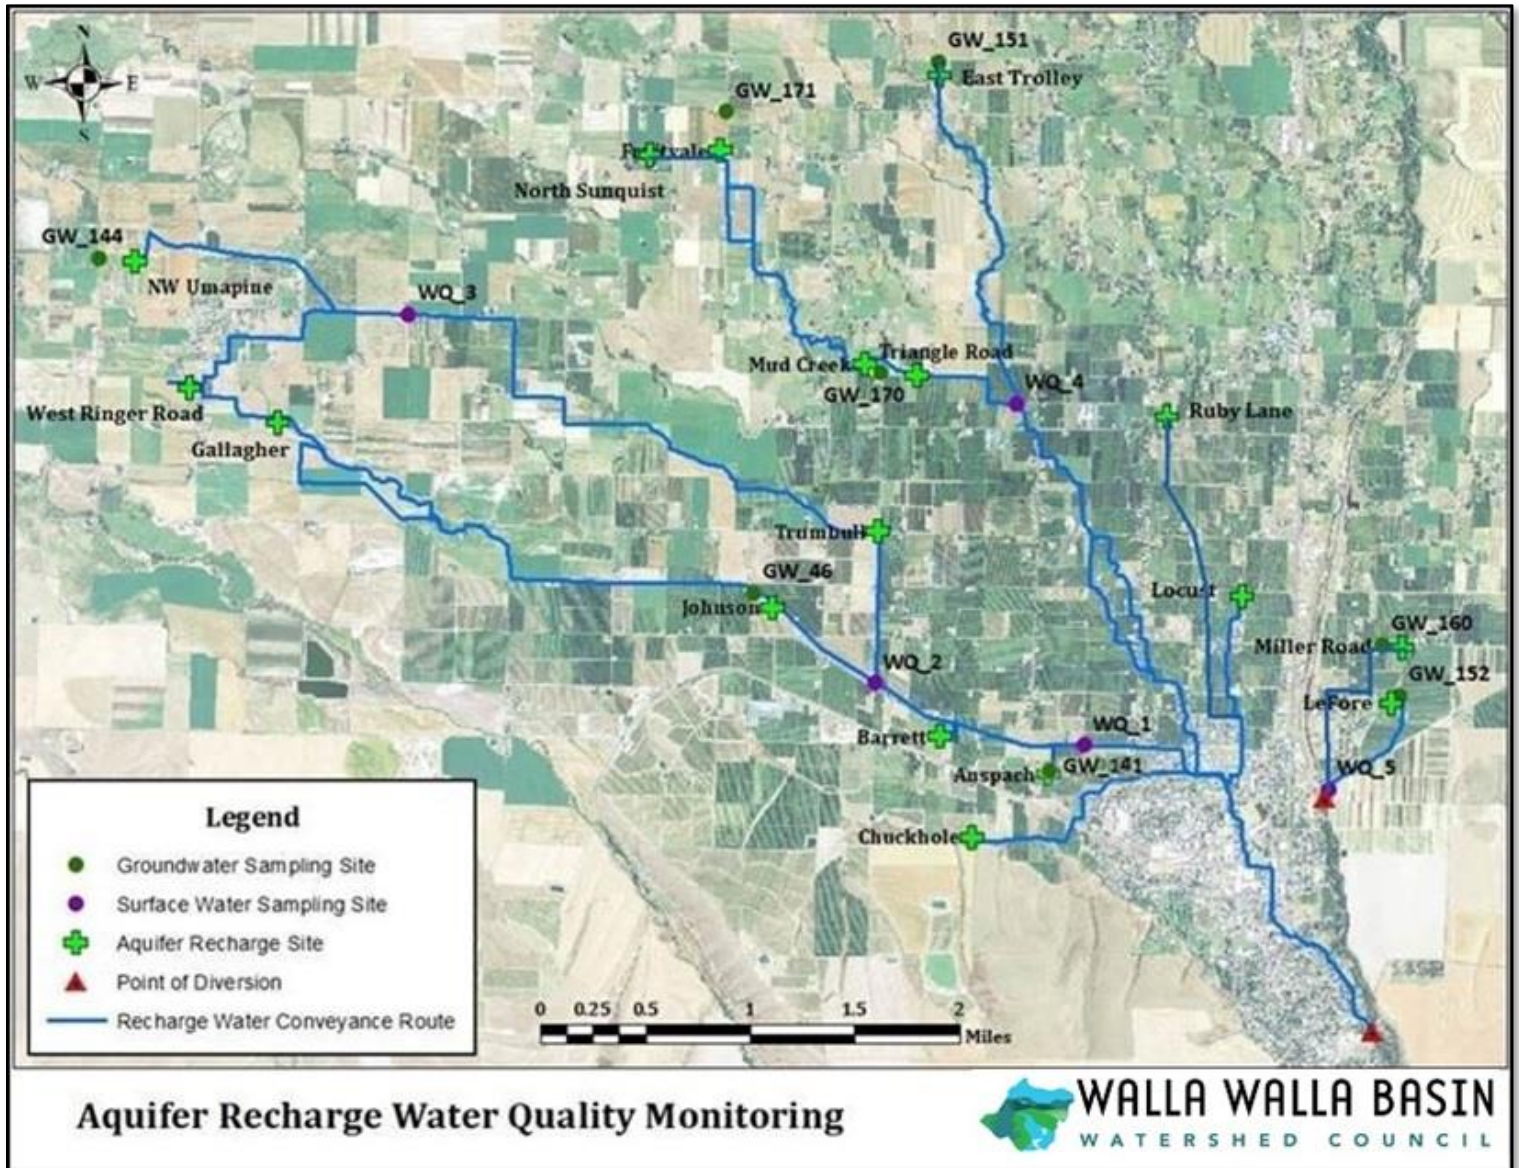
Figure 82. Water quality sampling locations for the managed aquifer recharge program in WY 2024.

In accordance with limited license LL-1848, water quality samples were collected once before and once after the recharge season. Grab samples of source water at five locations and groundwater at 8 locations were collected on November 14-15, 2023 and May 20-21, 2024 (Figure 82). The five source water locations were as follows: Source Water #1 (Zerba Weir), Source Water #2 (Duff Weir, S-418), Source Water #3 (Huffman-Richartz Split), Source Water #4 (Fruitvale, S-318), and Source Water #5 (Eastside). The eight groundwater wells were as follows: GW_046, GW_141, GW_144, GW_151, GW_152, GW_160, GW_170, and GW_171.

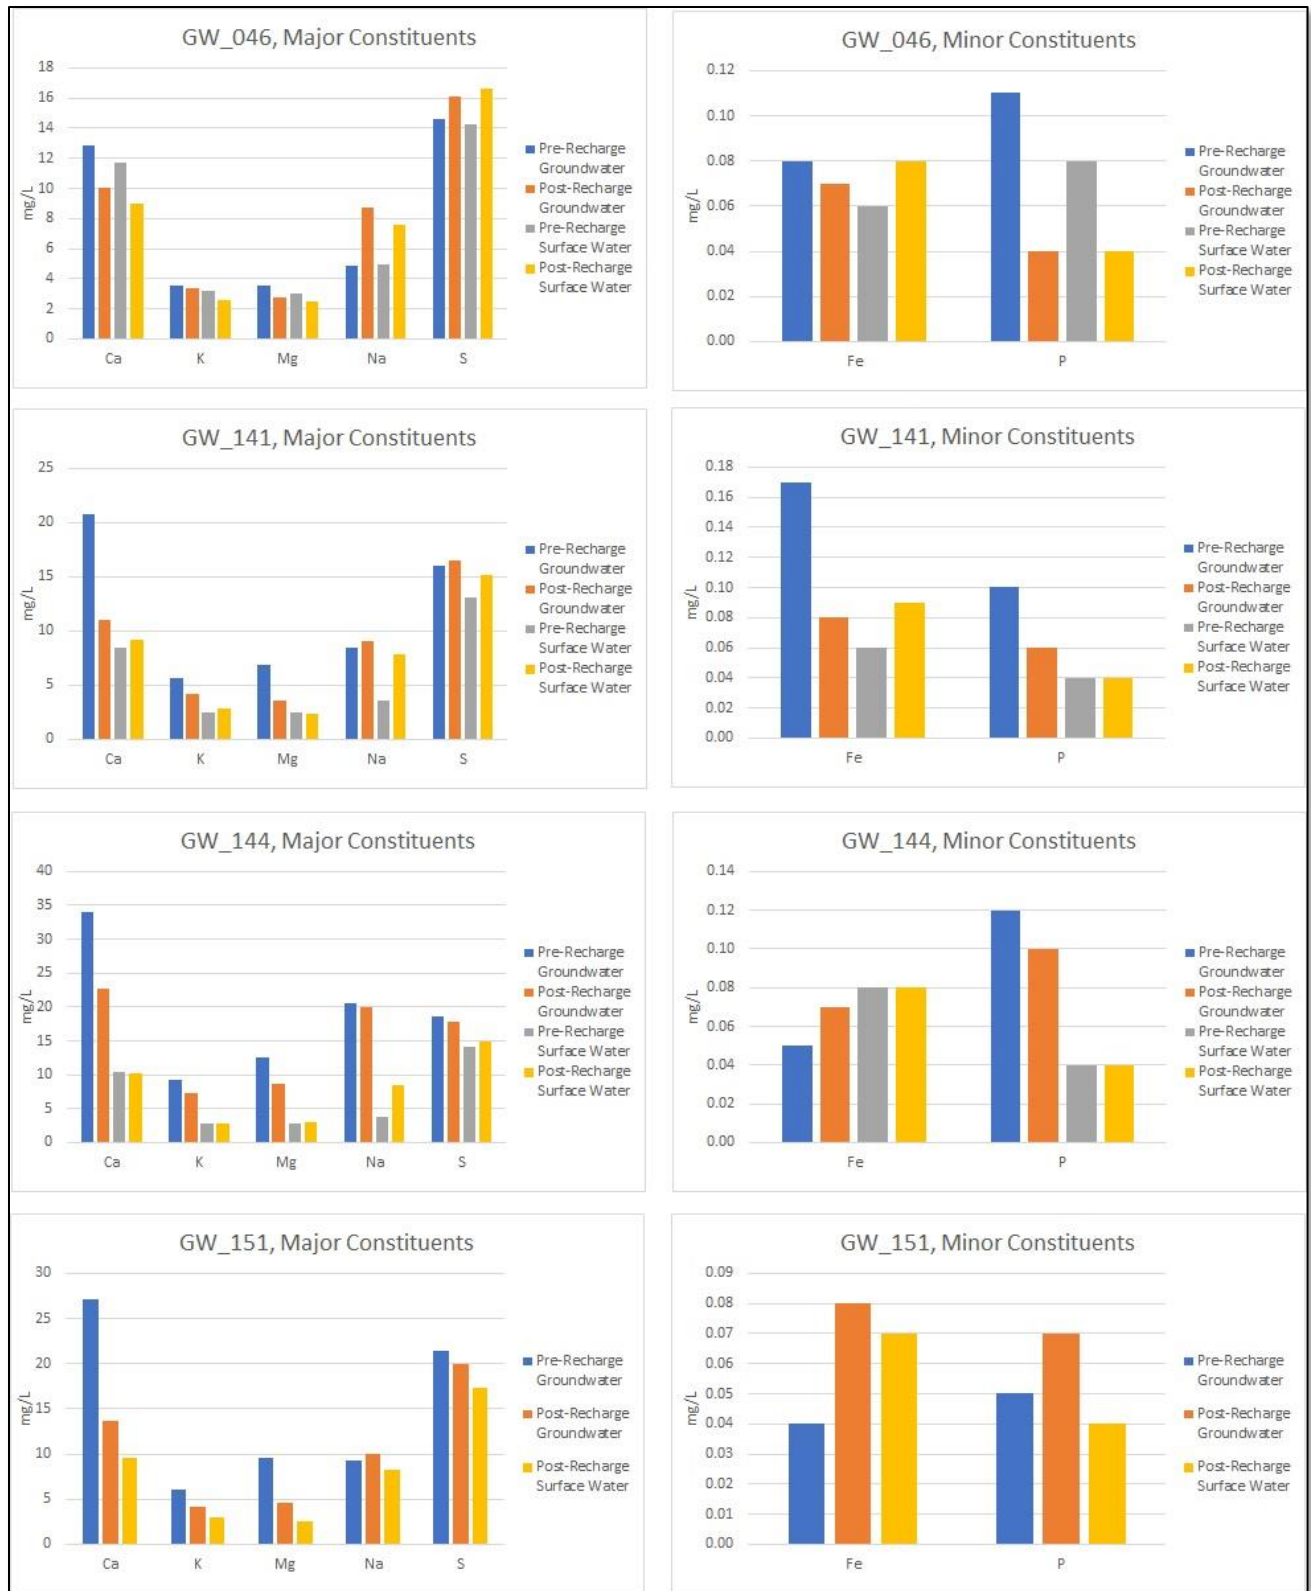
Figure 83. Water quality data, Unibest method, GW_046, GW_141, GW_144, and GW_151. GW_151 doesn't have pre-recharge surface water results due to Water Source #4 (Fruitvale, S-318) being dry during the pre-recharge sampling on November 14, 2023.

Figure 84. Water quality data, Unibest method, GW_152, GW_160, GW_170, and GW_171. GW_170 and GW_171 don't have pre-recharge surface water results due to Water Source #4 (Fruitvale, S-318) being dry during the pre-recharge sampling on November 14, 2023.

The water quality data suggest it is unlikely that groundwater quality degradation is occurring due to operation of the recharge sites. Often, the groundwater constituent concentrations are lower after recharge ends than before recharge begins. Out of 56 groundwater constituent concentrations measured with the Unibest method prior to and after recharge season, concentrations were lower (improved) after the recharge season in 52% of the values. Constituent concentrations in the source water were lower (better) than in the receiving groundwater in 91% of the pre-recharge and 89% of the post-recharge values. In 9 cases, source water contained a higher concentration than the receiving groundwater for a given constituent in both pre- and post-recharge sampling. In 5 of the 9 cases, this occurred with iron, in 2 cases for sulfur, in 1 case for sodium, and in 1 case for phosphorus (Tables 7-8 & Figures 84-85). The difference in iron concentrations in source water compared to groundwater in these 5 cases ranged from 0.01 to 0.03 mg/L (detection limit for the Unibest method is 0.05 mg/L). The difference in sulfur concentrations in source water compared to groundwater in these 2 cases was 0.38 to 0.49 mg/L (detection limit for Unibest method is 0.02 mg/L). The difference in phosphorus concentrations in source water compared to groundwater in the 1 case is 0.01 mg/L (detection limit for the Unibest method is 0.02 mg/L). The difference in sodium concentrations in source water compared to groundwater in the 1 case is 0.04 mg/L (detection limit for the Unibest method is 0.02 mg/L).
