North Fork Walla Walla River Sam's-Rea Design

Conceptual Design Report

PPS1007211143BOI | Final

Walla Walla Basin Watershed Council

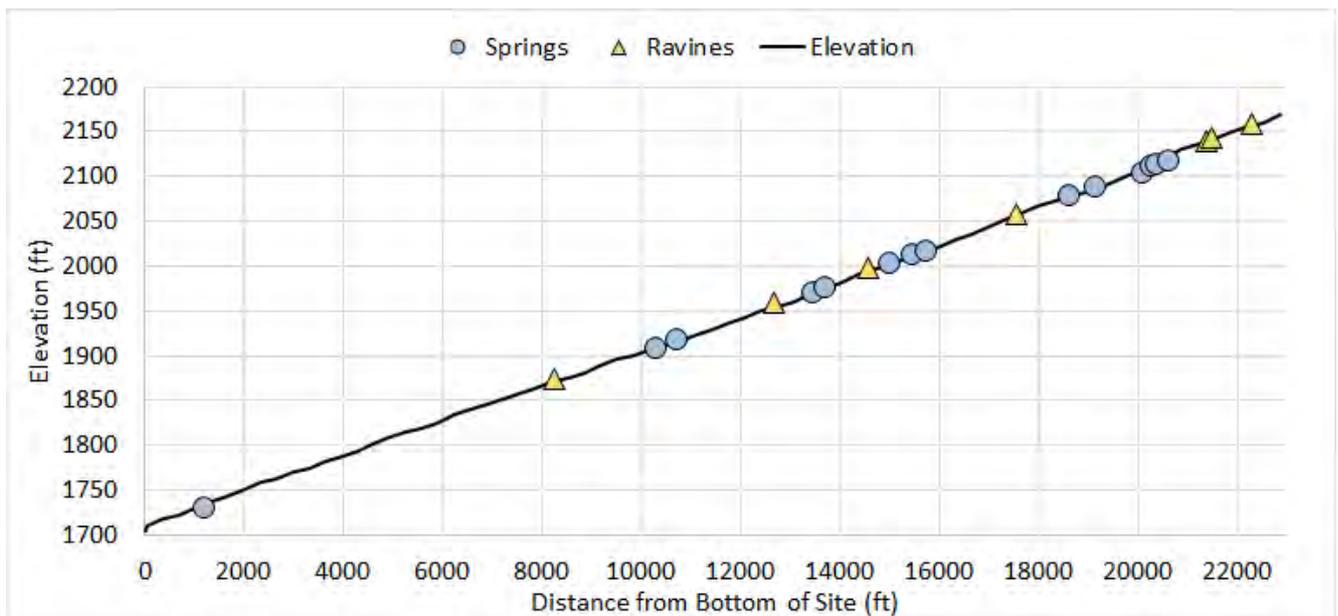
Figure ES-2. Main Stem Channel Bed Longitudinal Profile with Locations of Springs and Ravines that Cross the North Fork Walla Walla River Road through the Project Reach

Note: For all graphics, the left side of the horizontal axis is the downstream end.

An unpaved road within the floodplain parallels the north bank of the river through most of the Project reach. Travel through the Project reach and access into the upper watershed are difficult, due to significant erosion of the roadway that has occurred where the road intersects ephemeral drainages, or ravines, that flow into the main stem. The road also disconnects numerous spring seep sources from the main stem, which has caused ponding on the uphill side of the roadway and has reduced groundwater inputs into the main stem. Figure ES-2 shows the location of these springs and ravines in the Project reach.

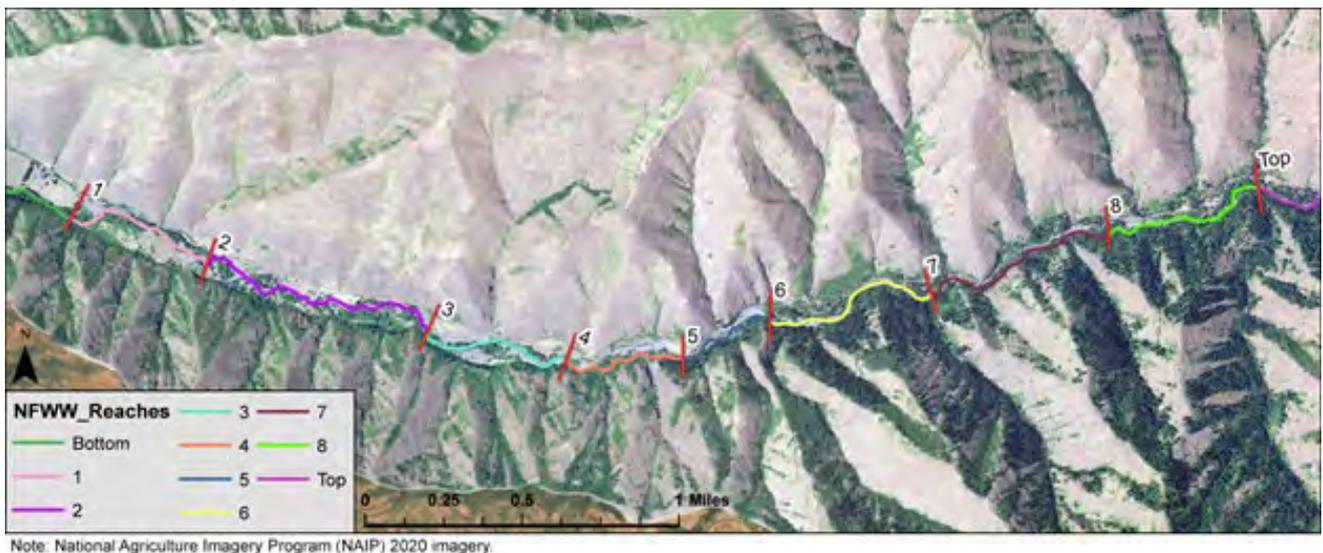
Figure ES-3. Overview of Reach Break Locations

The characterization of source, transport, and response reaches are critical to understanding watershed- and reach-scale hydrologic, hydraulic, and geomorphic processes, and to designing projects that are self-sustaining. The valley bottom width in the NF Walla Walla River fluctuates with fans, terraces, exposed bedrock, and the valley margin that force more confined sections. Reaches within the Project area were determined based on defining characteristics within the valley bottom, alluvial channels, and contributing hillslopes. Eight distinct reaches were identified based on longitudinal differences in hydrogeomorphic characteristics that influence river form and function (Figure ES-3). The downstream half of the Project area is generally wider than the upstream half. Channel slope is approximately 2%, and low flow (6 cfs) channel widths range from 11 to 15 meters.

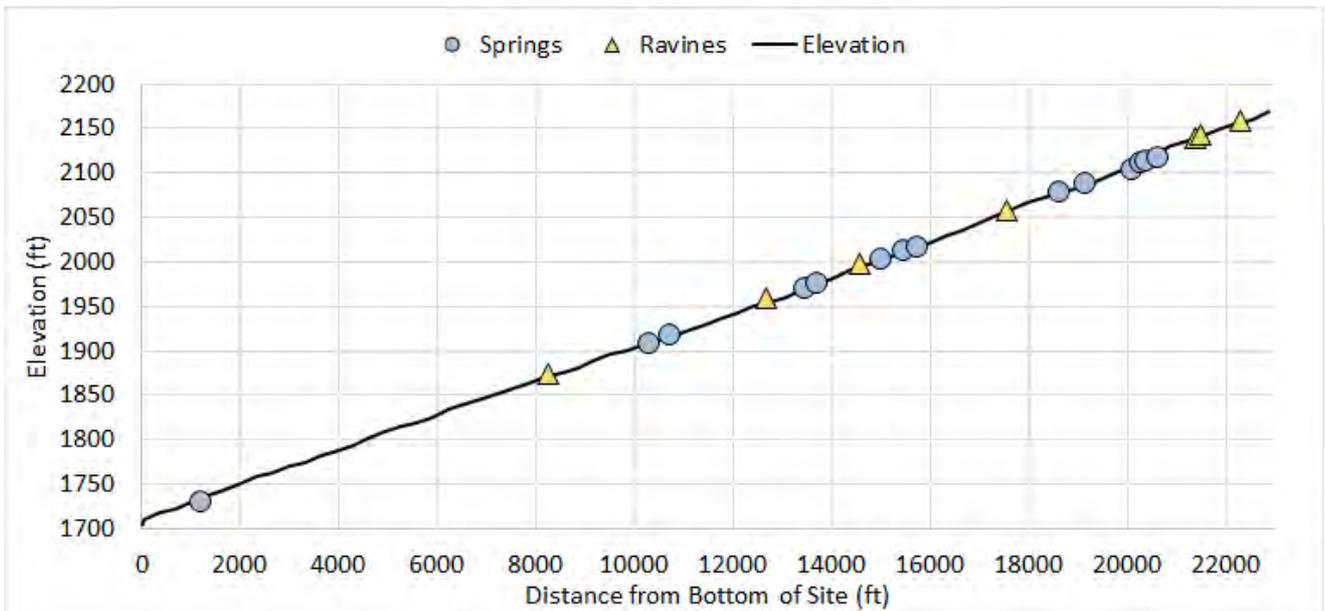
Figure 3. Main Stem Channel Bed Longitudinal Profile with Locations of Springs and Ravines that Cross the North Fork Walla Walla River Road through the Project Reach

Note: For all graphics, the left side of the horizontal axis is the downstream end.

An unpaved road within the floodplain parallels the north bank of the river through most of the Project reach. Travel through the Project reach and access into the upper watershed are difficult, due to significant erosion of the roadway that has occurred where the road intersects ephemeral drainages, or ravines, that flow into the main stem. The road also disconnects numerous spring seep sources from the main stem, which has caused ponding on the uphill side of the roadway and has reduced groundwater inputs into the main stem. Figure 3 shows the location of these springs and ravines in the Project reach. The proposed improvements to reconnect these springs to the main channel have been addressed in detail in the Springs Reconnection Memo (Appendix B).

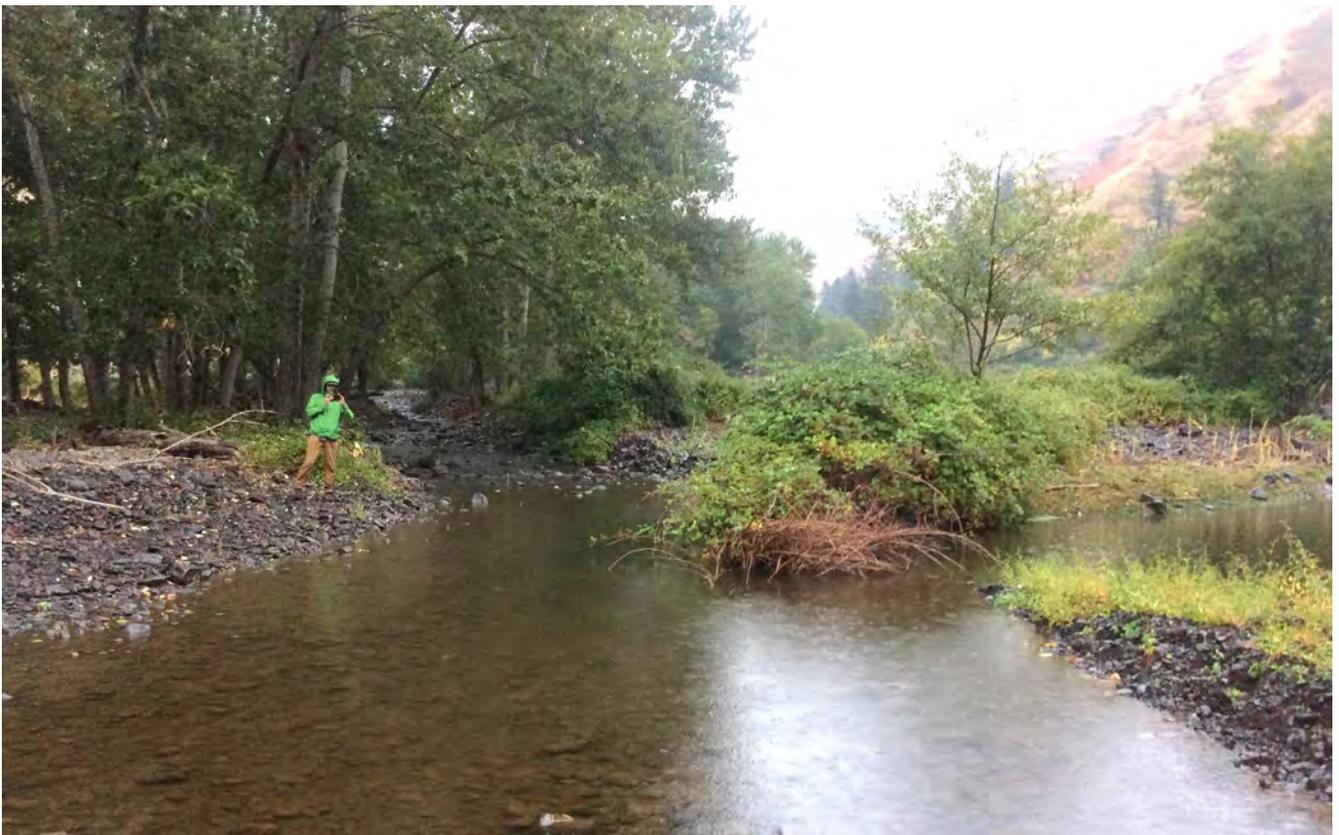
Figure 4. Postrestoration Vision for the North Fork Walla Walla River Sam's-Rea Reach

The floodplain would have complex topography with depression areas and upland areas that support a diverse mix of native aquatic, riparian, and upland vegetation. Wood structures would provide habitat complexity in the main stem, off-channel, and floodplain, and create roughness and micro-sites for establishing vegetation on the floodplain. Recolonization of the site by beavers would contribute to Project success and sustainability. Figure 4 illustrates an existing portion of the Sam's-Rea Reach that contains many of the elements of this vision.

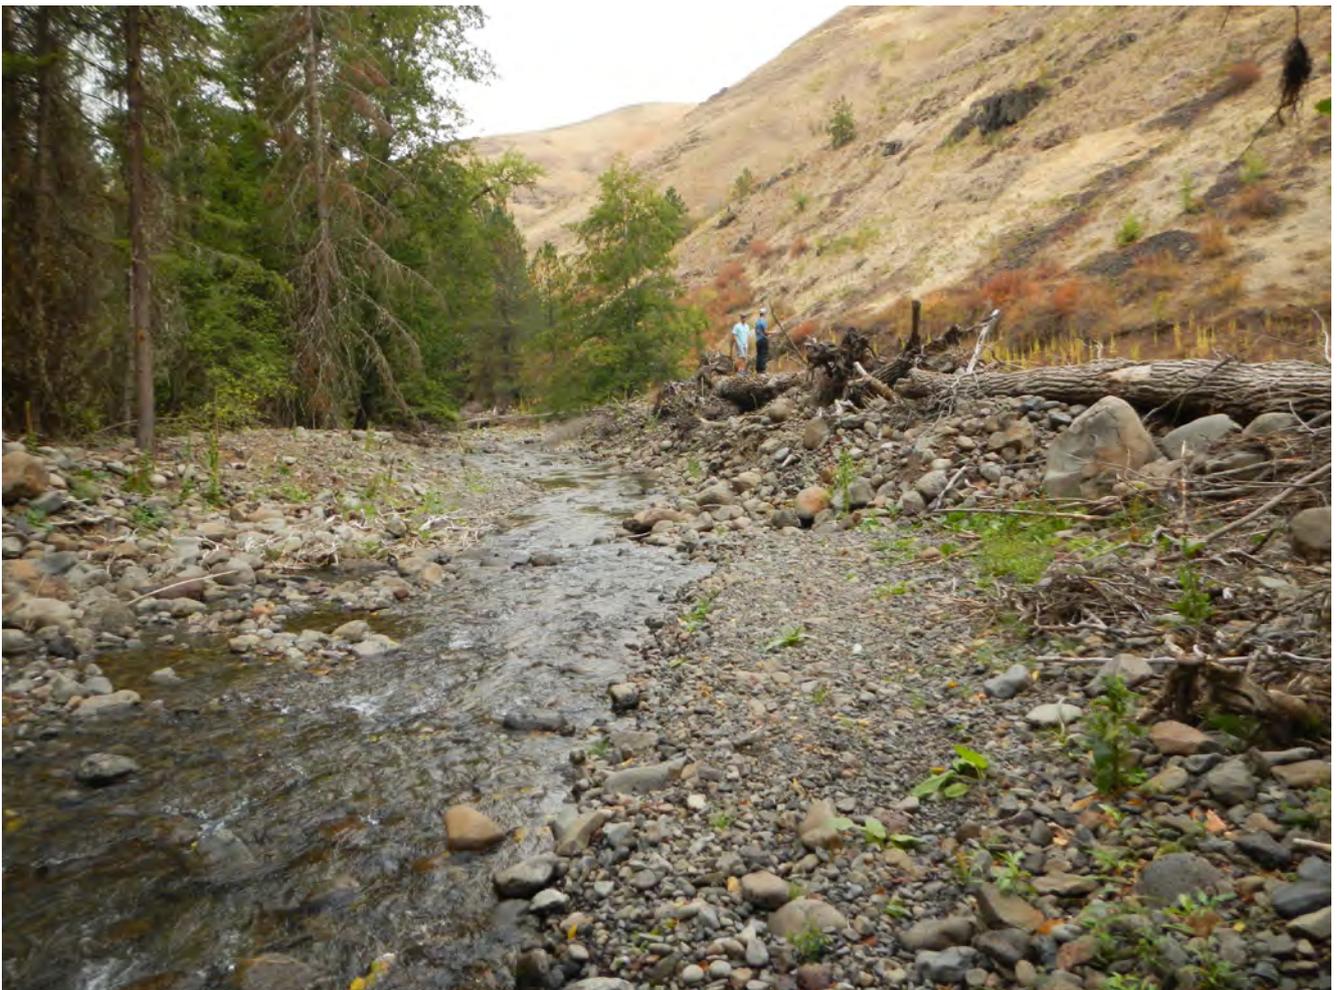
Figure 6. Pushup Levee Constructed After the 2020 Flood Events (Near River Mile 9.1; Photo is Facing Downstream, and Staff are Standing on Top of the Levee on River Right)

Evidence of anthropogenic actions to the stream channel was also observed during the site visit. In total, 10 pushup levees channelize the river and block flow to side channels and floodplains. Figures 6 and 7 illustrate the size and scale of these levees, and Appendix A includes the location of each levee. Although these levees are intended to reduce flood damages to the road, they drastically reduce natural floodplain function during high flow events and exacerbate downstream flooding. During the low flow conditions present during the site visit, numerous off-channel habitat features, such as side channels and alcoves, were disconnected by these levees, greatly reducing aquatic habitat complexity and connectivity. These disconnections are likely present across a wide range of flows, reducing multiple habitat uses for native salmonids throughout the Project reach.

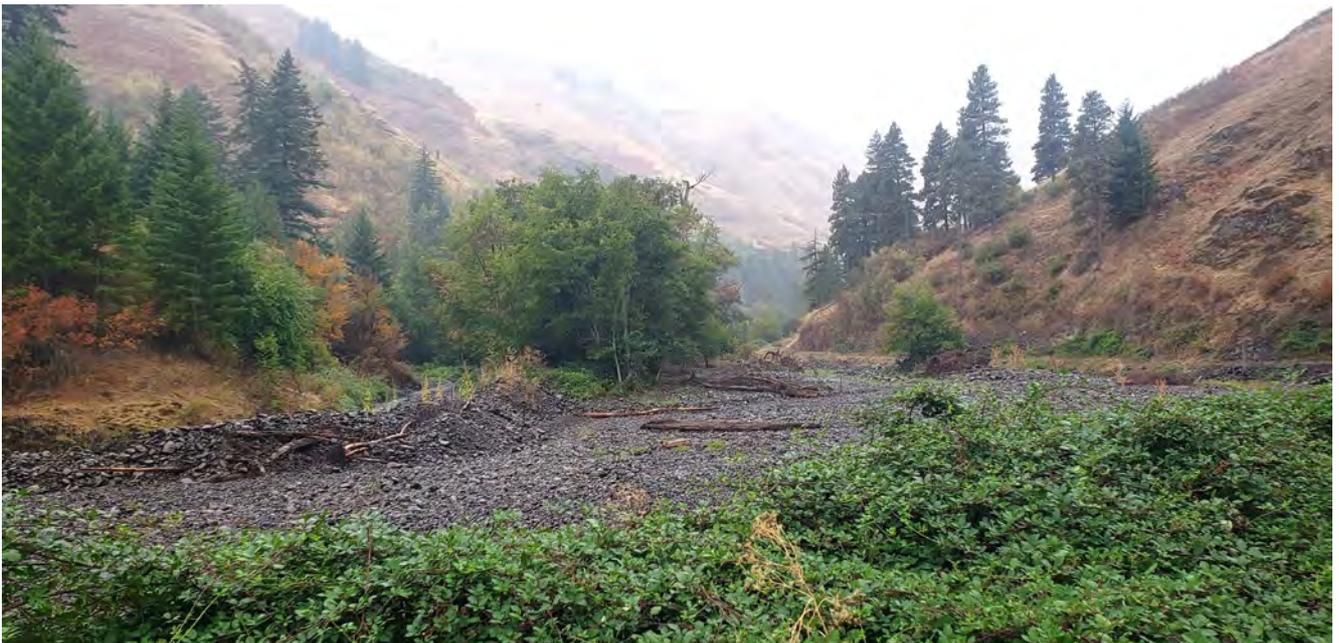
Figure 7. Pushup Levee Drastically Reducing Side Channel and Floodplain Connectivity (Near River Mile 6.2; River and Levee are on the Far Left, Disconnected Floodplain is on the Right, Road is on the Far Right, Photo is Facing Downstream)

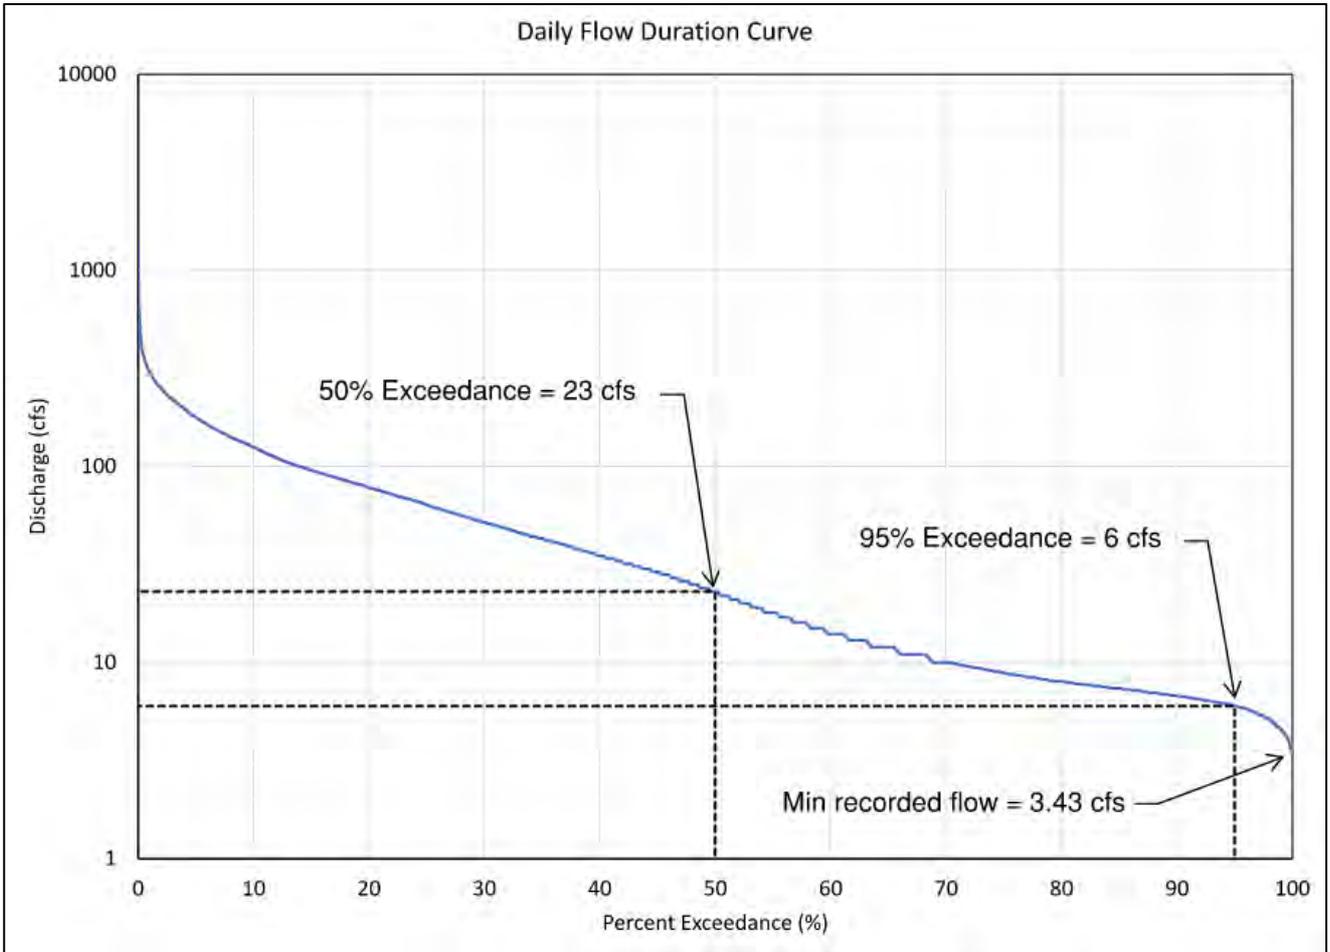
Figure 8. Daily Flow Duration Curve for the North Fork Walla Walla River Sam's-Rea Reach

Hydrology of the NF Walla Walla River was evaluated to characterize the magnitude of large floods and low flow conditions in the Sam’s-Rea Reach. A flood frequency analysis was performed for the NF Walla Walla River using the annual peak discharge data collected at OWRD gage station 14010800 (location shown on Figure 2), and Table 2 includes the resulting peak flow statistics. Additionally, a daily flow duration analysis was performed with the daily discharge data collected at this stream gage to determine the daily mean flow values that have been exceeded for various percentages of the total period of record. Figure 8 shows the daily flow duration curve from this analysis. Appendix B includes a detailed memorandum describing the complete hydrologic analysis of the NF Walla Walla River.

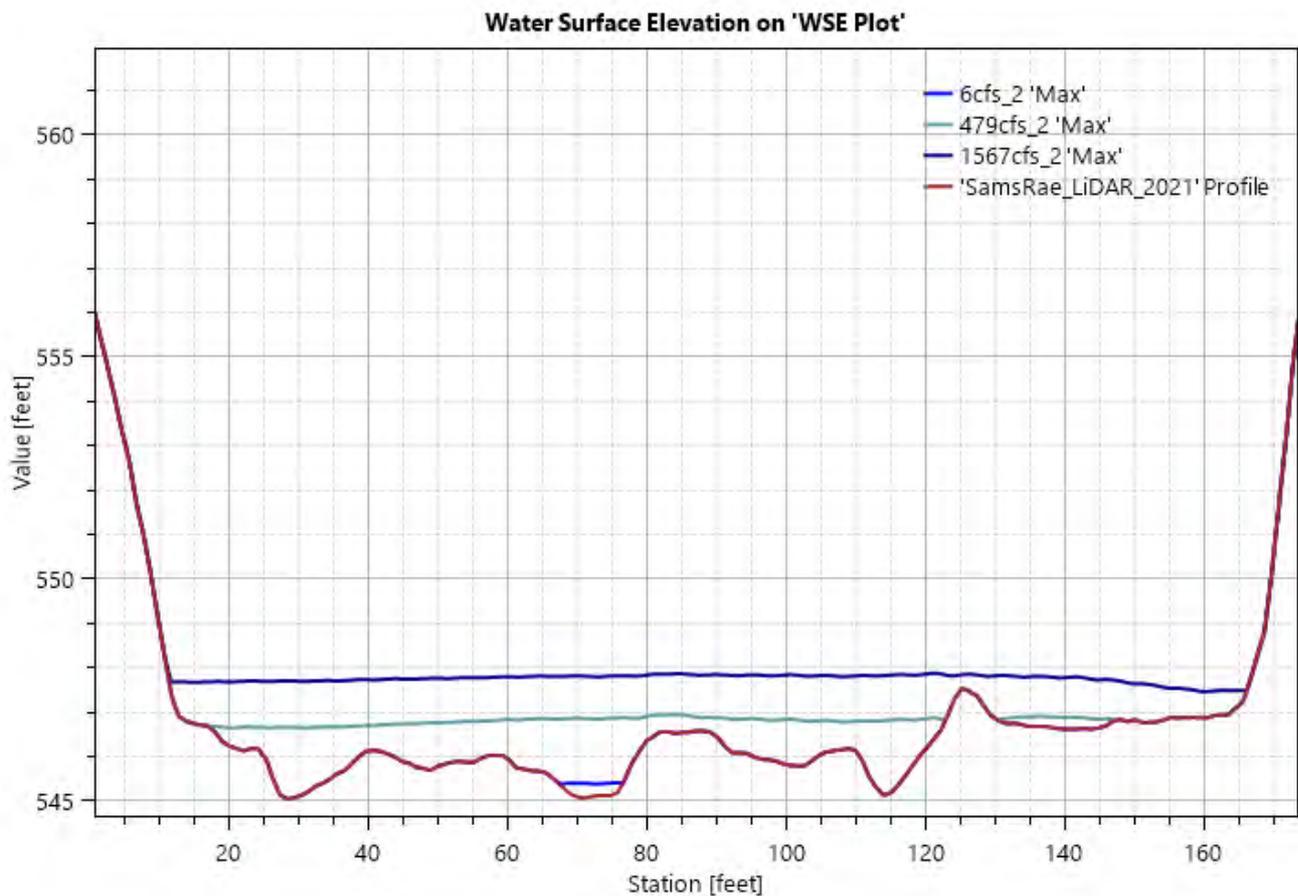
Figure 9. Water Surface Elevations for Flows Modeled at Low Flow (6 cfs), 2-year Flow (479 cfs), and 100-year Flow (1,567 cfs) Showing a Well-connected Floodplain (Note the Presence of Multiple Channels in the LiDAR Terrain Profile)

Preliminary model results were visualized and evaluated using geographic information system to produce reach-scale maps showing water surface extents and flow patterns for the low flow, 2-year flow, and 100-year flow simulations. Appendix A provides these maps, and Figure 9 shows a cross-section with the water surface elevation results from the three model simulations.

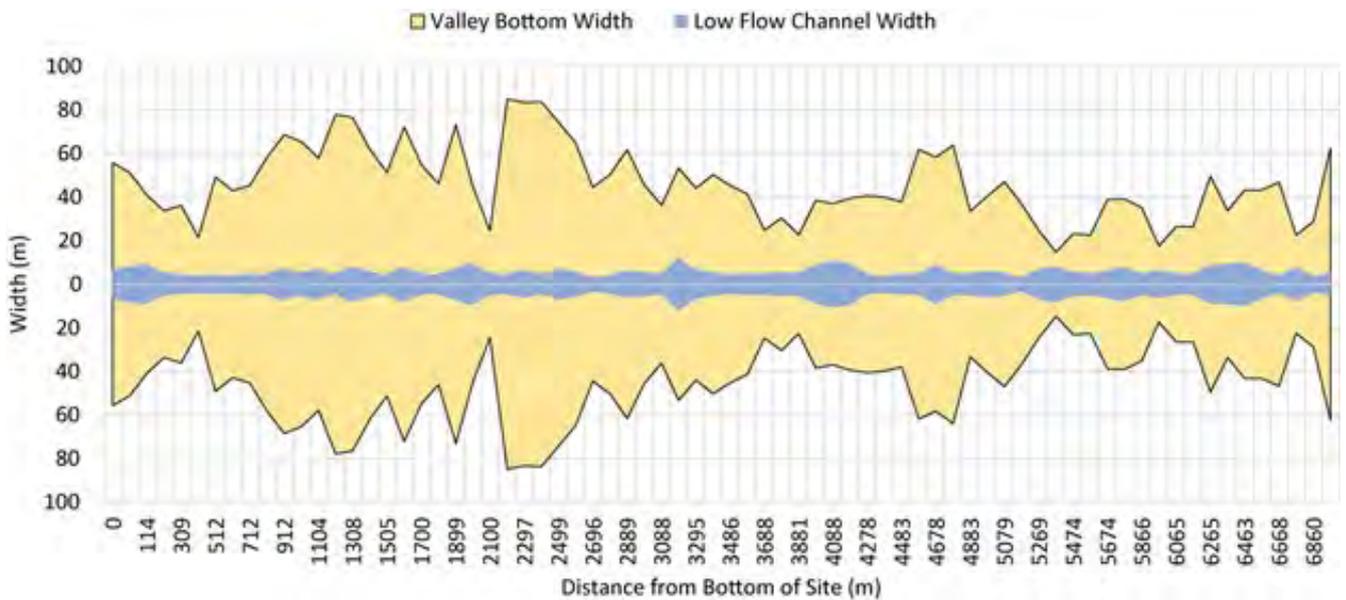
Figure 10. Profile of Valley Bottom Width and Low Flow Wetted Channel Width Through the Project Area

A river valley bottom represents the maximum extent of potential floodplain and channel migration zone. The valley bottom width in the NF Walla Walla River fluctuates with fans, terraces, exposed bedrock, and the valley margin that forces more confined sections (Figure 10). The downstream half of the Project area is generally wider than the upstream half. This trend is expected when moving upstream in a watershed; however, fans from tributaries impose additional confinement on the valley bottom.

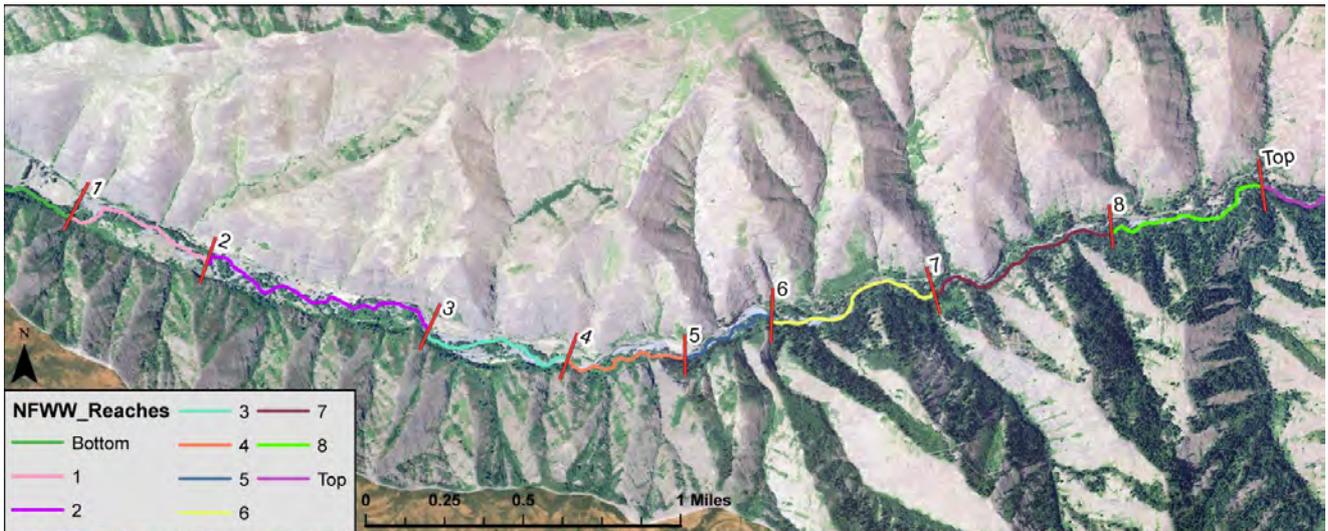
Note: National Agriculture Imagery Program (NAIP) 2020 imagery.

Figure 11. Overview of Reach Break Locations

Reaches within the Project area were determined based on defining characteristics within the valley bottom, alluvial channels, and contributing hillslopes. Eight distinct reaches were identified based on longitudinal differences in hydrogeomorphic characteristics that influence river form and function (Figure 11). Each reach was further refined based on a visual assessment of condition using remote sensing analysis and ground validation. Reach lengths range from 563 to 1,410 m, with an average reach length of 924 m (Table 4). Tables 5 and 6 summarize defining characteristics of each reach.

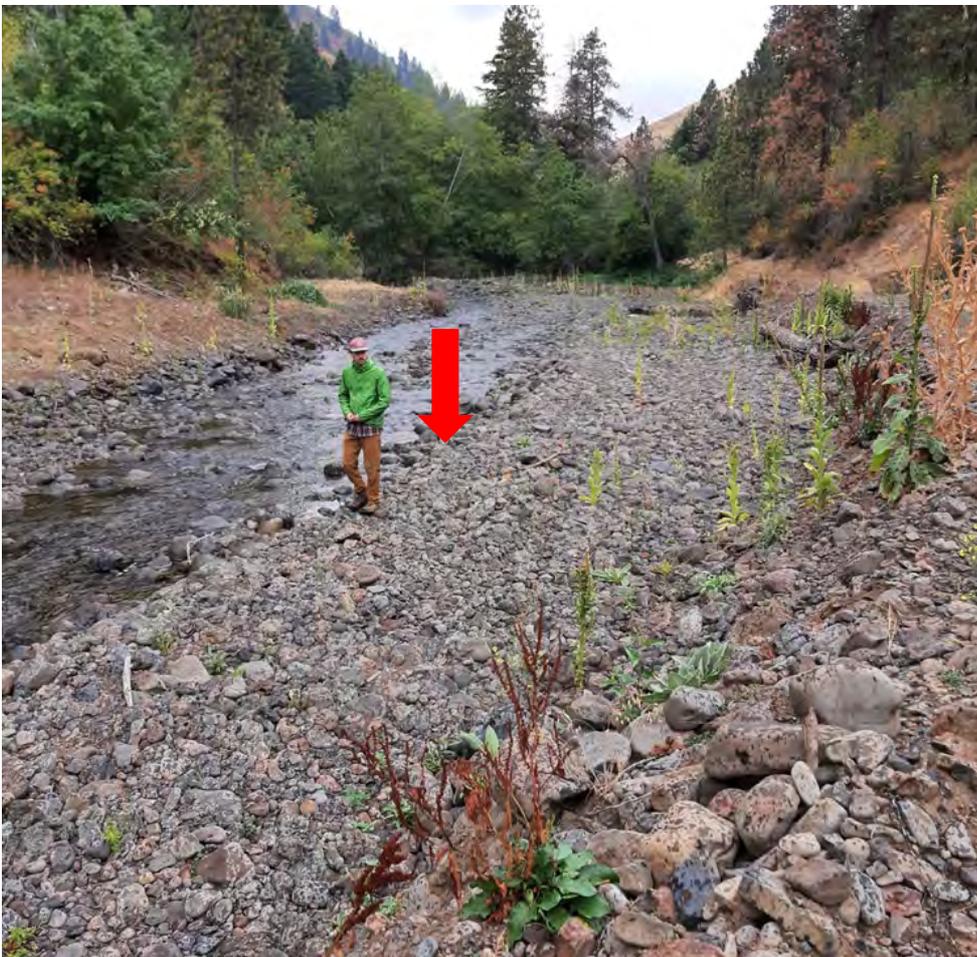
Figure 12. River Reach Near River Mile 8.1 that is Experiencing Active Channel Downcutting (Incision) Due to Confinement

Levees constrict the channel and initiate an unsustainable negative feedback loop of processes that destabilize the channel. For example, a constricted channel increases velocities and shear stresses, increases channel bed and bank erosion, reduces groundwater elevations, and reduces forage for wildlife and livestock. Even with just 1 year of flows following creation of the channel-constricting road near RM 8.1, field observations suggest that the channel is actively incising (downcutting). Figure 12 shows this location.

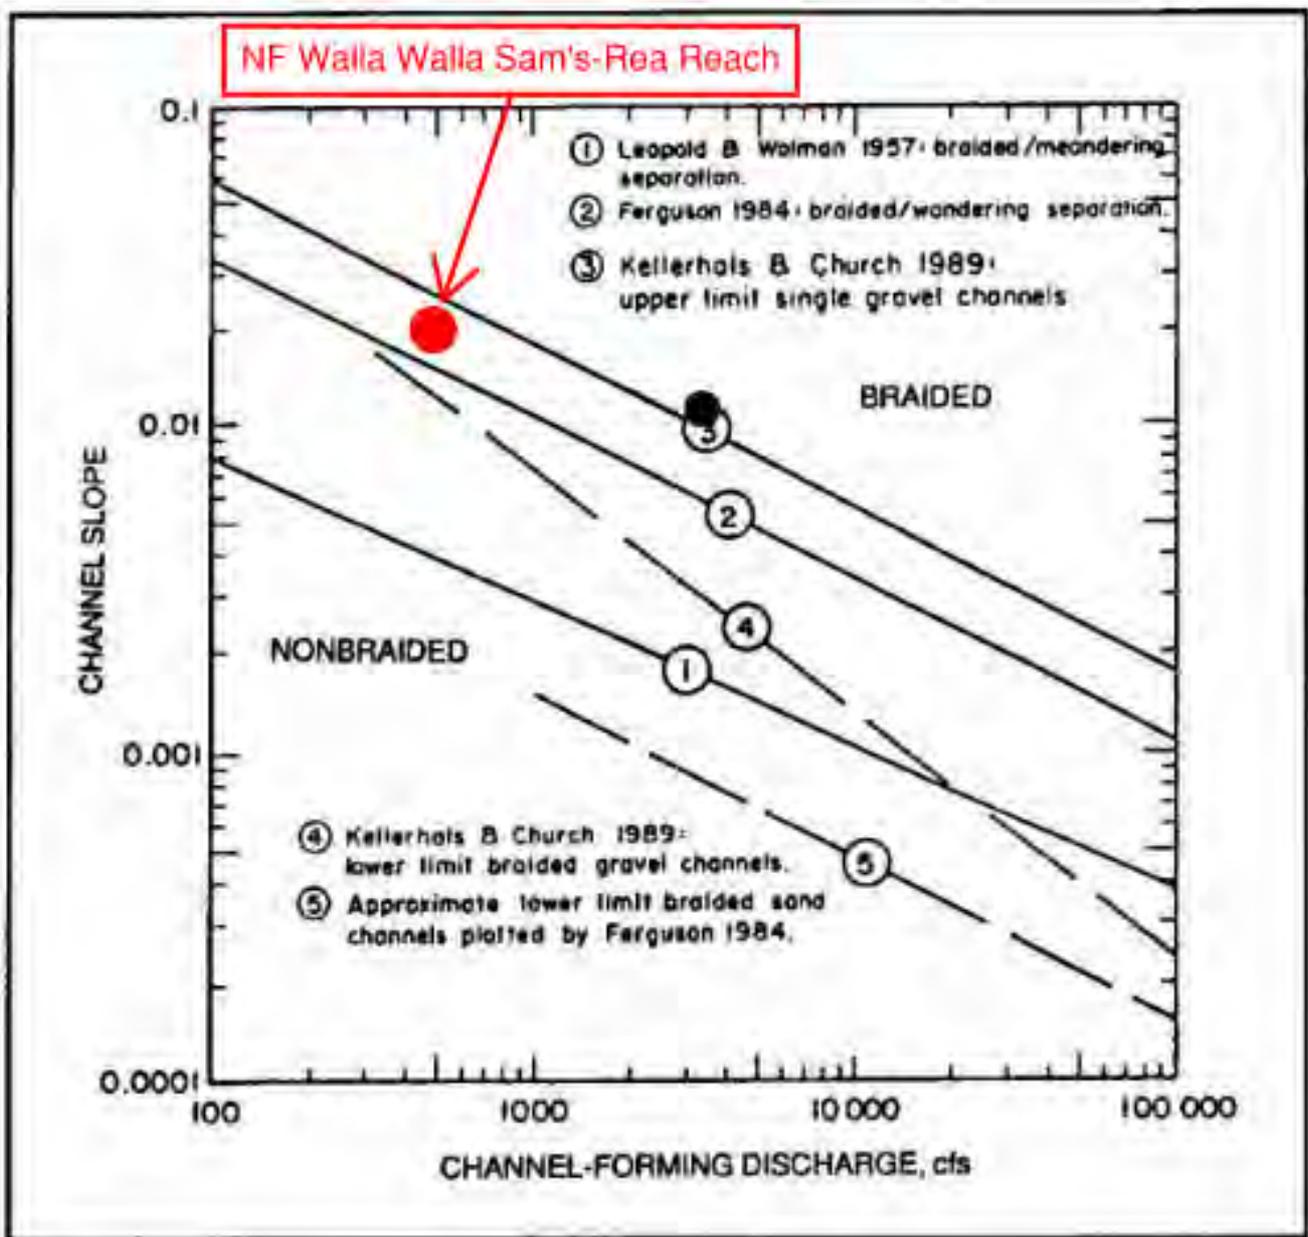
Figure 13. Project Reach (2-year Discharge and Reach Average Slope) Plot Position on Slope-discharge Chart Distinguishing Braided from Nonbraided Channels
 Source: USACE, 1994.

Designing and constructing a single-threaded meandering channel is a suitable approach in some geomorphic settings, but the planform of the NF Walla Walla River in the Project reach tends more toward a wandering or braided (multithread) channel rather than a nonbraided (meandering, single thread) channel. Factors that contribute toward a braided channel include increases in slope, discharge, and sediment supply. Figure 13 illustrates the relative position of the Project reach on a graphic prepared by USACE (1994), which summarizes threshold lines of five different studies comparing slope-discharge relationships and channel planforms. With a channel-forming (2-year) discharge of 479 cfs and an average slope of approximately 2%, the Project reach plots well into the range of braided channels (see the red dot on Figure 13); therefore, trying to design and construct a single-threaded meandering channel is not recommended as a sustainable and stable approach in this river system.

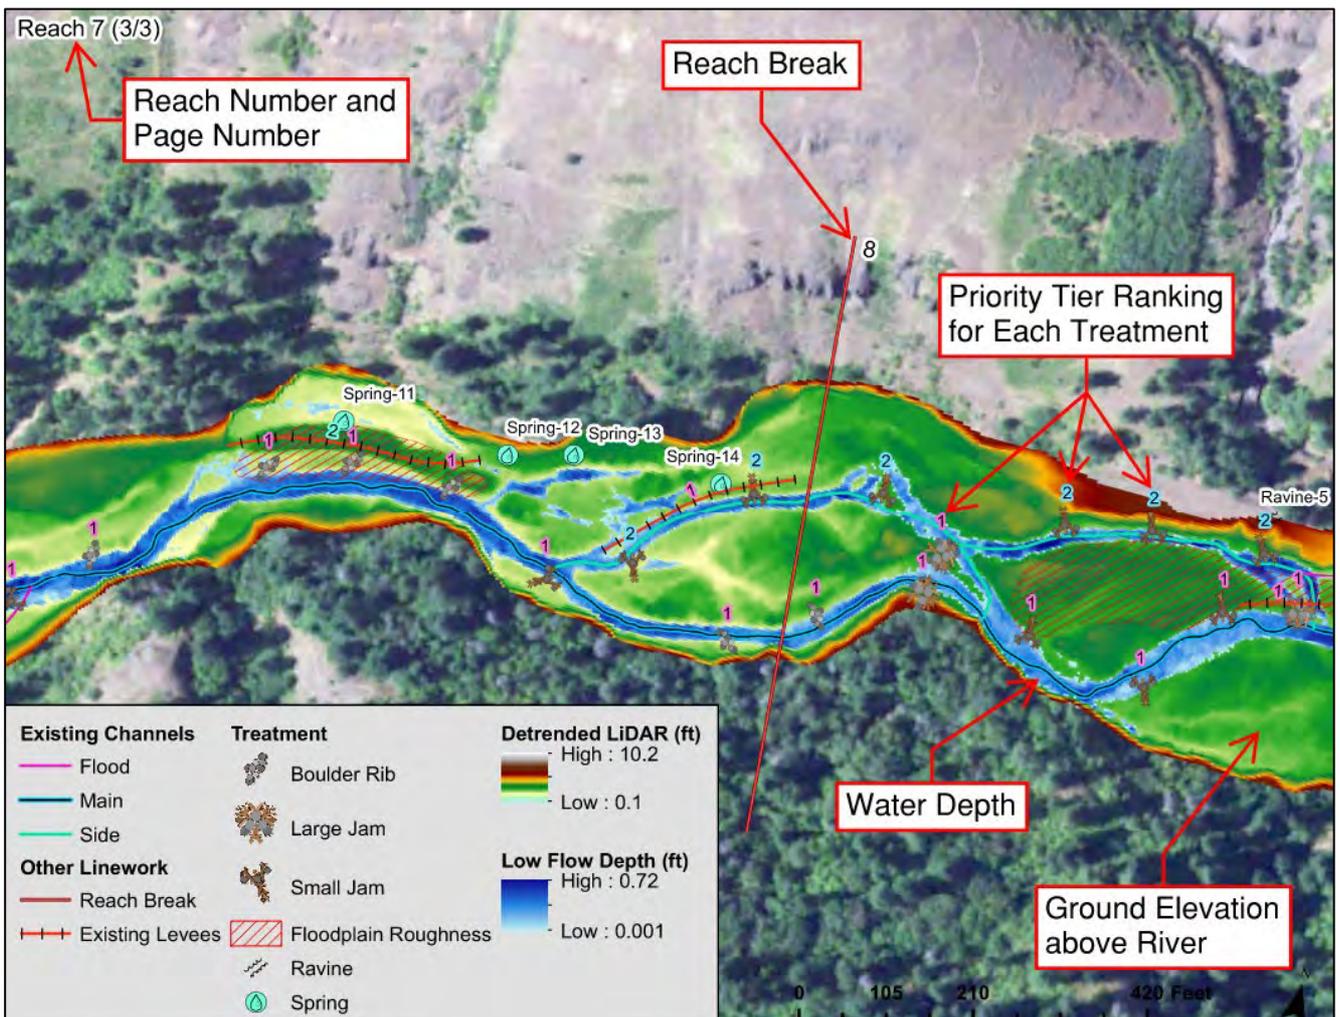
Figure 14. Concept Map Example, including Priority Tier Rankings for each Design Element

The design elements have been incorporated into the concept design in several ways and will be refined in future design phases to achieve structure, reach, and Project objectives. The design elements have been assigned a 3-tier priority ranking (1 = highest priority, and 3 = lowest priority) based on the expected magnitude of geomorphic and biologic benefits. As Figure 14 illustrates, the concept maps in Appendix A indicate the priority tier for each design element.

Table 7 summarizes the design elements from Appendix A, by reach and priority tier. For the entire 5.3-mile Project reach, a total of 31 boulder ribs, 44 large jams, and 205 small jams have been proposed. The total proposed increase in floodplain roughness is more than 30 acres.

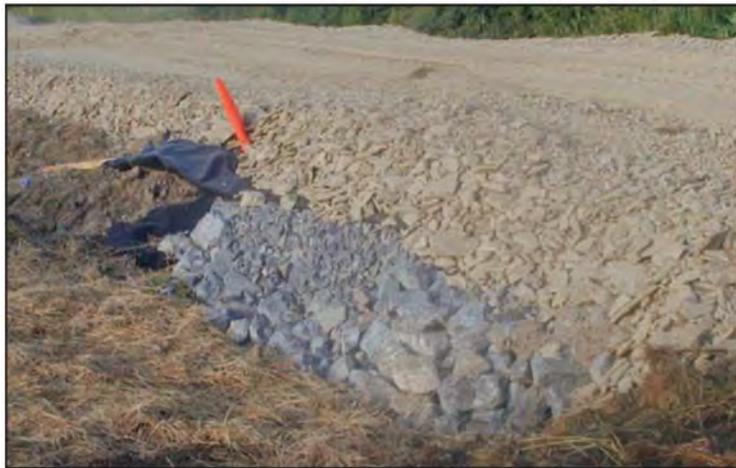
Figure 3. Porous Rock Mattress – Side View of Actual Installation

Porous rock mattresses (for example, French mattresses) are typically utilized in areas where the roadway fill is less permeable than the surrounding soils, and the roadway prism intercepts the natural subsurface flow path of groundwater or shallow surface flow, causing surface ponding on the uphill side of the road. They allow the water to flow through highly permeable roadbed substrate while maintaining the structural integrity of the roadbed for vehicular traffic. Additionally, this treatment is applicable where installing cross drains and culverts would be difficult due to the surrounding grades and vegetation. Porous rock mattresses also allow the water to be shielded from the warming effects of the sun while flowing subsurface below the roadbed, improving downstream water quality and reducing roadway erosion. Figures 2 and 3 provide graphical illustrations of porous rock installations.

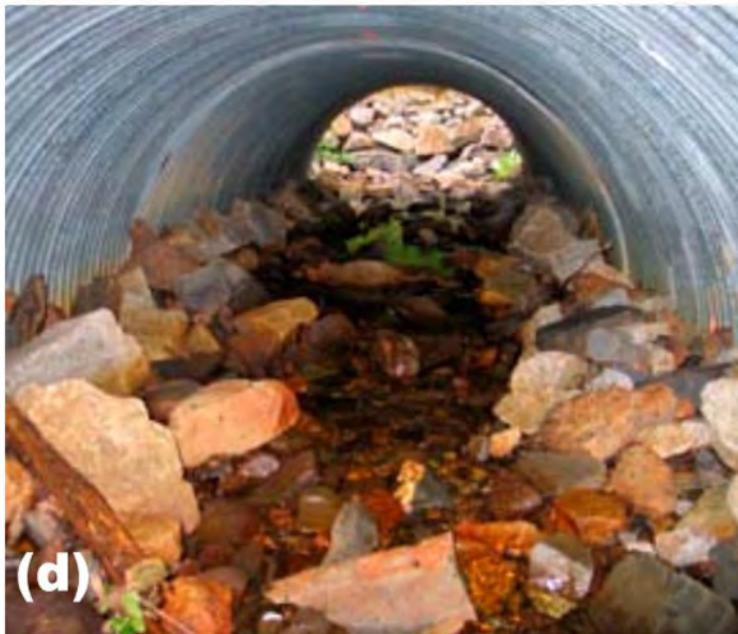
Figure 4. Open-bottom Arch Pipe Example

The open-bottom arch culvert is a common application for stream-road crossings that allows for adequate channel spans and natural channel bottom stream simulations for AOP. Open-bottom arch culverts are constructed using galvanized steel, aluminum, or steel-reinforced materials, depending on the application conditions. Concrete footings are typically constructed as a connection foundation for the open-bottom arch culvert. Care (through engineering analysis) must be taken to ensure that the footings are not undermined by scour, which could compromise the open-bottom arch culvert system that supports the overlying roadbed. Figure 4 shows a typical open-bottom arch pipe application.

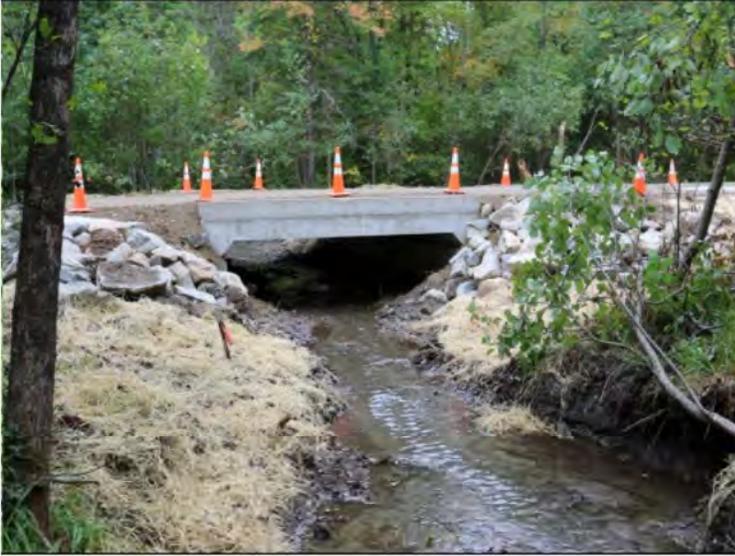
Figure 5. Three-sided Box Culvert Example

A three-sided box culvert is another bottomless option for stream-road crossings that provides stream spanning flexibility while accommodating AOP considerations for a long-term solution. This option can be constructed using steel-reinforced concrete, galvanized steel, or aluminum materials. Figure 5 shows a three-sided box culvert installation example.

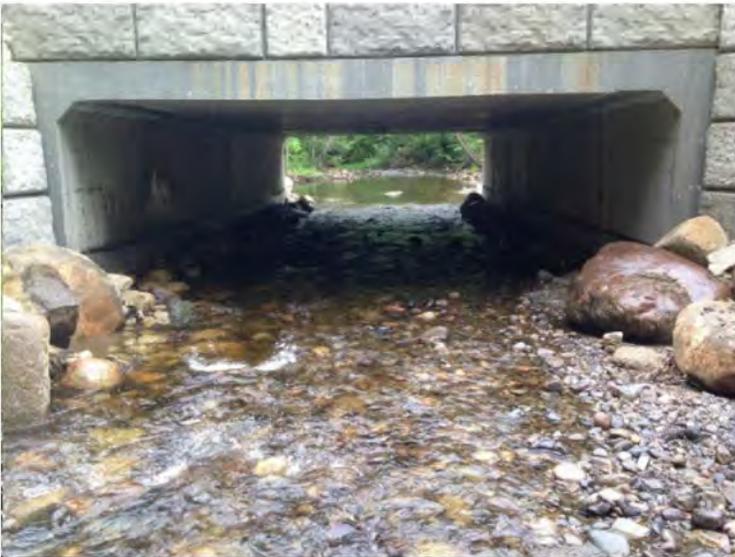
Figure 6. Embedded Box Culvert

Embedded culverts consist of box culverts, arch pipes, and round pipes. Embedded culverts allow for substrate to be placed in the invert area of the culverts, but do not allow for the fluctuations of natural geomorphic processes that open-bottom structures provide. The embedded culverts have a fixed bottom that limit the natural scour and deposition of substrate. The embedded culvert must span the stream, which limits round pipes to low-flow applications. Materials limit the lifespan of the embedded culvert relative to the exposed bottom portion of the culvert that are subject to submersion and corrosion. Figures 6 and 7 depict examples of embedded culverts.

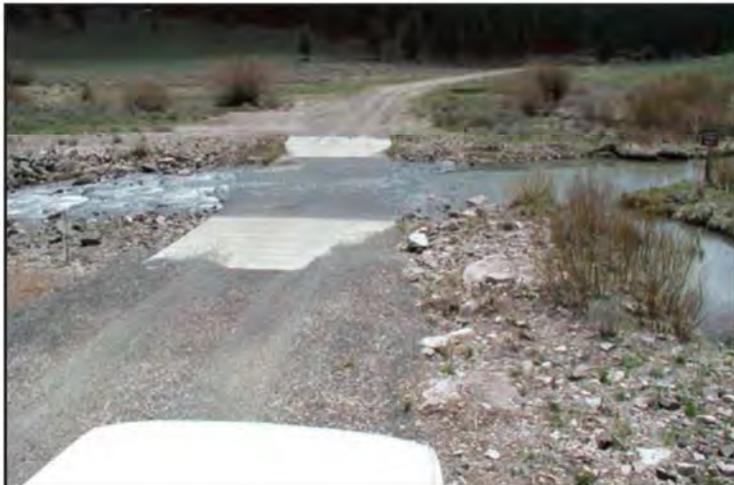
Figure 8. Low-water Ford Example

A low-water ford is installed at or near streambed elevations and can be surfaced with rock, concrete, or other materials. This treatment option is typically installed in ephemeral or low baseflow channels and where the channel is broad and shallow. Figure 8 depicts a typical low-water ford application.

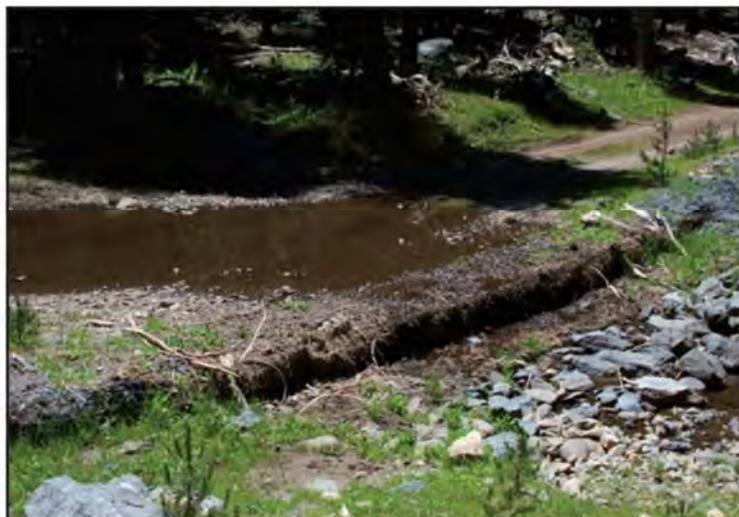
Figure 9. Gabion Ford Crossing

A gabion ford crossing is another type of low-water crossing with a different type of construction than on-grade installation. The gabion ford crossing allows for a drop in elevation on the downstream end of the crossing and is therefore not conducive for applications where AOP considerations are a factor. Figure 9 shows a typical gabion ford crossing.

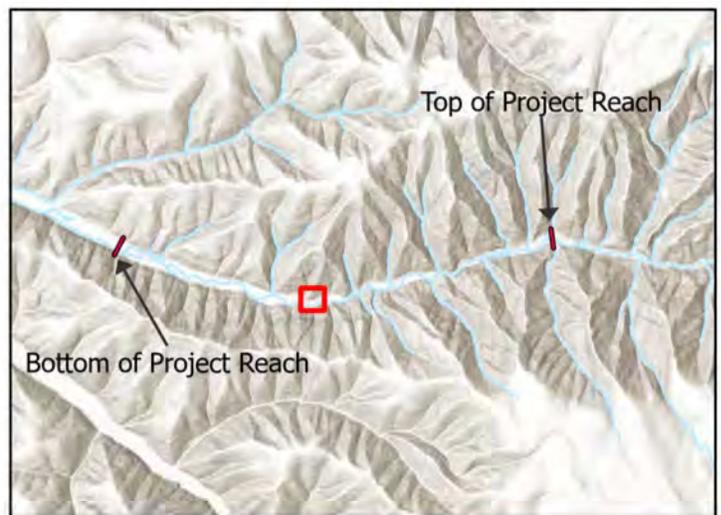
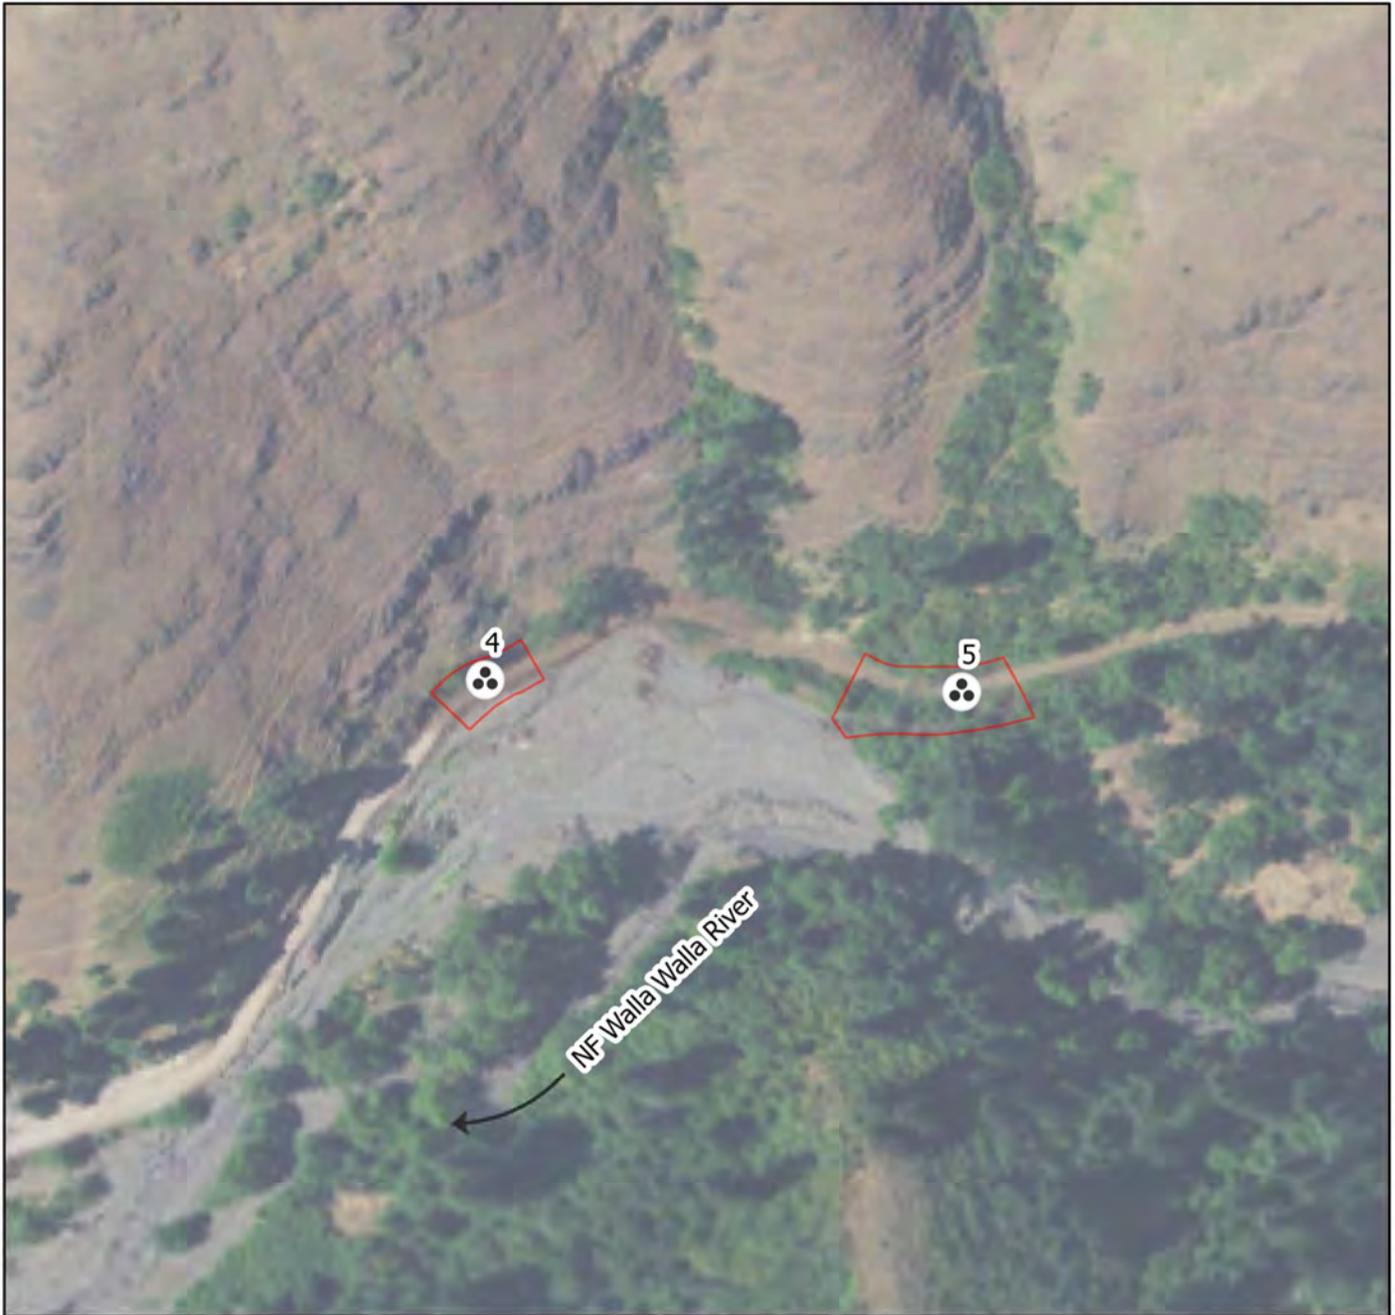
ATTACHMENT 2.2
Springs 2 and 3
 North Fork Walla Walla River Sam's-Rea Design
Proposed Conceptual Springs Treatment Applications
