North Fork Walla Walla River Sam's-Rea Design

Conceptual Design Report

PPS1007211143BOI | Final

Walla Walla Basin Watershed Council

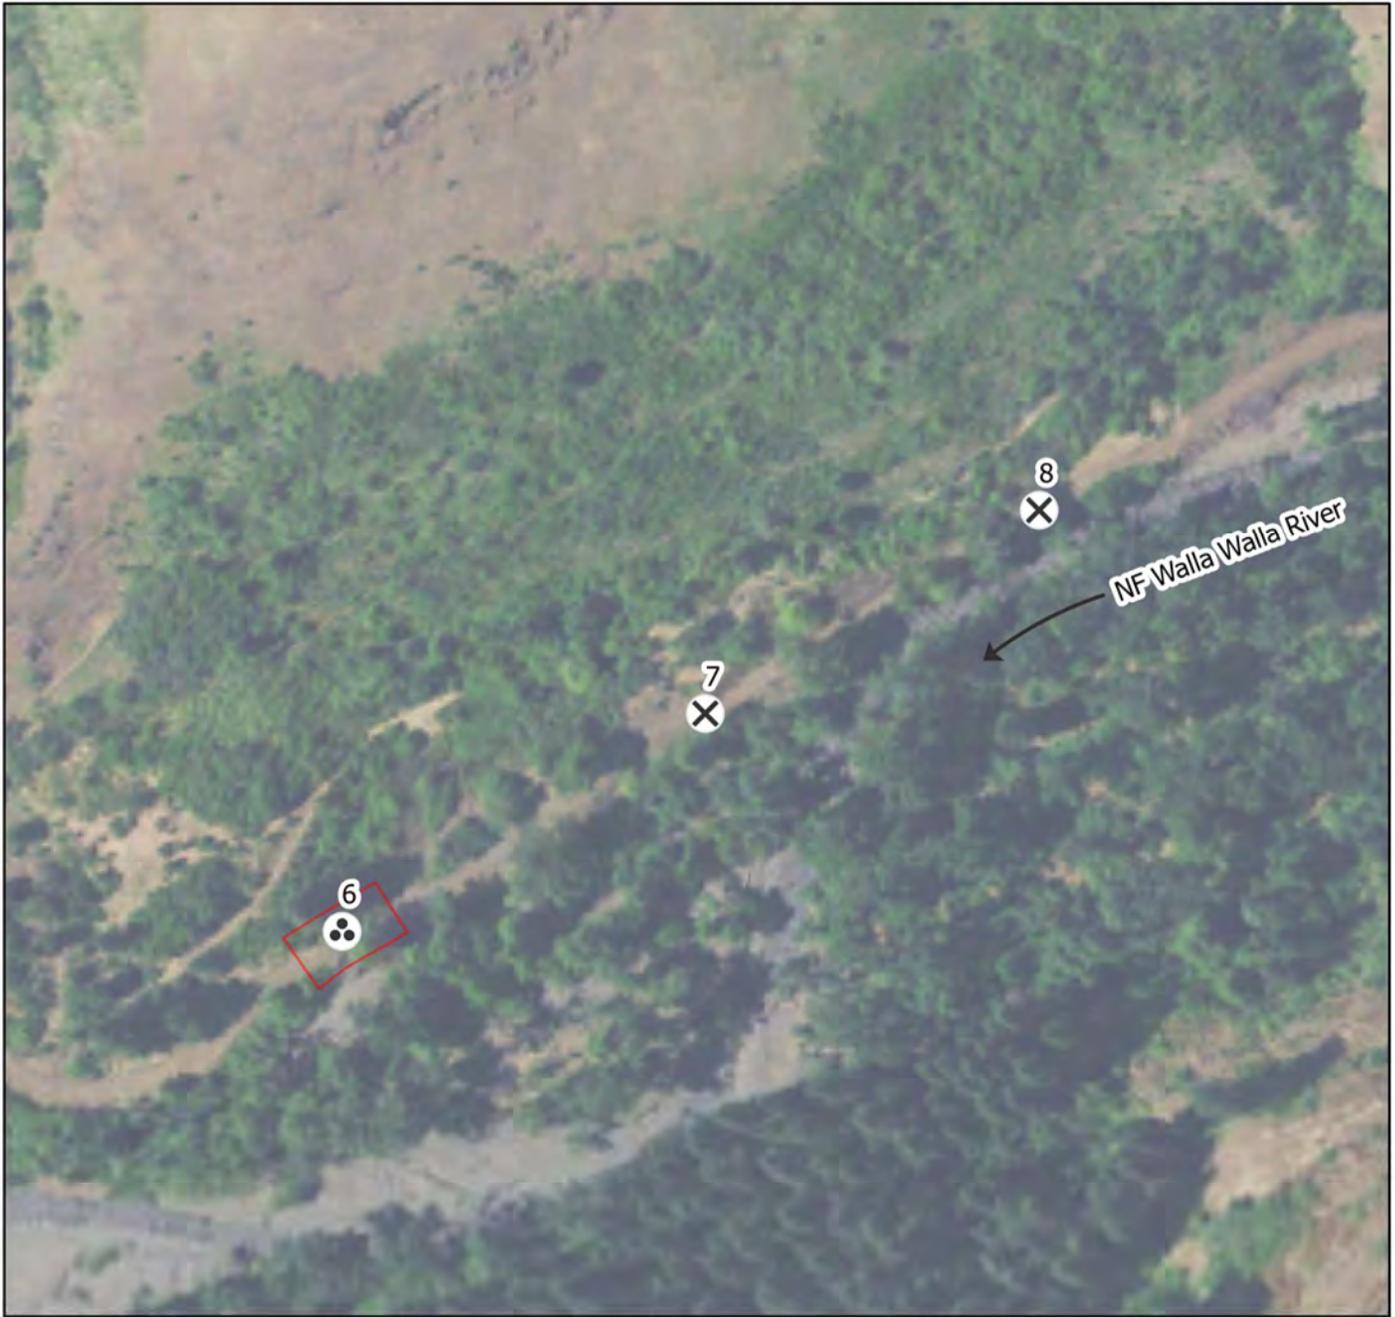
ATTACHMENT 2.3
Springs 4 and 5
 North Fork Walla Walla River Sam's-Rea Design
Proposed Conceptual Springs Treatment Applications

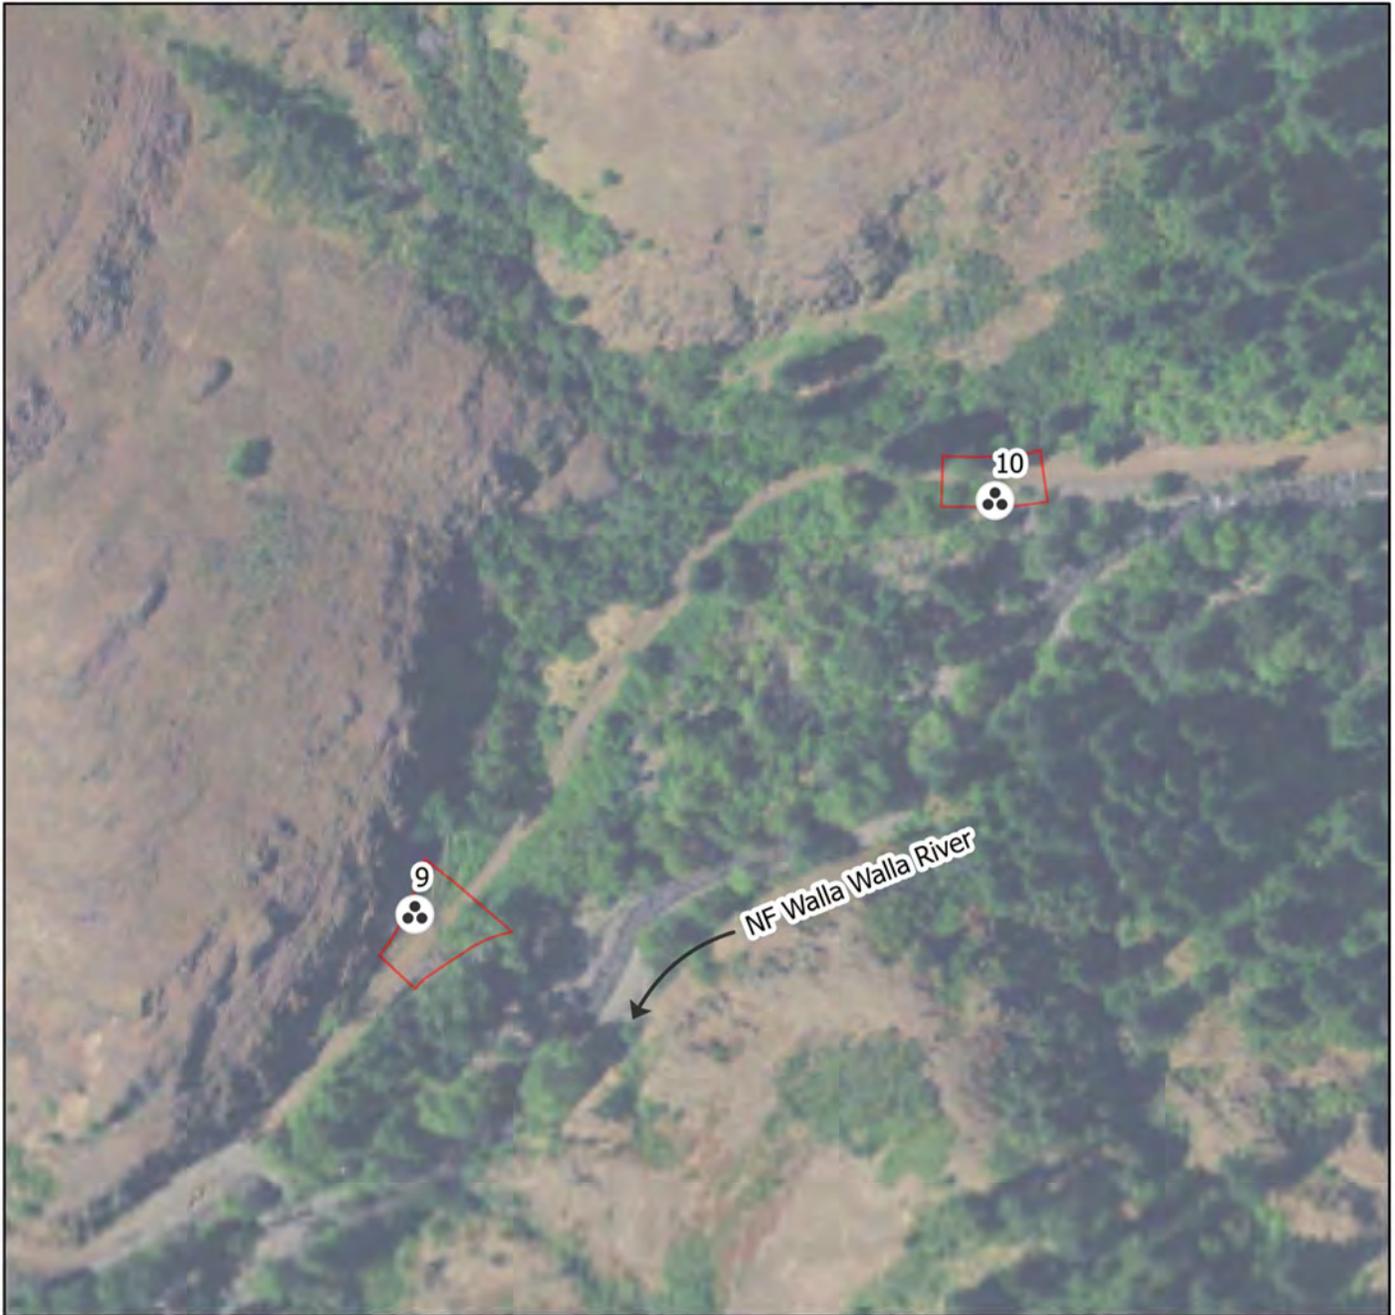
ATTACHMENT 2.4
Springs 6 through 8
 North Fork Walla Walla River Sam's-Rea Design
Proposed Conceptual Springs Treatment Applications
